# Using systems thinking to evaluate a major project

## The case of the Gateshead Millennium Bridge

Diana White and Joyce Fortune

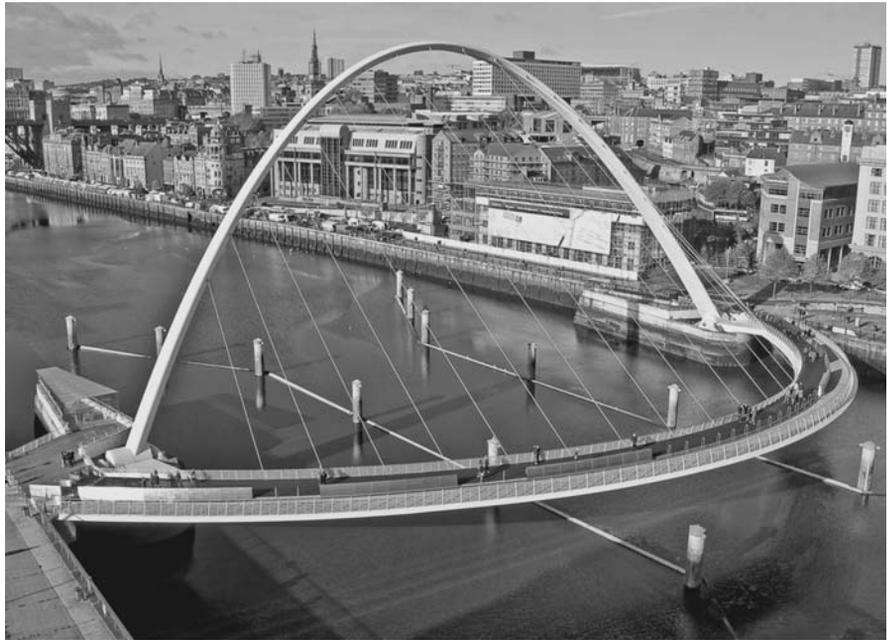
**Figure 1.**  
The Gateshead  
Millennium Bridge

The now famous winning design is shown in Figure 1. The bridge consists of two arches, one curved in plan to provide the deck and the other supporting the deck by means of 18 stressed steel suspension rods. The arches pivot around their common springing points on hinge assemblies supported by reinforced end supports situated on the riverbed approximately 5 metres from each of the quaysides. Six hydraulic rams (three housed in each end support) push or pull against steel paddles attached to the hinges rotating the deck and its supporting arch so that as the overhead arch swings downwards, the deck moves up. When they are level they offer headroom of 25 m to allow vessels to pass underneath. As Figure 2 shows, this opening and closing procedure evokes the action of an eye slowly blinking.

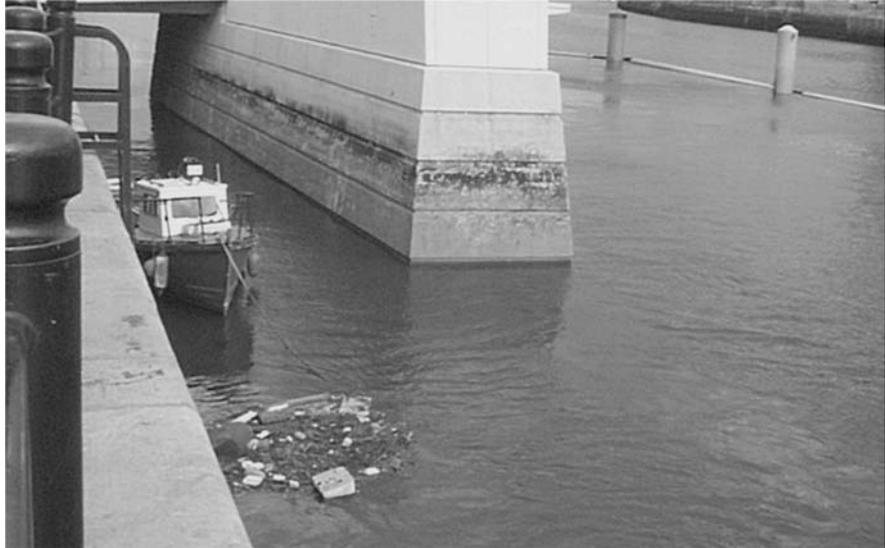
**Figure 4.**  
Problems with the vessel  
collision protection system

When the piles and booms were in place it soon became obvious that the booms interrupted water flow on the north side of the river. As Figure 4 shows, this caused debris to collect behind them and between the end support and the quay wall.

However, despite the passage of the years the story was not over. The piles had been driven into sand to allow them to deform if a heavy vessel hit them so the
