# PRESERVING THE STAVE CHURCHES

## CRAFTSMANSHIP AND RESEARCH

## Craftsmanship and Research

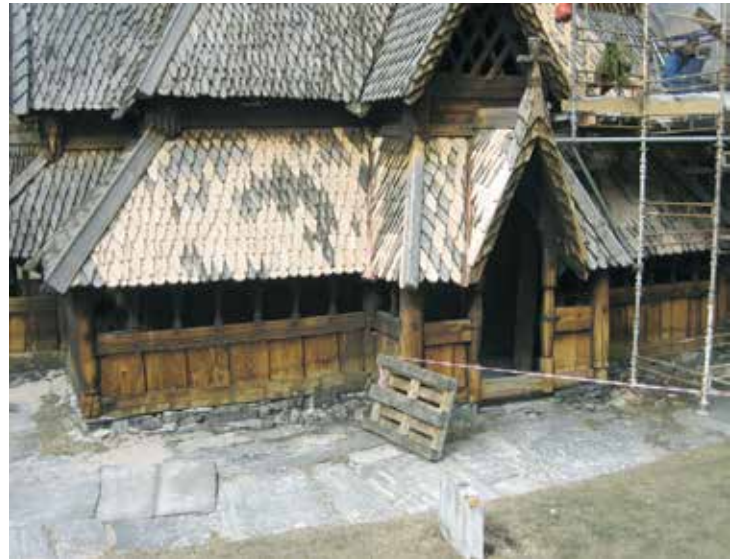
Test area for replacing roof shingles on the southern pentice. Photo: Sjur Mehlum 2010.

It became clear that several thousand shingles would have to be replaced in order to repair the roof properly. However, the shingled roof is such a central feature of the stave church that its appearance would change drastically if all the shingles were replaced. It would be extremely difficult, if not impossible, to fashion new shingles that would recreate the impression created by several hundred years' of weathering and minor repairs. So a decision was made to create some test sections

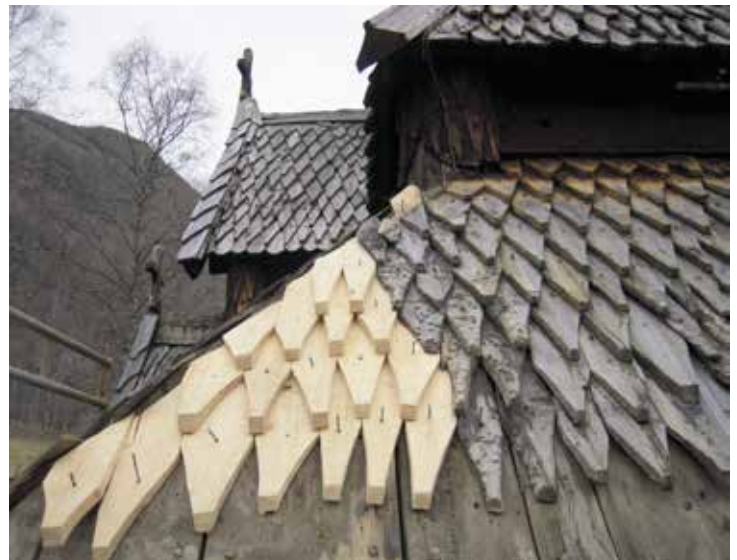
Replacing roof shingles; each shingle was fitted individually. Usable shingles were kept. There is no cardboard, foil or other waterproofing beneath the shingles. Photo: Harald Ibenholt 2009.

Several test areas were made on the roof, using a variety of working methods. Working in cooperation, a suitable method was found which ensured the preservation of the still usable shingles, while accommodating the new ones in a balance between preservation and renovation. It is of utmost importance that the roof has to remain waterproof for a long time, and this eliminates

After making some test areas, the Directorate for Cultural Heritage concluded that a method involving simple replacement with hewn shingles would be suitable for the entire church. Before this assignment could commence, however, it was important to find the right material.

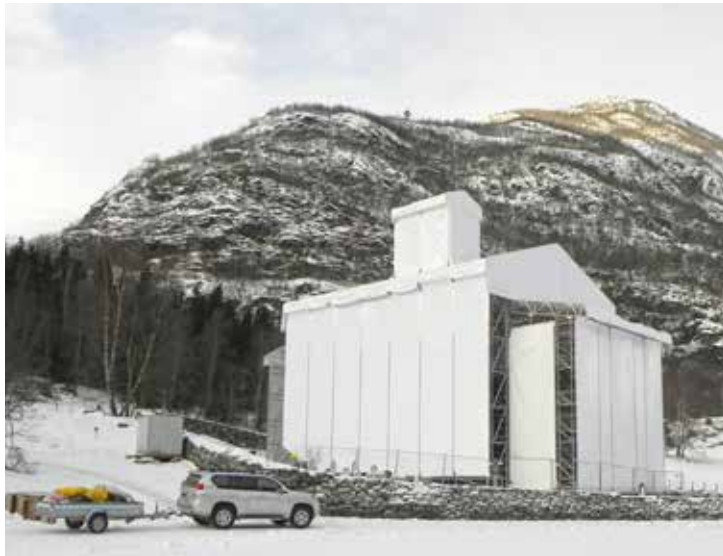
Borgund stave church covered in scaffolding, viewed from the south-east. Photo: Hans Marumsrud 2011.

Eventually, enough suitable material was found, and the production of shingles could begin. Part of the preparations involved determining what sort of scaffolding should be erected. A large scaffold was decided upon, wrapped with tarpaulins around the entire building (see photograph on next page). This scaffolding covered two needs: it gave the craftsmen safe and good working conditions as well as allowing the Society for the Preservation of Ancient Norwegian Monuments, who owns the church, to guide the tourists around the scaffolding to see the work being done. (The same solution was chosen when the shingles at Gol stave church were replaced a few years later.) The scaffolding at Borgund also provided an opportunity to carry out a thorough 3D scan of the turret.<sup>15</sup>

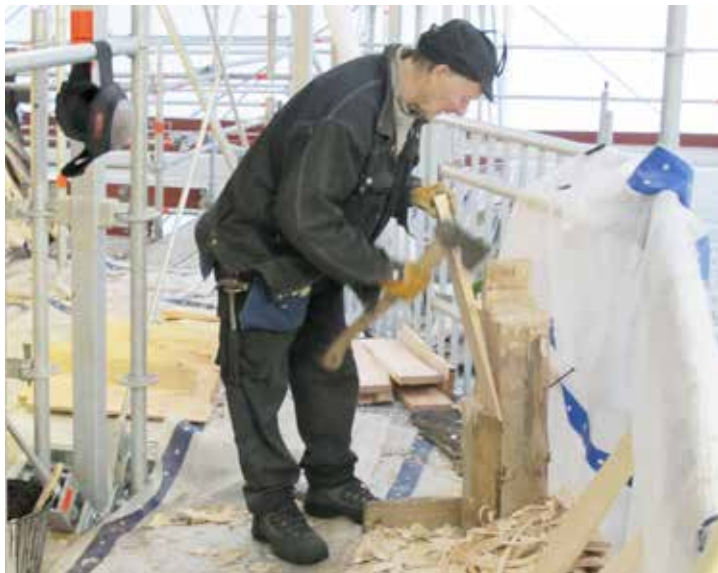
Axel Andersen hewing new shingles at Borgund. The photo was taken on the scaffolding. Photo: Sjur Mehlum 2011.

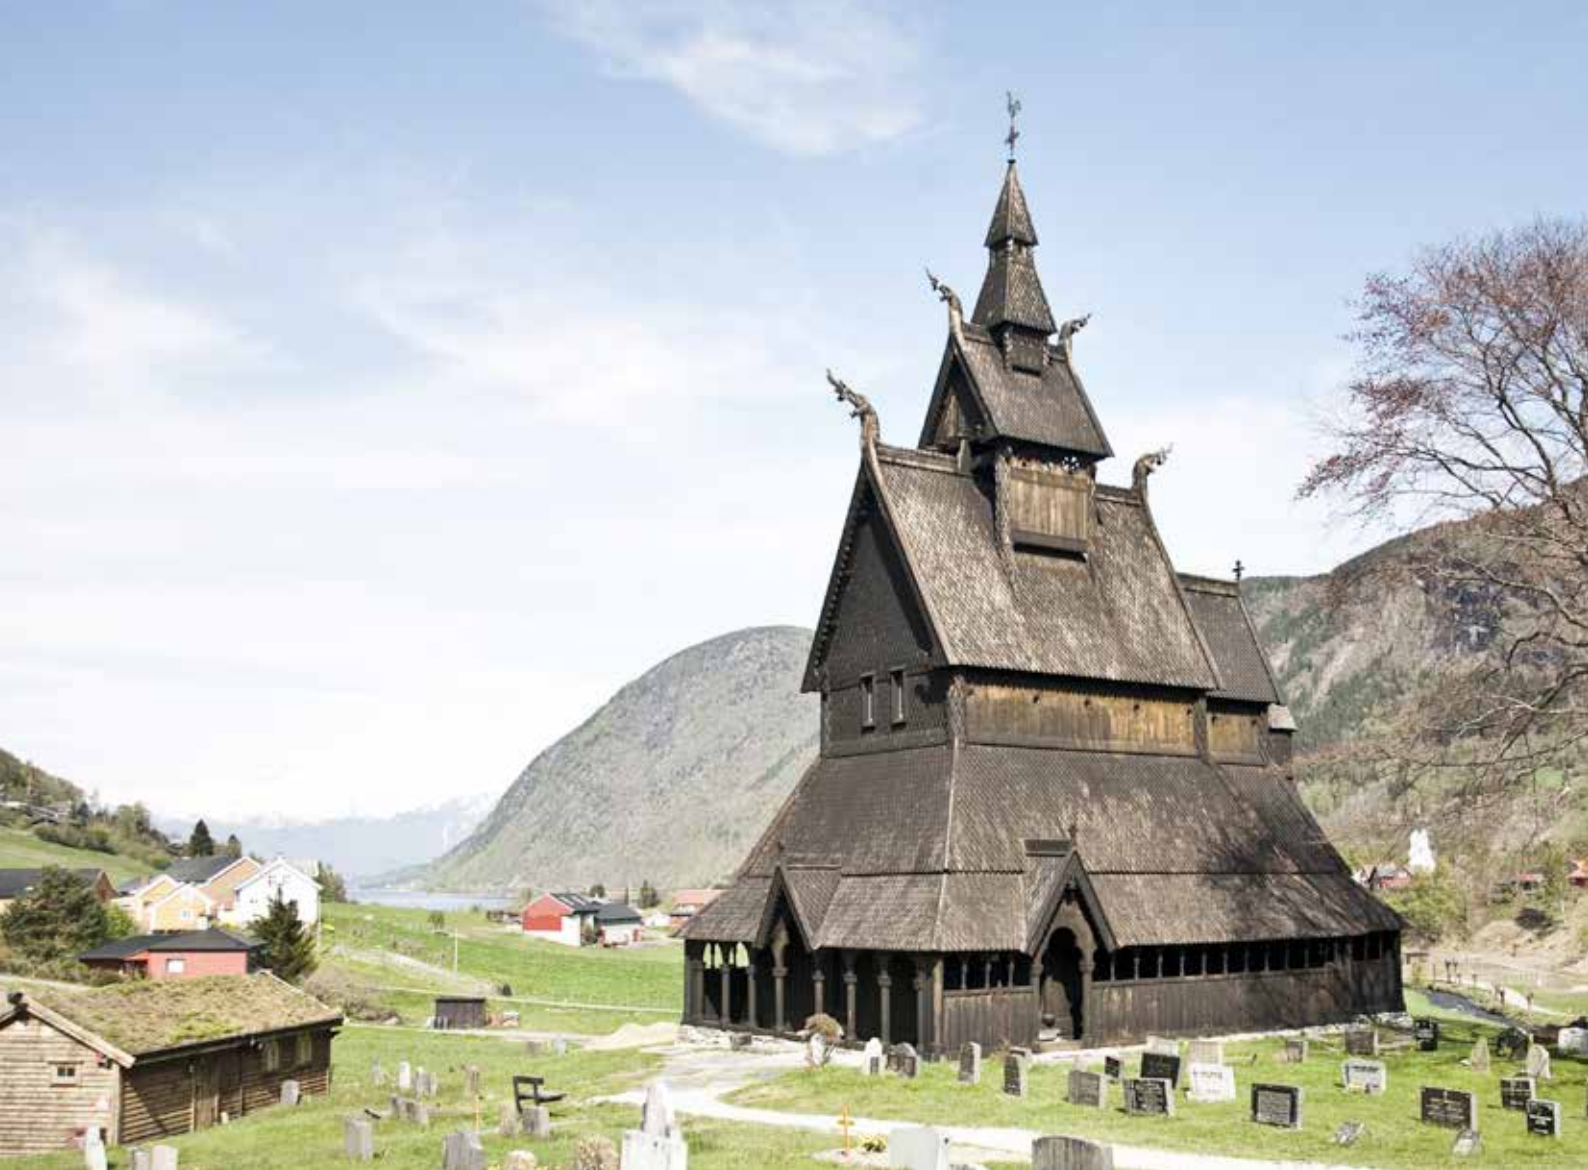
Hopperstad stave church, the roof was covered with sawn shingles during the restoration in the 1880s. Viewed from the south-west.  
Photo: Marcin Kaliński 2011.

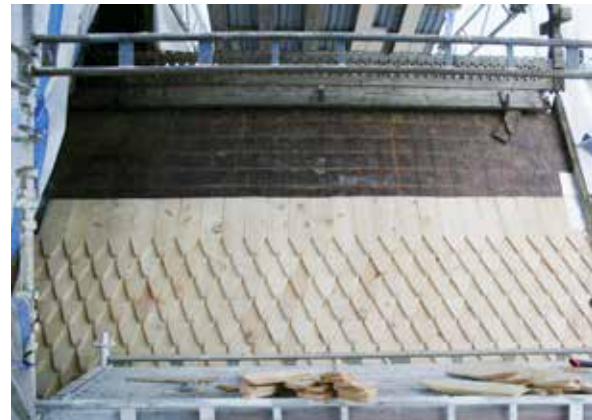
Replacing roof shingles at Hopperstad. Unlike Borgund, here the shingles were changed in whole areas. There is no cardboard, foil or other waterproofing beneath the shingles here either. Photo: Nedre Jølster bilelag, undated.

When the craftsmen of the Stave Church Preservation Programme made their initial investigations at Hopperstad, they discovered that many of the shingles were split or had been damaged by rot and the roof needed considerable repairs. Some minor repairs had previously been done on parts of the roof, but as inferior materials had been used, and the skills on how to lay the shingles had been lacking, the newer shingles were in many cases in worse shape than the ones from 1885.

The initial plan was to replace individual areas of the roof where this was deemed absolutely necessary. However, a large tree kept areas of the roof damp and shaded, especially on the north side of the church and meant that a blanket of moss and lichen grew on the roof. As at Borgund, a choice had to be made regarding the use of hewn or sawn shingles. Sawn ones were chosen as these were an important part of the church's architecture. Sawn shingles of good quality, made properly, have a very acceptable lifespan of about 100 years. At both Borgund and Hopperstad it was important to retain distinctive visual appearances. So, hewn shingles were selected at Borgund and sawn ones at Hopperstad. This was the main idea when it was decided to replace all the shingles at Hopperstad, whereas at Borgund only the damaged shingles were replaced.

The work had to be planned long before it could start, and as was the case at Borgund, considerable time was spent finding the right quality of pine wood and producing the shingles. Because of this, the work took two seasons. Laying shingles is much less complicated when all of them are replaced simultaneously. The shingles are then put in place row by row, as had been done in the 1880s. The new shingles copied the materials, design and laying pattern used before. To complete the job, the shingles were treated with pine tar. A total of 19,000

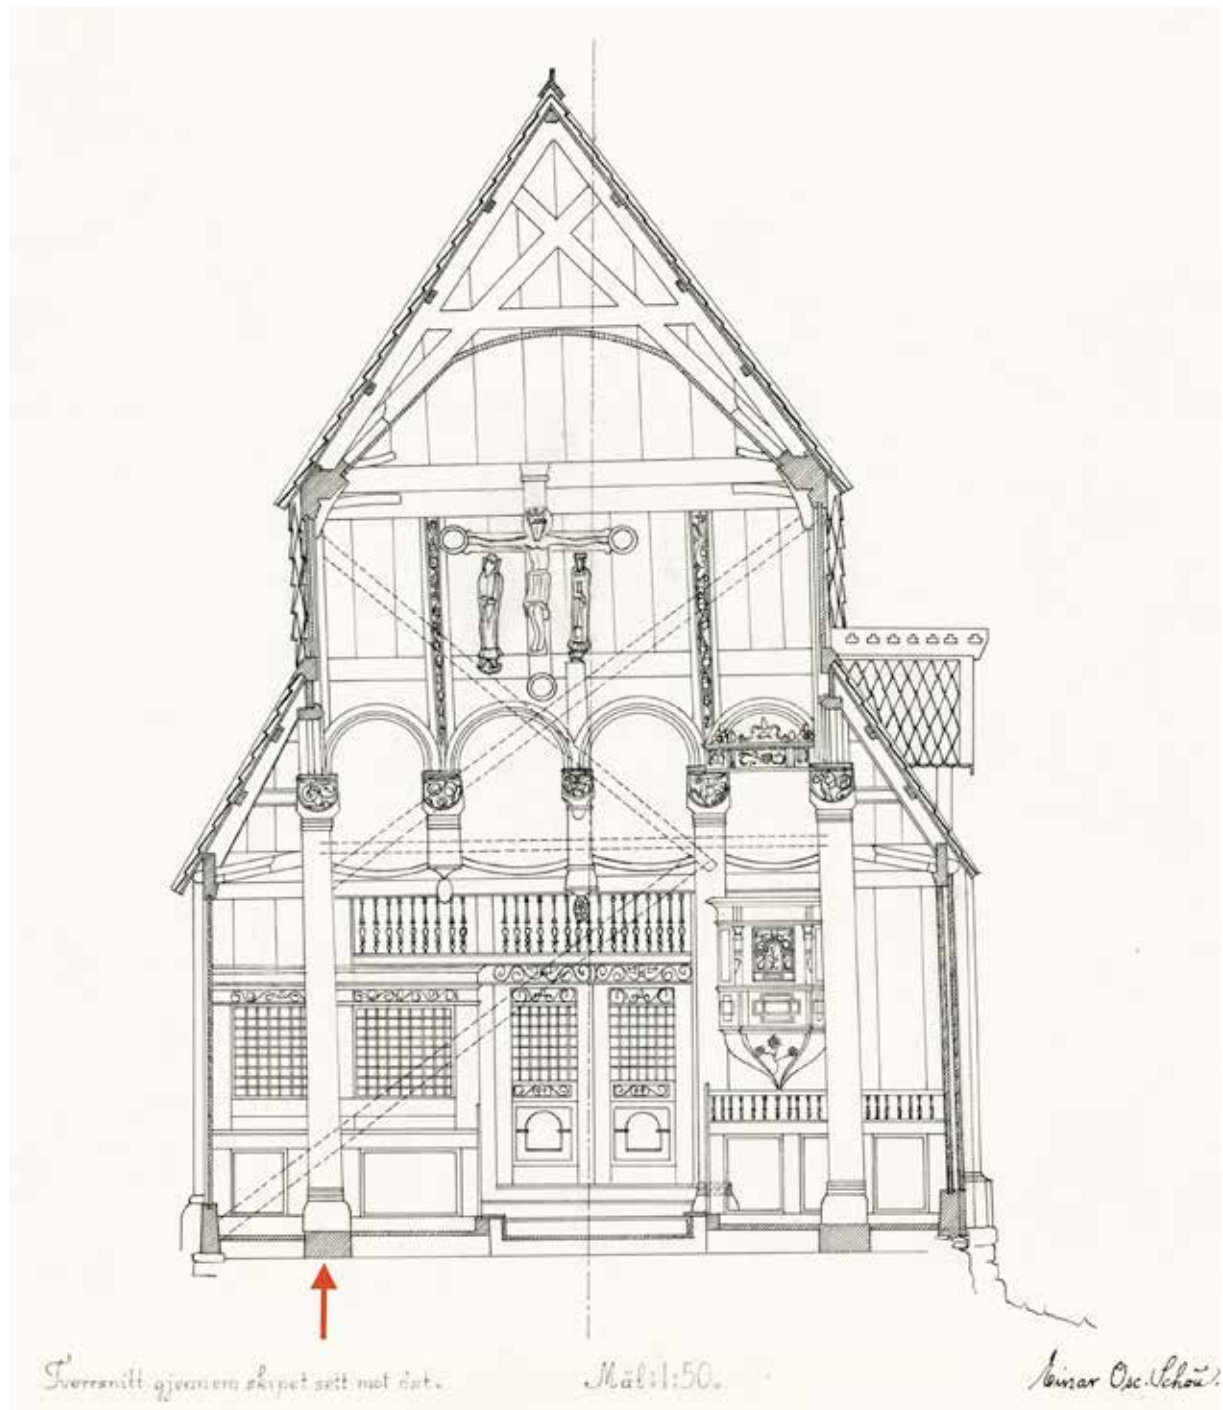
Elevation showing cross-section of the nave at Urnes stave church from the east. Subsidence on the church's north side is indicated by a red arrow. Drawing by Einar Oscar Schou. Undated.

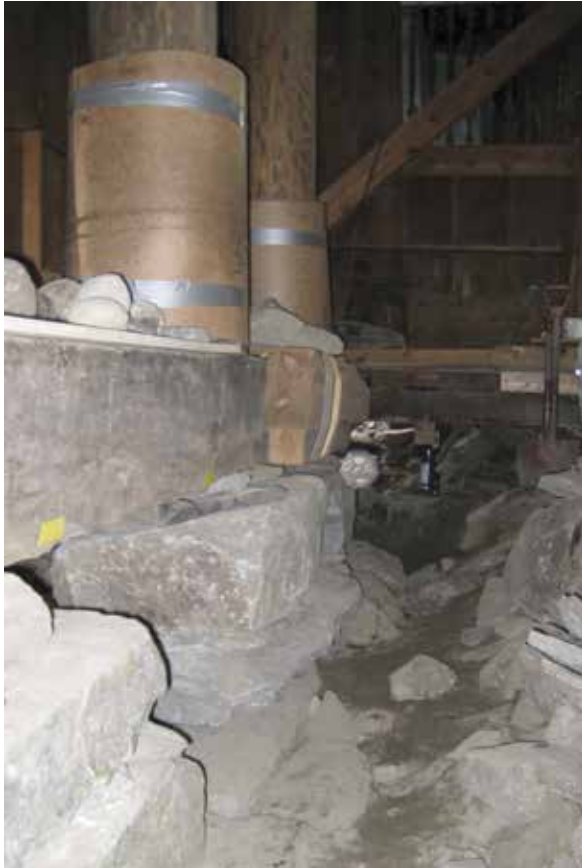
New foundations under the raft beams, work done during the Stave Church Preservation Programme. Photo: Marit Westli Arntzen 2009.

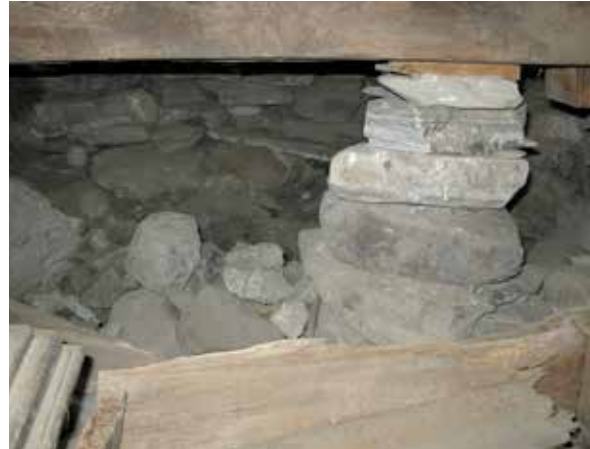
Unsteady, incomplete foundations under the raft beams, put in place around 1970. Photo: Ina Borgen Snarud 2008.

beneath the church floor showed that the foundation supports were few and of poor quality. This included not only the raft beams in the nave, but in all the areas that could be investigated. It became clear that the only way to get a complete view of the situation was to remove the church floor.

A decision was made to strengthen the foundation beneath the church even before the floor was removed, but a complete assessment of the situation was only possible once the floorboards had been removed. The conclusion was that the whole foundation and stone walls beneath the church had to be rebuilt.

After numerous inspections and evaluations, the Directorate for Cultural Heritage opted to jack up the church. Meticulous planning contributed to a highly successful operation. The stone foundations below the

raft beams and stone supports beneath the aisle walls were dismantled, and masons rebuilt them under the entire church. The job required the use of 50 cubic metres of stone.<sup>26</sup> Very precise stonework was needed to stabilise the new foundations. The masons opted to use dry stone masonry, meaning the work was done without the use of mortar and large stone plinths were placed at the base of the foundations. Once this was done, the floor was reassembled. The floorboards were now placed on joists which ran between the raft beams, as it was originally. In other words, the secondary tier of joists from 1971 beneath the raft beams was left out. Then the interior was reconstructed.

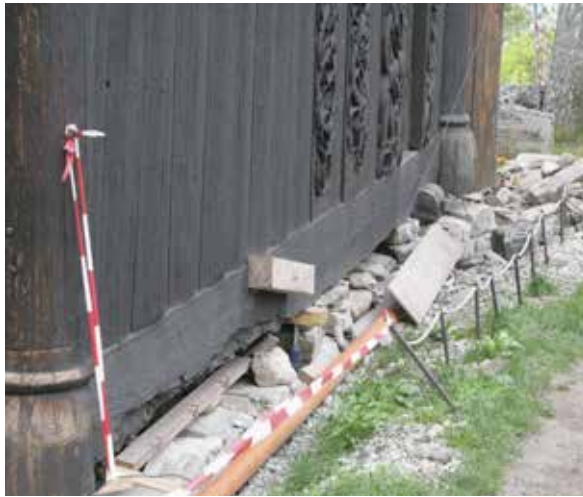
Rot-damaged sill beam on the north wall of the nave. The foundations were repaired, but not the rotten material, as it is not load-bearing. Photo: Sjur Mehlum 2009.

In connection with the lifting of the church, the wall beam on the northern aisle wall was lifted out of the ground, and an evaluation was made whether the damage caused by rot should be repaired by splicing in new wood.

However, as the rot was only of visual importance, rather than structural, these areas were not spliced. This decision and approach had an impact on decisions regarding other, older rot damage in the church. Extensive damage in the original material at Urnes was evident, for instance in the raft beams, but this was rarely repaired or treated in any way. Such repairs would involve interfering with the original medieval material, of which the Directorate for Cultural Heritage is highly restrictive.

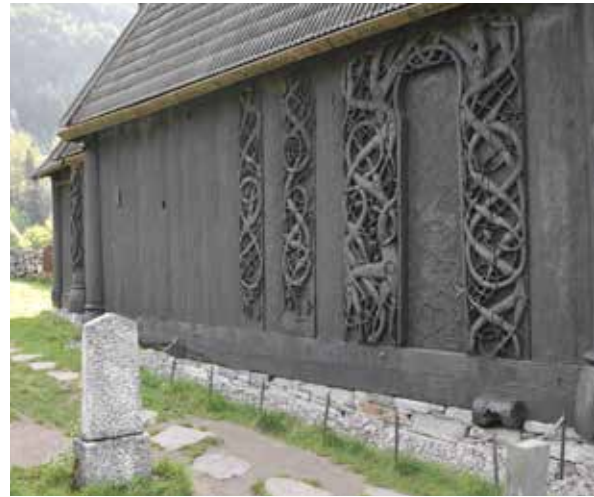
New foundations under the sill beam on the north wall. The sill has been raised by about 10 cm with good clearance from the ground. This will help prevent further rot damage. Photo: Leif Anker 2013.

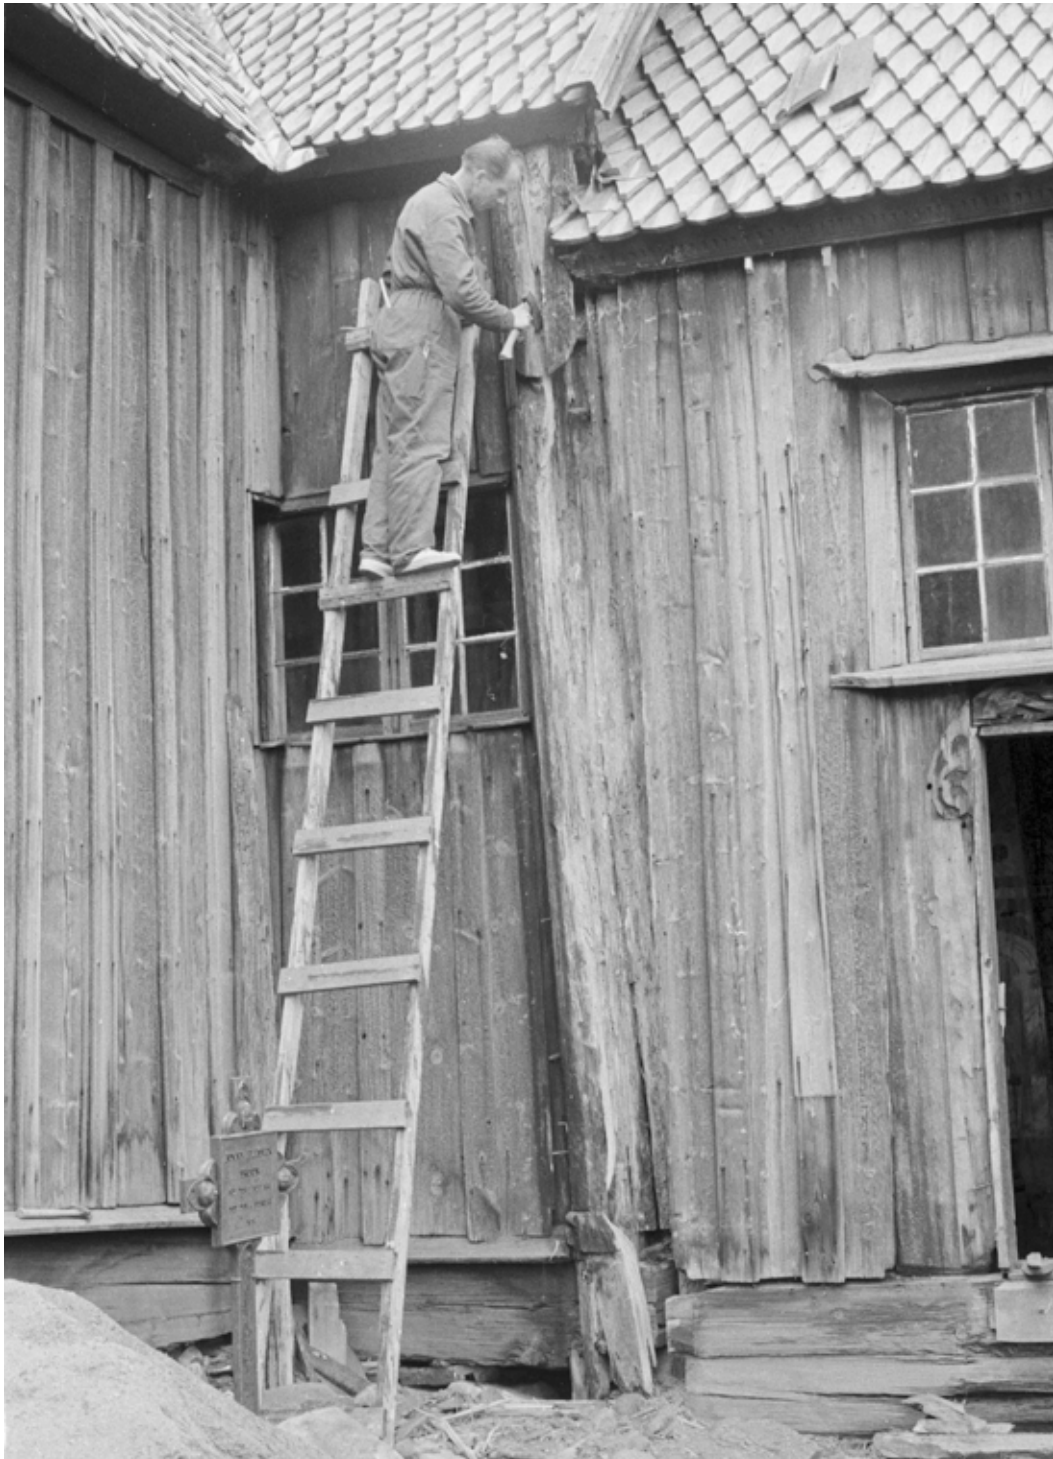
Nore Stave Church. South-east corner post of the nave has extensive rot damage along the whole length of the post. It was also repaired in 1969. Photo: Arne Madsen 1969.

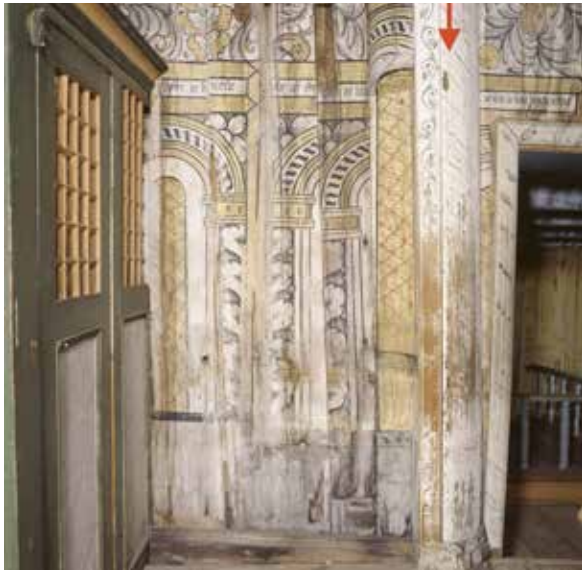
Both the south-eastern corner post in the nave, and the northern intermediate post in the chancel, had suffered considerable damage caused by rot, and both posts had lost much of their loadbearing ability. The south-eastern corner post in the nave had been repaired in 1969 using a new post which was attached to the rotten one with metal bands. However, this proved largely unsuccessful. Any attempt to re-establish the building's original supportive and bracing system, would mean that the posts would have to be replaced, and the new ones would have to be connected with the sill beam at the bottom, and with the wall plate at the top. The

Intermediate post in the north wall of the chancel, marked with a red arrow. Damaged above the ceiling and under the floor. Photo: Birger Lindstad and Joppe Christensen 1995.

There was also great danger that the decor on the wall planks might be damaged if the posts were to be replaced. To enable the north wall and its wall panel to continue to support the weight of the roof, damaged portions of the wall beam were spliced, and work was done to ensure that this area was supported on a solid rock foundation. The south-eastern corner post was upgraded by replacing the post from 1969 with one which fit the remains of the original post better. Now most of the roof weight could be carried by the new post.

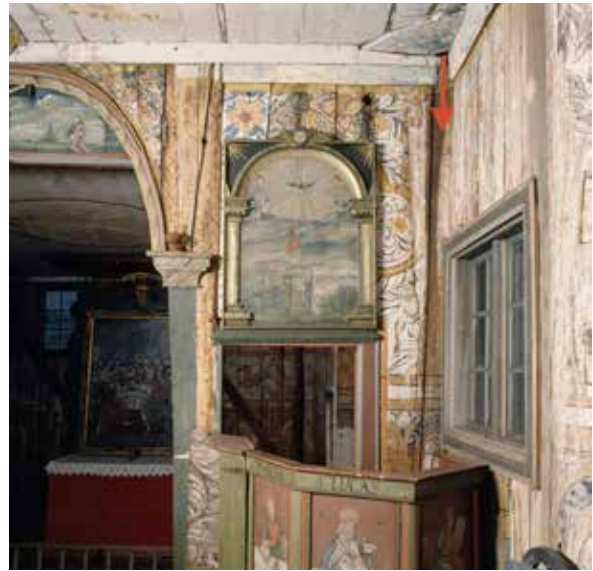
South-east corner post of the nave, marked with a red arrow. Photo: Birger Lindstad and Joppe Christensen 1994.

New, adjusted post for repairing the south-east corner post. The west side of the post is adjusted to the rot damage. This method secured the support of the roof while preserving the interior of the church. Photo: Hans Marumsrud 2003.

Repaired south-eastern corner post. The post was then panelled as it was before repair work commenced. Photo: Hans Marumsrud 2003.

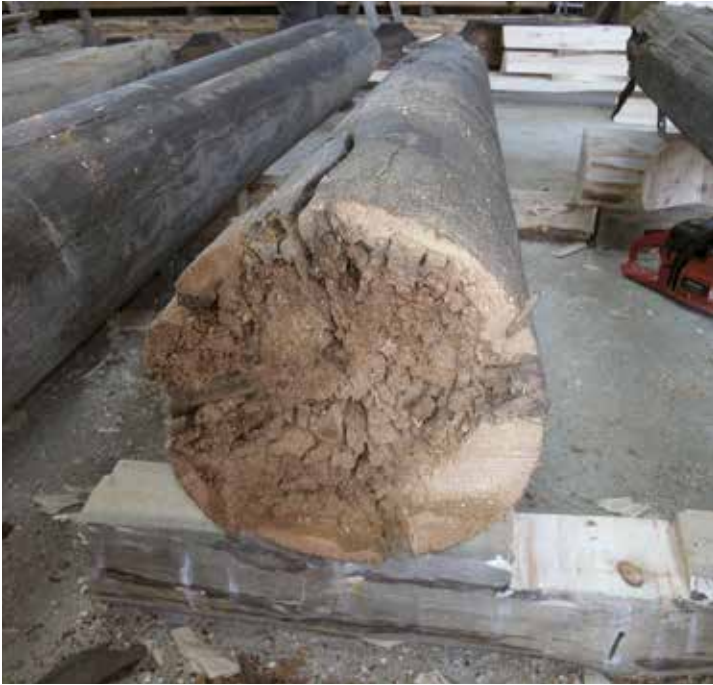
Rotten post from the bell tower. The lighter areas show healthy wood. Photo: Ellen Devold 2005.

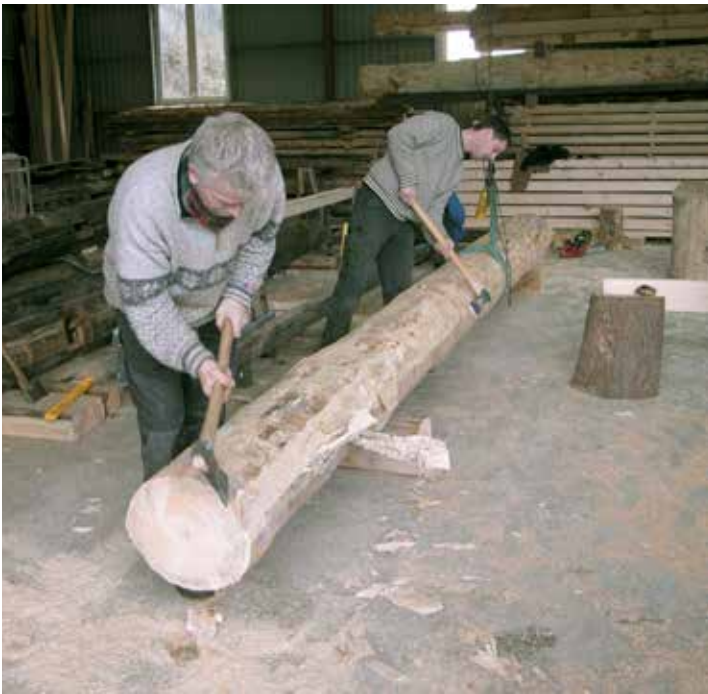
Making a new post. From the left, Erlend Gjelsvik and Stig Nordrumshaugen. Photo: Ellen Devold 2005.

The solution chosen was to repair the bell tower by replacing the rotten material. This was a major task, so it was decided that the entire bell tower had to be dismantled. The upper section of the bell tower was first lowered down and then the post construction was taken apart piece by piece. Everything was transported to a workshop where the repairs were carried out. An advantage of dismantling the bell tower was that the individual construction elements could now be examined thoroughly by the craftsmen who studied and documented the joints, dowels, slits and old tool marks.

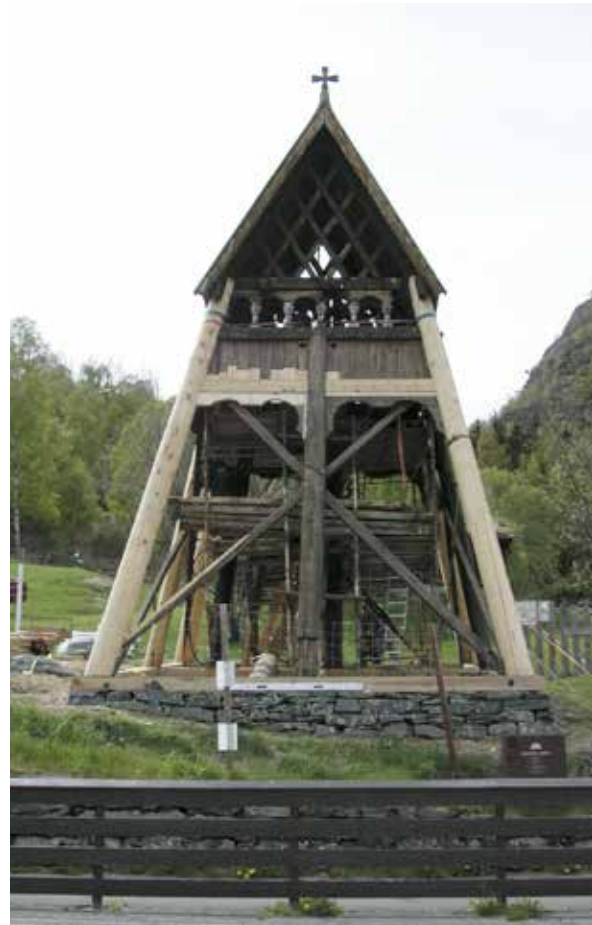
The bell tower viewed from the east, after the repairs to the load-bearing structure had been completed, and before it was panelled. Photo: Ellen Devold 2006.

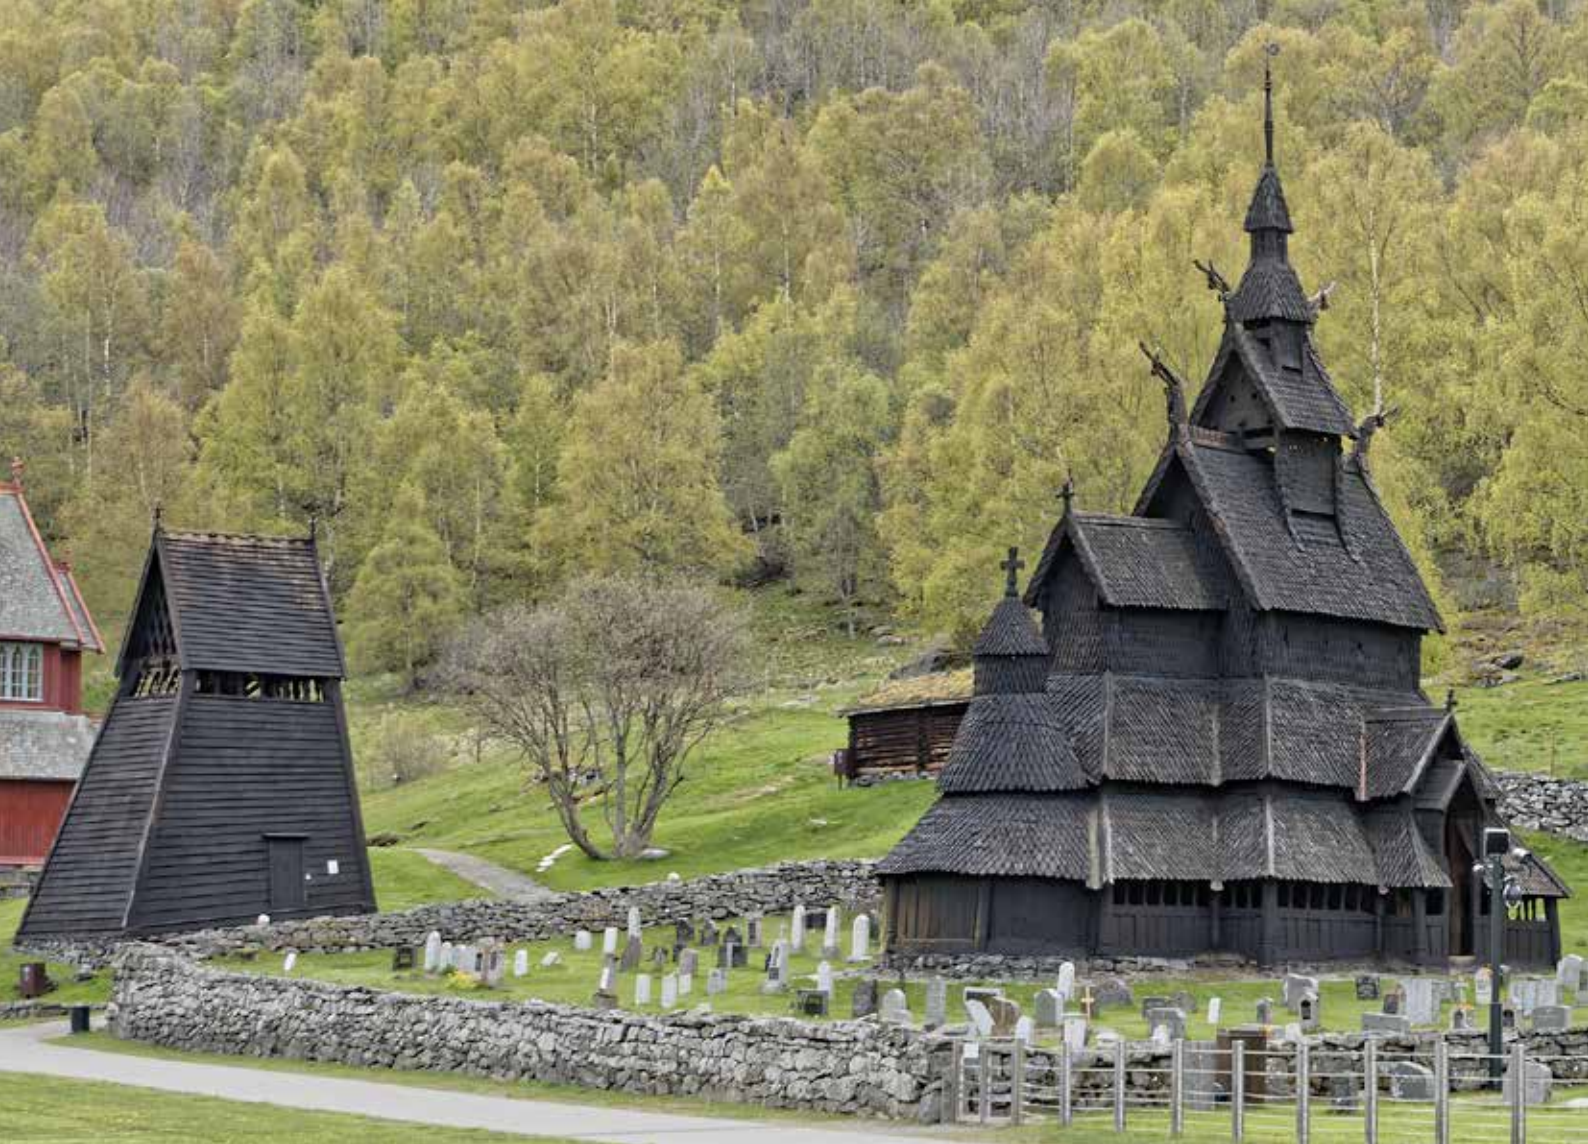
Borgund stave church and bell tower, after the work had been completed. Both the church and the bell tower are treated with pine tar.  
Photo: Dagfinn Rasmussen 2015.

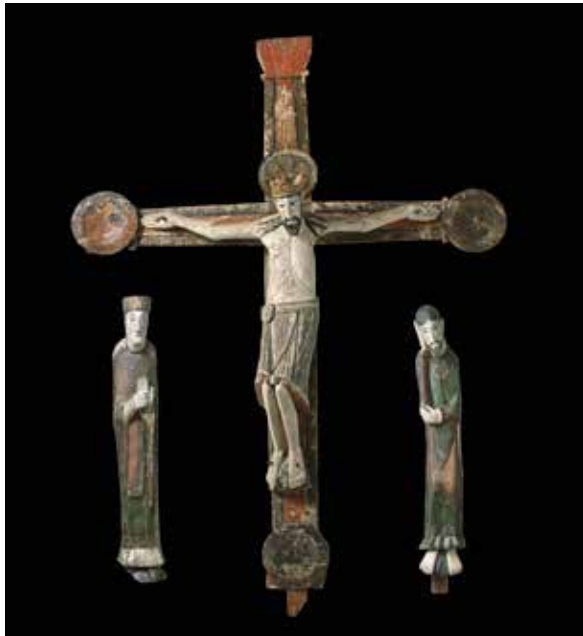
The calvary group in Urnes stave church after conservation 2001–2003. Photo: Birger Lindstad, 2003

The calvary group has been treated once before. In 1957 it was not only cleaned and conserved; large amounts of flaking paint were camouflaged by retouching. In the period 2001–2003, it was also given a protective coating of varnish.<sup>14</sup> However, with reference to the above-mentioned guidelines, the new flaking was not retouched: "... the goal of individual treatment of certain objects is to protect the cultural relic's original material, its authenticity and integrity, and the treatment should primarily be limited to cleaning and consolidation."<sup>15</sup>

*The Management Guidelines for World Cultural Heritage Sites* make allowances for individual treatment principles of specific objects, partly on the basis of their context. The fact that the calvary group hangs high in the nave of the church, and is hard to see, was also noted as an argument for not retouching.<sup>16</sup> The treatment of the group might have been otherwise if it had hung in a more conspicuous place. The flaking paint and gilding might then have been retouched.

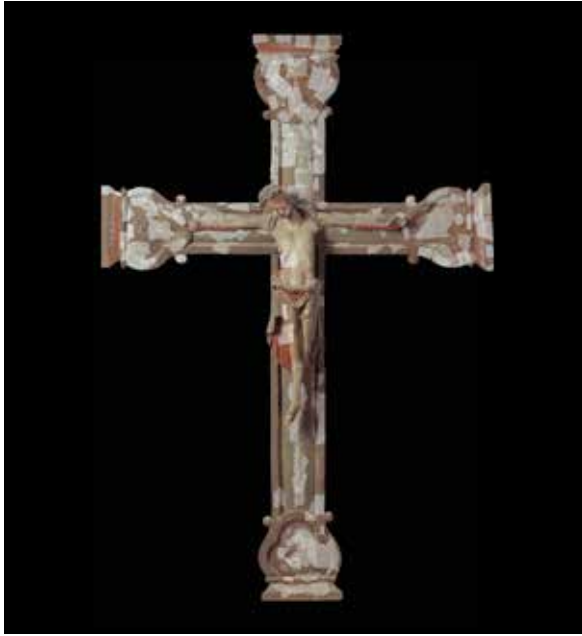
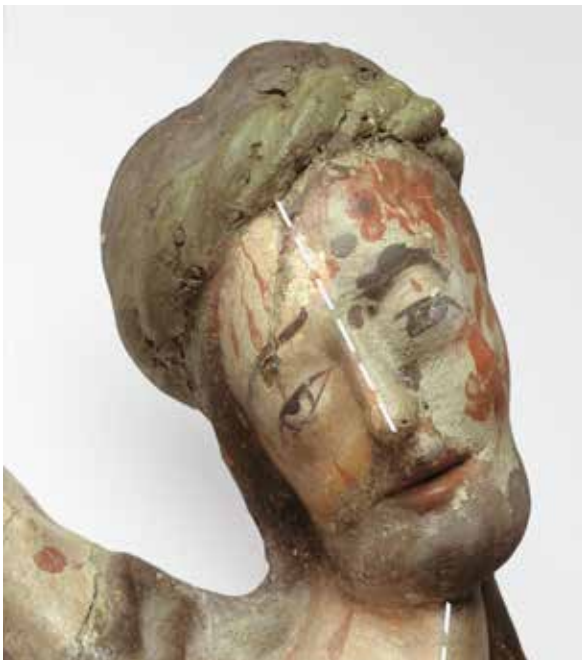
The Ringebu I crucifix, before treatment.  
Photo: Birger Lindstad 2002.

The Ringebu I crucifix, detail of the face, right side over-painted. Photo: Birger Lindstad 2002.

The conclusion was to consolidate the crucifixes, clean away the dirt and water-soluble coatings of paint.

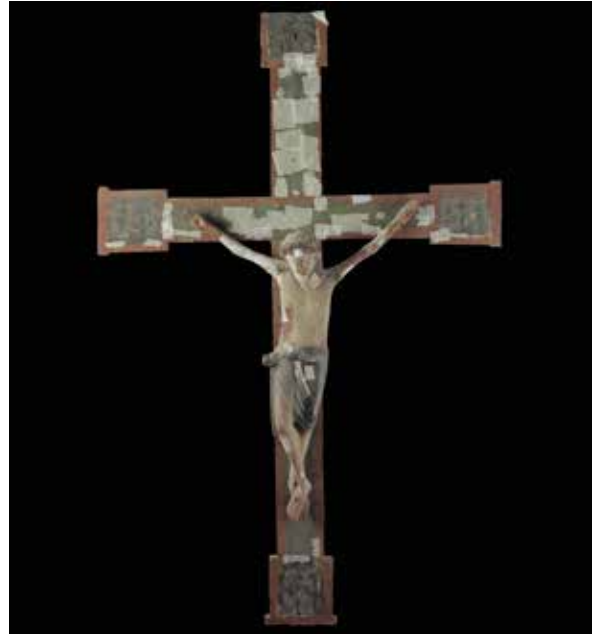
The Ringebu II crucifix, before treatment.  
Photo: Birger Lindstad 2002.

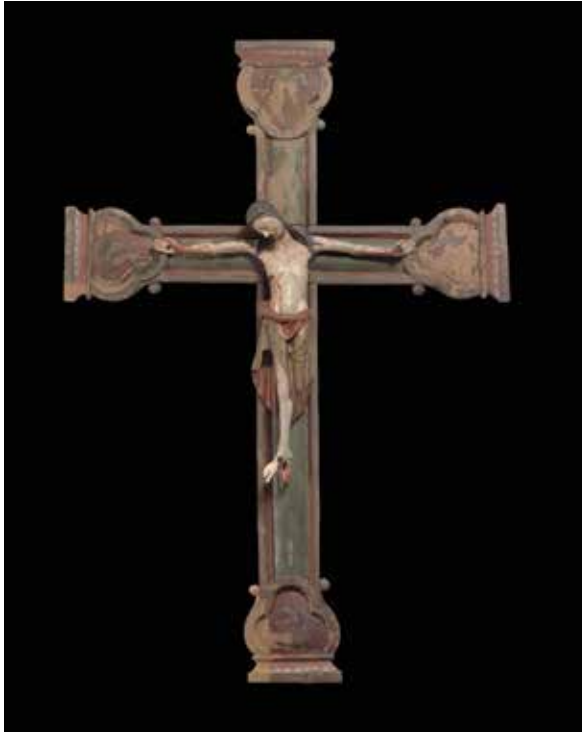
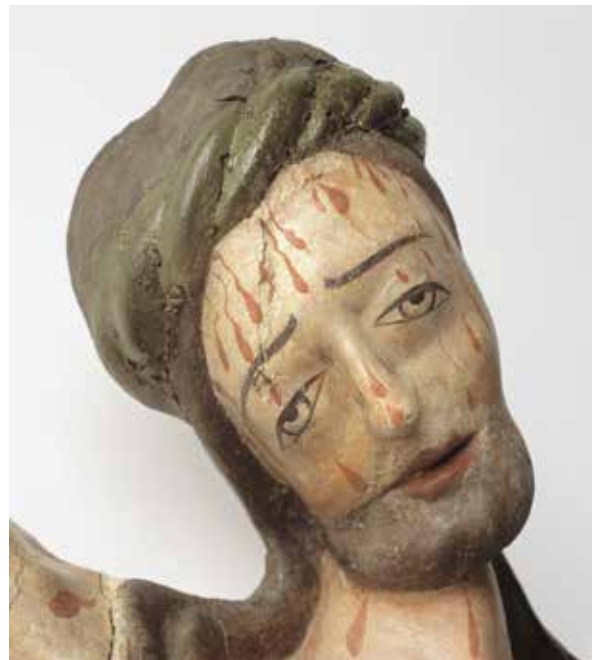
The Ringebu I crucifix, after treatment. Photo: Birger Lindstad 2002.

The Ringebu I crucifix with the over-painting removed and re-touched. Photo: Birger Lindstad 2003

Different conservation values are thus weighed against one another and have been given different emphasis in the hundred years or so that the Directorate for Cultural Heritage has had responsibility for the preservation of art and furnishings in the churches.<sup>36</sup> In certain cases, the value of the experience steers the treatment. Perhaps this was the case when the chancel of Rollag stave church was given a fresh coat of paint in 1933: a desire to recreate something that was lost. Perhaps it was this experience value which indirectly set the stage when Professor Erla Hohler of the University of Oslo argued in favour of retouching a damaged medieval sculpture, in order to "increase its 'legibility' and improve its overall impression".<sup>37</sup> The treatment of the Ringebu I crucifix can be seen and understood in this context.

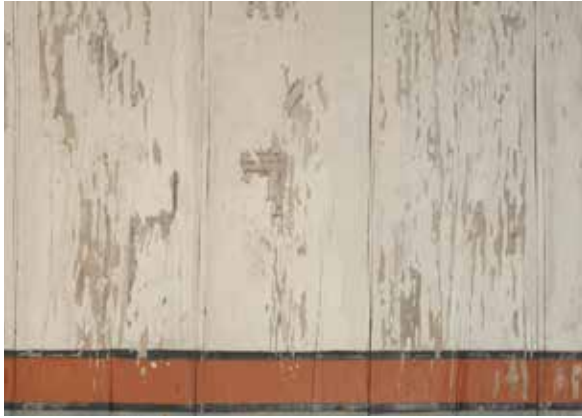
Only the nave of Flesberg stave church has survived. When the condition of the art and furnishings in the church was registered in 2002, the medieval walls in the nave were white, with blue imitation wainscoting approximately 150 cm high. Visible beneath the relatively large flaked-off areas of paint were the remains of the earlier decoration of the ambulatory (ill. p. 56,

top left), not dissimilar to the 1650s decoration in Nore stave church.<sup>28</sup> The white paint was assessed to be in category 2, as there was "... loose paint across the entire white surface".<sup>29</sup>

Flesberg stave church, north wall of the nave, detail before removal of overpainting. Photo: Jørgen Solstad, NIKU, 2006.

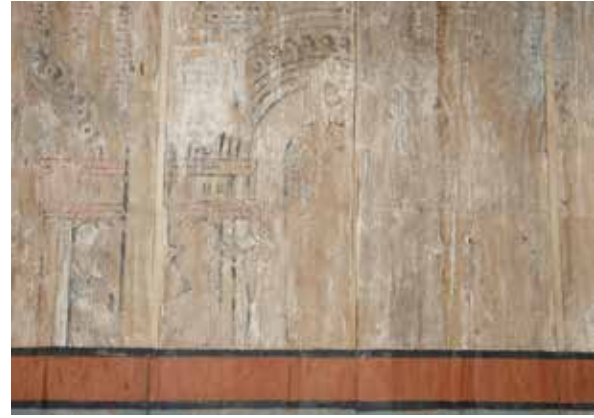
Flesberg stave church, north wall of the nave, detail after several layers of paint had been removed and the arcade painting from the 1600s became visible. Photo: Iver Schonhowd, Riksantikvaren 2013.

So it is interesting that even though the discussions linked to the uncovering of the distemper paint decoration in Flesberg stave church revolved around making its older history visible, the choice was made not to retouch it, enabling the viewer to experience it as authentic. This authenticity is a fact, inasmuch as nothing new has been added; what one sees may well be the same as a viewer saw before the decoration was painted over for the first time. However, the decoration today does not give an

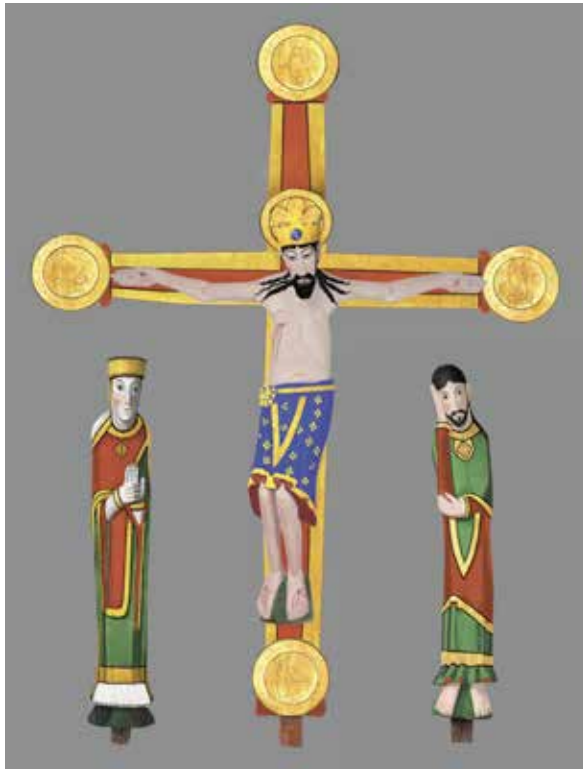
Reconstruction of how the calvary group in Urnes stave church could have looked like in the 1200s, after it was partly overpainted. Digitally rendered by Anja Sandtrø ©NIKU, 2003.

The polychromy from the Middle Ages was digitally reconstructed through an analysis of the wood, chalk, pigments and binding agent, as well as studies of the stratigraphy of the colours and the gilding (ill. above). The analysis results have been clearly detailed in Norwegian and English previously, so only the most important results will be mentioned here.<sup>46</sup>

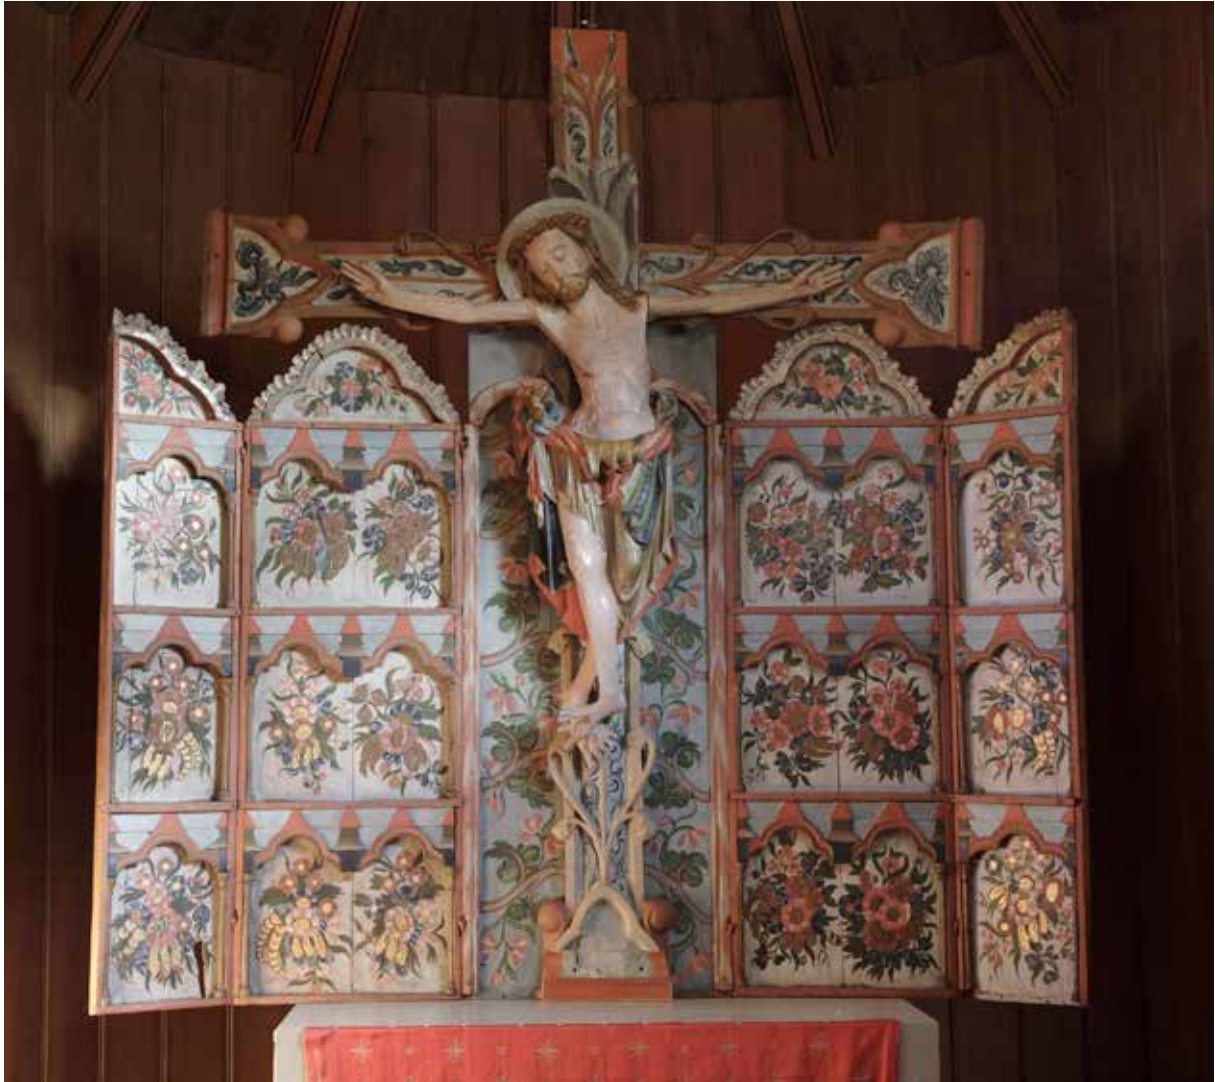
The altarpiece in Hedalen stave church. The altarpiece is a collage from the 1700s, composed of a medieval crucifix and a medieval tabernacle which was then brought up to date with rose painting. Photo: Birger Lindstad 2007.

The Hedalen crucifix is from the second half of the 13th century.<sup>49</sup> The crucifix was overpainted and used as part of the church's altarpiece in the 1700s and that is where it still stands in the church.<sup>50</sup>

It was inspected while being consolidated, cleaned and retouched in 2008 (ill. next p.). The objective was to find out what the crucifix looked like when new, how it was made and from which materials. The cross is made of alder.<sup>51</sup> The sculpture consists of three parts; the arm piece, the body with the head and crown of thorns, and the halo. The halo is made of pine and the other parts are of birch.<sup>52</sup> All these tree species grew in Norway during the Middle Ages, which means that the crucifix could have been made in Norway. There is uncertainty

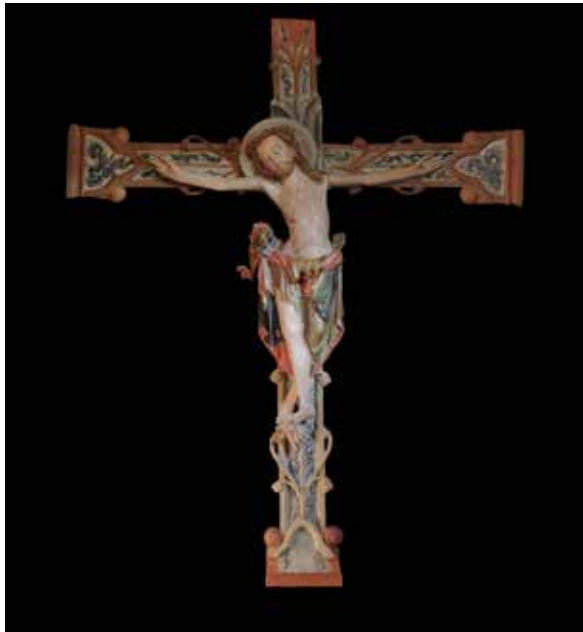
The crucifix in Hedalen stave church, after conservation in 2007. Photo: Birger Lindstad 2007.

The result of the study of how the crucifix could have looked when new is seen in on next page. The polychromy is representative of the second half of the 1200s. The cross is green, with imitation gilded and red detailing. How the four trefoil-shaped cross medallions were decorated is unknown. An underlying dark red

hue is visible in a tiny peeled-off part on one of medallions, and a decorative band has been documented on the cavetto of the outer part of the cross medallion using infrared photography. The observations trigger associations with the cross medallions in the Ringebru I crucifix's golden evangelist symbols on red-glazed silver foil (ill. p. 61, left). The medallions' cavettos are painted in red shades and decorated with a black band. The Hedalen crucifix's medallions may have been decorated in a similar way.<sup>54</sup>

Christ had a pale, smooth, skin colour, half-closed eyes and golden hair, beard and moustache.<sup>55</sup> Decorative tracks of blood ran from his nail wounds. A golden loin cloth wrapped around his hips had a yellow lining and a green and black striped belt. An infrared photo-analysis of the halo, now painted grey, shows that it dated from the Middle Ages. A red cross, contoured in black is painted on an imitation gilded base (ill. next p., left). The halo is stylistically reminiscent of the cross halos on panel paintings of this period, for example the Heddal frontal from around 1250.<sup>56</sup>

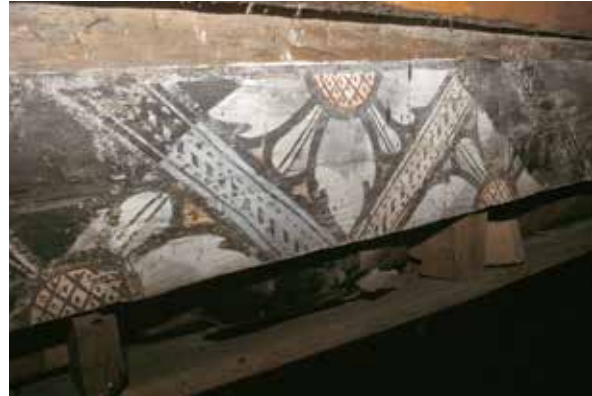
Decorative distemper painting on the lower wall plate in the chancel screen in Rollag stave church. The decorative painting has been hidden by an epitaph for almost 300 years. Photo: Mille Stein, NIKU, 2003.

Dating made on a stylistic basis should, if possible, be verified by other methods. If the wall decoration is from around 1300, the wall plate must be contemporaneous, or older. So the wall plate was tree-ring dated.

This showed that the tree was felled soon after 1431. Therefore the decoration dates at earliest from the mid-1400s. A number of art historians were asked to assess the dating of the decoration based on the age of the wall plate. The conclusion is that such medieval decorative bands survived and continued to be used as a motif for several centuries.<sup>78</sup>
