# PRESERVING THE STAVE CHURCHES

## CRAFTSMANSHIP AND RESEARCH

## Craftsmanship and Research

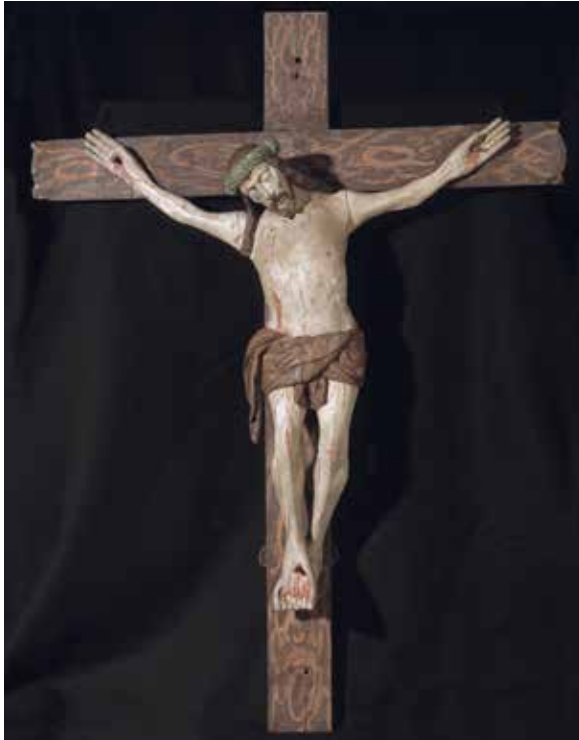
The Rollag crucifix photographed after treatment in 2005. The veining on the cross is from 1942 and may be an imitation of earlier veining on the cross. Photo: Arve Kjersheim 2005.

A crucifix hangs on the chancel wall of the nave in Rollag Stave Church (ill. next p. left).<sup>79</sup> It has been dated to around 1450–1500 and is thought to have been made in Norway.<sup>80</sup> The crucifix has been overpainted, the figure once and the cross three times. The crucifix was examined to determine its original polychrome appearance and to test the theory that the arms are secondary.<sup>81,82</sup>

Chalk analyses showed that the chalk used to prime the arms differed from that used to prime the hand and torso. X-rays of the crucifix showed that the arms were carved from a different type of wood – probably oak – than the hands, the figure and the cross, which are all probably in pine. The x-rays also revealed that repairs had been made to the attachments of the arms. Nor do the arms match the hands, they are much too thin. Holes on each of the arms of the cross may mean that the hands were originally fastened closer to the body than they are now. The study confirms that the arms and torso did not originally belong to one another, and

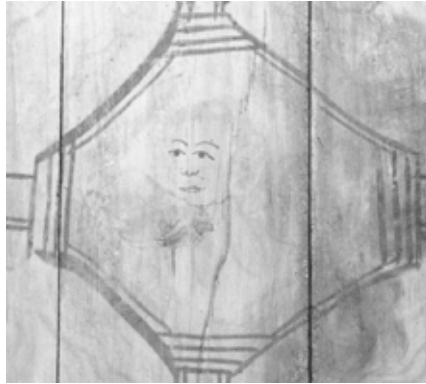
Infrared photo of the ceiling in the nave of Rollag stave church shows an overpainted ceiling painting with a man's face from 1683.  
Photo: Henrik Smith, NIKU, 20006.

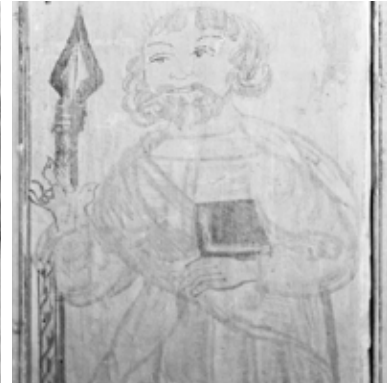
A similar man's face can be seen in the infrared photo of the over-painted «Lady's Seat» in the nave. Photo: Edwin Verweij, NIKU, 2014.

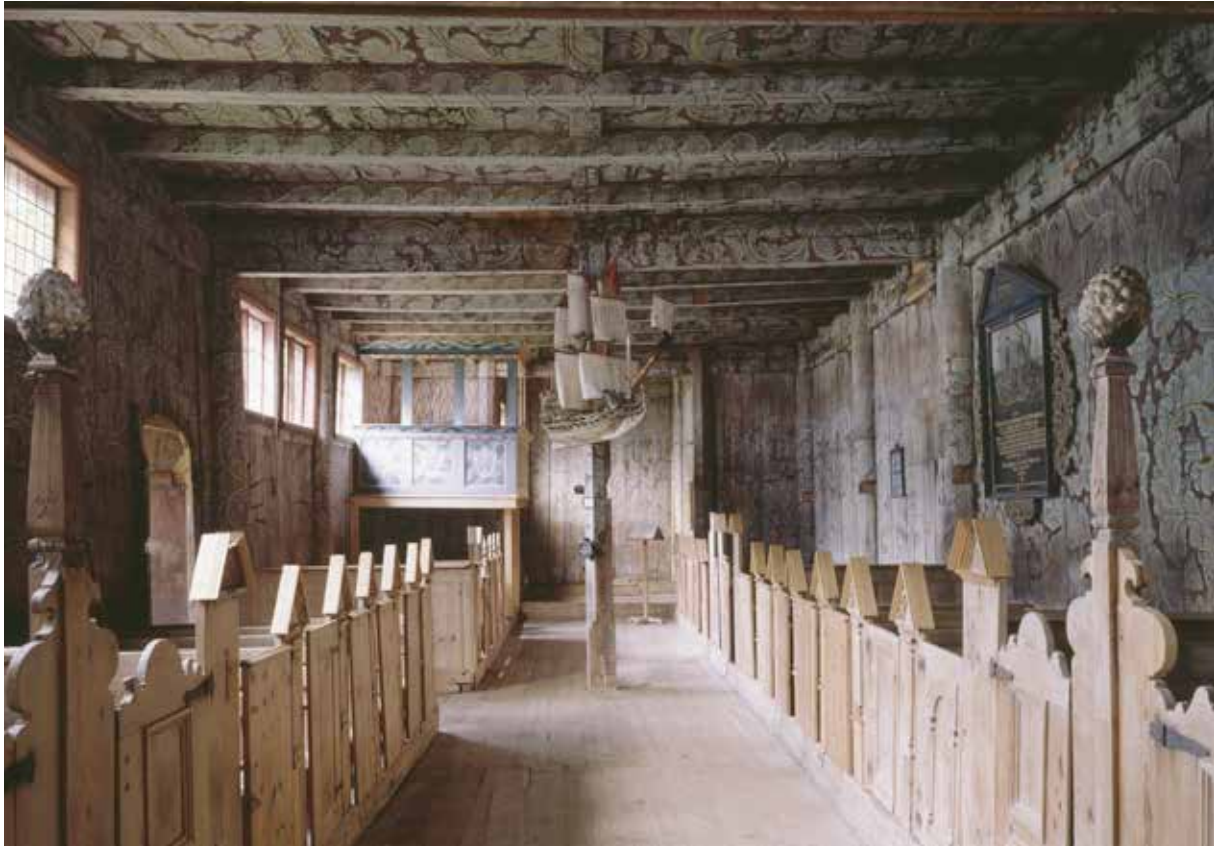
Kvernes stave church. Nave seen towards the west with the priest's family pew on the south side of the nave. The back wall of the pew has an imitation two-tone Ikat weaving, painted in distemper in the middle of the 1700s. The church interior was decorated in 1633, according to an inscription on a memorial on the north wall of the nave. The grey vines on a red ground with details in black, white and yellow cover the walls and ceiling and dominate the large, open interior. Photo: Jiri Havran, date unknown.

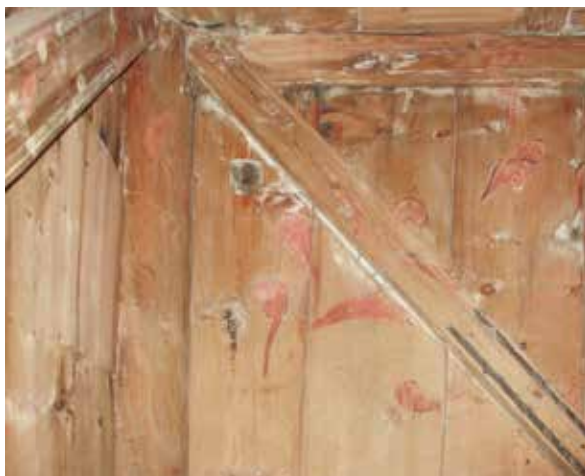
Borgund stave church. Good lighting reveals traces of decorative distemper painting in a number of places in the washed church interior. Here fragments of vine decoration can be seen up on the wall in the south-east corner of the nave. The colours in the wood show the direction of the vines. Photo: Tone Marie Olstad 2015.

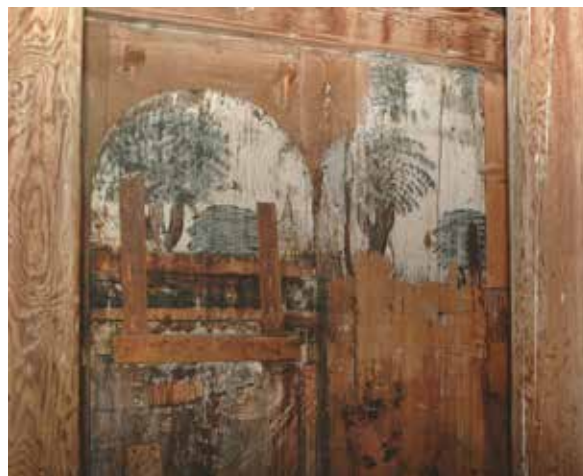
Hopperstad stave church. Like Borgund, the decorative distemper painting in Hopperstad was washed off at the end of the 1800s as part of the restoration of the church. Fragments of the painting can be seen in a number of places in the church. Here the wall painting has been preserved in the south-west corner of the nave. The decoration is best preserved on the back of the door which was probably missed when the church interior was washed, and this has preserved the painting. Painted draperies lower on the wall, «landscape» with trees and building above the draperies. The decoration above the draperies resembles the decoration in the nave of Flåm church, but the painted decoration in Flåm church was added somewhat later. Photo: Iver Schonhowd 2003.

the church interior which deserves preservation. It has not always been this way. In Hopperstad stave church, as at Borgund, decorative distemper painting from the 1600s covered large parts of the church interior until it was washed off in connection with restoration work in the years 1885–1891.<sup>5</sup>

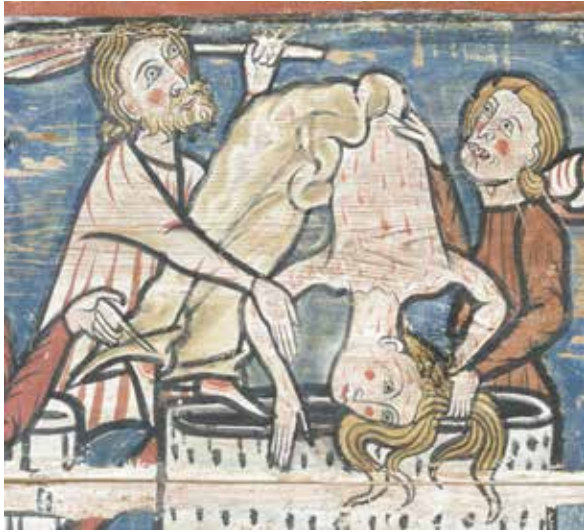
Torpo stave church. Painting from the 1200s on the baldachin. Detail from the story of St. Margaret. The motif is painted on a white ground in a thin, black colour before the main colours in each area are added. Then the details are applied. Finally the black contours are painted in. Note how the brush marks define the face of the figure on the left. High humidity, fluctuations in humidity and possibly previous consolidation work has worn away the painting so that the wooden structure can be seen. The colours are generally best preserved where there are several layers of paint. Where paint is missing on the joint between the plates, there was originally a canvas strip covering the joint. The black lines above the joint are secondary additions, probably from the treatment in the 1930s. Photo: Birger Lindstad 2009

The Torpo church decorative distemper paint from the 1200s can serve as an example of medieval painting techniques. The painter at Torpo began by applying a white paint layer. After it dried, the motifs were then drawn onto this white ground with diluted black paint. No signs of supplementary sketched or etched guiding lines for the motif have been found. The colours were filled in between the black lines. The density and structure varies from the opaque to just a thin glaze of paint. Colour shading is done both wet-on-wet and as a separate layer on dried paint. Finally, the contours were added.<sup>36</sup> In the contemporaneous paintings from Ål stave church, the motifs were etched onto the planks before the paint was applied. Here too, the colours were painted onto a thin white paint layer.<sup>37</sup>

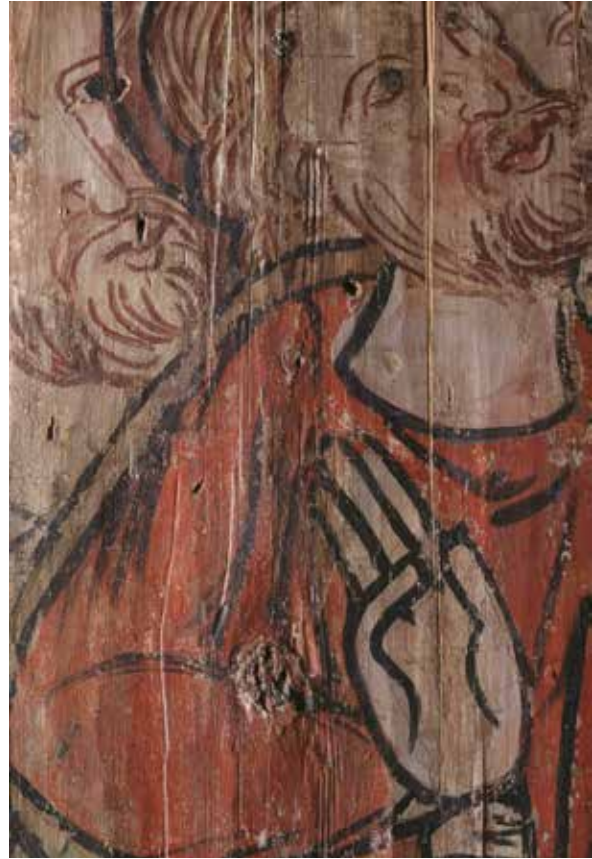
Ål stave church museum. The walls in Ål stave church. Detail of figure in painting from the 1200s. The motif is etched into the wood before a white ground is applied. The etching can clearly be seen on the hand towards the bottom of the picture. Then the main colours are applied before the details and contours are added. Unlike the painting in Torpo, the contours of the face and hair are applied using a brown colour. Photo: Arve Kjersheim 1997.

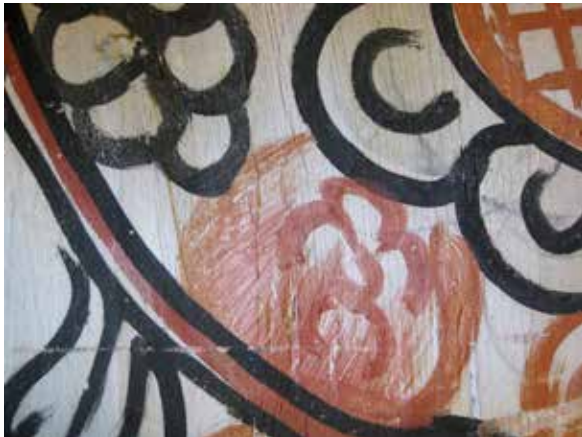
Umes stave church. Detail from the vine decoration from 1601 on the north wall. The decoration is drawn on a thin, white ground with a silver-coloured hard pen which can be seen in the upper-right of the picture. Then the coloured areas are painted: blue, red and a yellow-red. Finally the black contours are painted which define the motif. As is the case here, there is often little correspondence between the sketch and the final contours. The sketch appears to have been done to place the motif on the wall. This could be interpreted as the painter knowing the motif he wants to paint, or that he has a model. Photo: Tone Marie Olstad 2011.

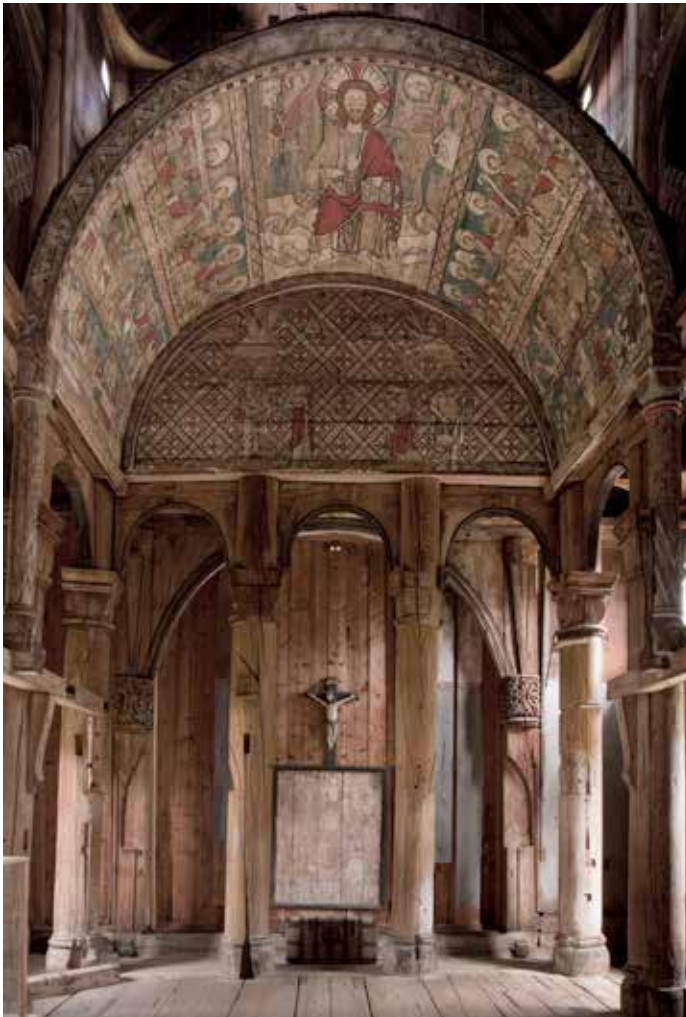
Torpo stave church. The baldachin and back wall have decorative distemper painting from the middle of the 1200s. This is the best-preserved medieval painting in the stave churches, and the one that best conveys the experience the decorated interior leaves. Photo: Birger Lindstad 2011.

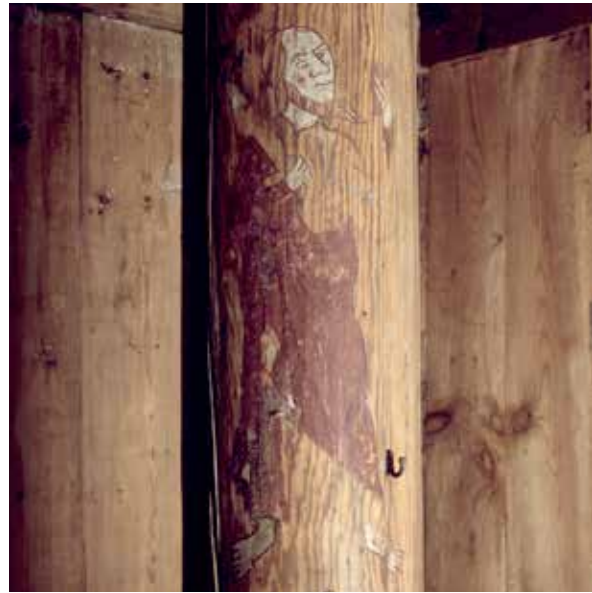
Hopperstad stave church. Painted distemper decoration dated to the end of the 1200s on one of the staves in the chancel. Only fragments of the medieval painting have been preserved. The architect Peter Blix, who recorded the figures on the two pillars in the chancel, describes one figure as St. Paul and the other as St. Peter. Photo: Birger Lindstad 1993.

the flanking chancel pillars one can see traces of painted saintly figures which must have been done by a fully-experienced 'pintare' in the late 1200s."<sup>48</sup> One of the figures is relatively well-preserved.<sup>49</sup>

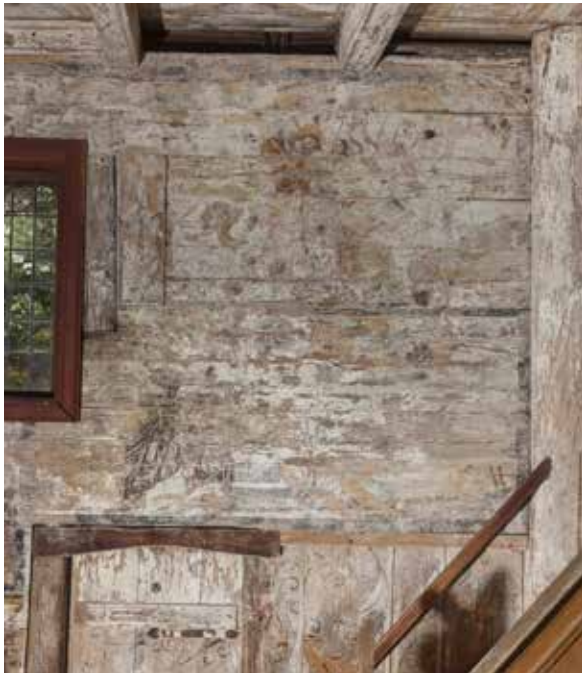
Kvernes stave church. Left part of the south wall of the chancel. The 1600s decoration which tells a story in pictures with biblical motifs at two levels, has been later whitewashed and then uncovered again. Large parts of the decoration have been lost. What has been preserved has been disfigured by damage, mis-colouring and traces of whitewash. The decoration is almost illegible. The «Kiss of Judas» is one of the motifs that can be seen. Photo: Birger Lindstad 2013.

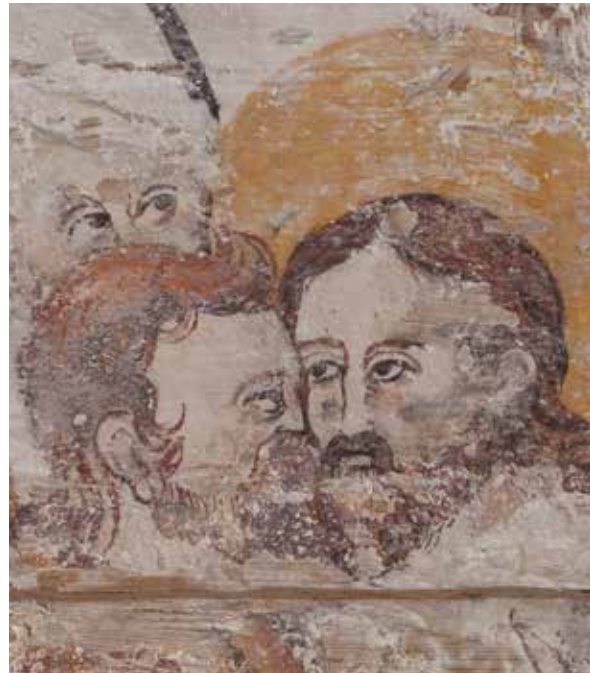
Kvernes stave church. Left part of the south wall in the chancel. Detail. In spite of damage and traces of whitewash, the detail from the «Kiss of Judas» shows the high quality of the decoration. Only the decoration in Oppdal church is comparable in terms of quality. Photo: Birger Lindstad 2013.

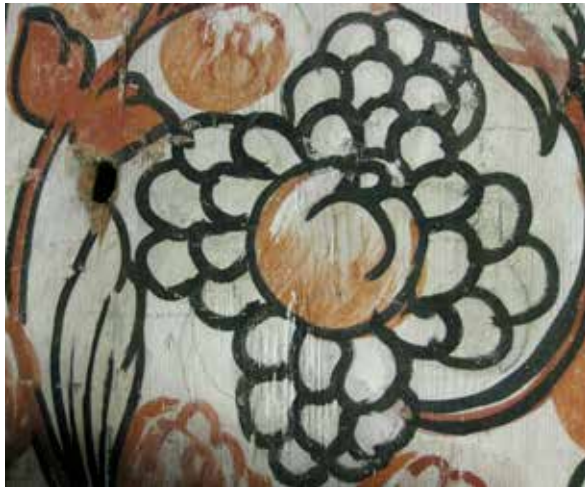
Urnes stave church. Detail from the vine decoration from 1601 on the west wall. The painter has used vines, leaves and fruit typical of the 1600s. Note the pattern sketches which have only been partly followed. Today the painted vine decoration in Urnes is dominated by black, white and red, but traces of colour can be seen upon closer inspection. Photo: Tone Marie Olstad 2011.

The art historian Agnete Mohn describes the wall decoration from 1601 in Urnes thus: "[...] the painting appears surprisingly sharp and clear. Perhaps because the light has not been able to fade the original colours much, [...] both the drawing and the colours emerge strongly from the white chalk ground. The black contours are the most important part of the decoration,

but the Renaissance's typical colours of reddish brown and yellow are used [...].<sup>89</sup>

I have observed faded greens, yellows and purple colour areas in the wall painting, in addition to the colours mentioned by Mohn. The faded areas were very probably painted using organic pigments. Yellow pigment has been observed on the ceiling of Urnes, which has been deemed to be orpiment, in the centre parts of the large flowers in the decorative painting (which are now white).<sup>90</sup>

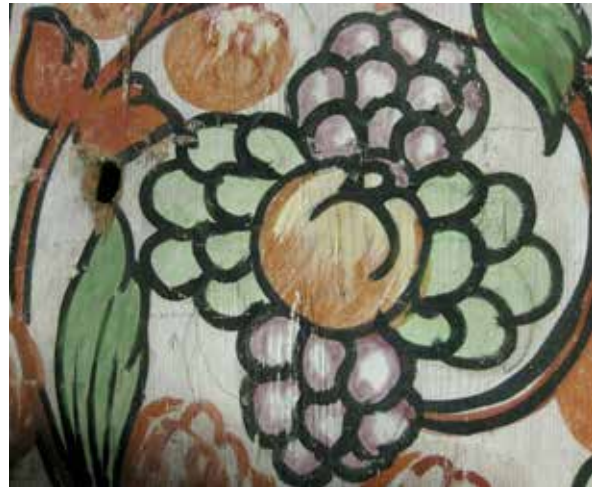
Urnes stavkirke. Same detail from the vine decoration from 1601, but with reconstructed colours. The reconstruction is the author's interpretation of what the decoration may have looked like, based on observations of details in the decoration. More time for assessment and analysis of the faded colours could alter the reconstruction. Photo/reconstruction: Tone Marie Olstad 2011.

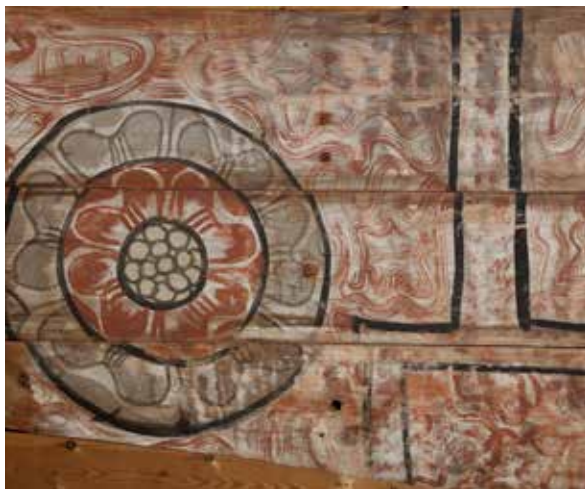
Urnes stavkirke. Part of ceiling with decoration from 1601. The ceiling is divided into fields with a large, round flower in each field. The circles are etched into the wood. The background motif, the red, wavy, parallel lines can be seen in a number of decorated interiors, for example in Kaupanger and in Grip. The painted decoration seems to have four colours: red, grey, white and black. Photo: Birger Lindstad 2011.

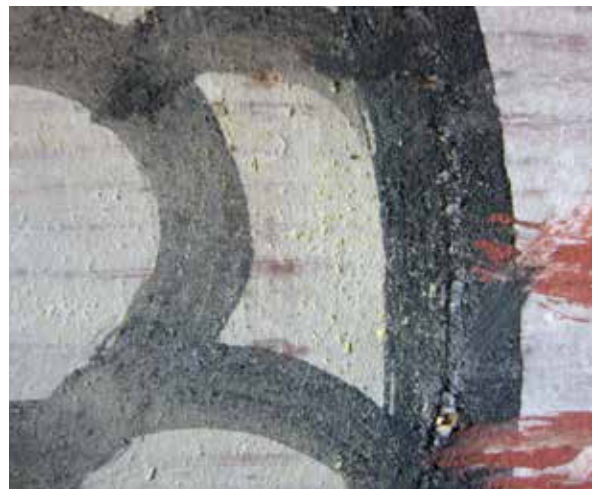
Urnes stave church. Section of figure 15. The section is from the innermost circle in the flower: On a thin white ground, we can see two red stripes from the petals in the middle circle, short, black brush strokes that create the «stamens» in the innermost circle, etched into the wood to mark the circle which has been drawn in black. Inside this circle, in the left half of the picture, are granules of yellow pigment lying on top of the black colour. This is auripigment, a yellow pigment which fades, but which can be recognised by the large, angular pigment particles. The centres of the flowers were originally yellow. Photo: Tone Marie Olstad 2011.

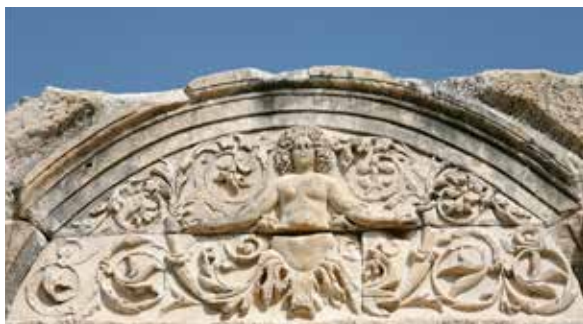
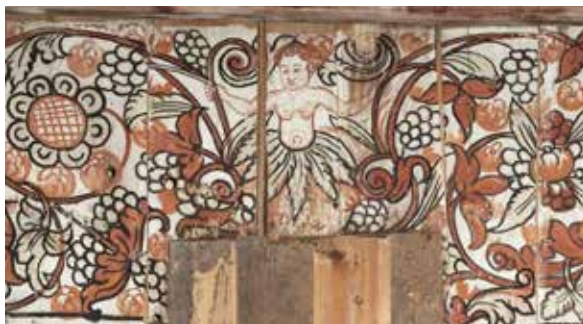
The church painter very probably had a pattern as a starting point for the decoration. One autumn day in Ephesus I suddenly came face-to-face with Urnes! The motif from the decoration in the gable end in the Temple of Hadrian (100-500 AD) in Ephesus in Turkey – uppermost in the picture – may have made its way across time and space before ending up as a pattern for the Urnes painter in 1601. In the lower half of the picture, the east wall at Urnes. This motif is hidden by the altarpiece, installed at a later point in time. Photo (top): © José Luiz Bernardes Ribeiro 2011. Photo (bottom): Birger Lindstad 2011.

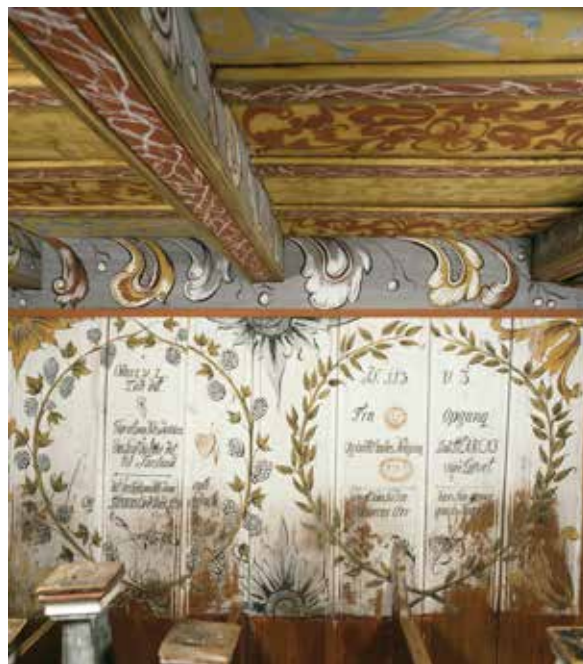
Nore stave church. Northern cross-arm. East wall. A picture bible published in Copenhagen in 1710 was the pattern for the rebus paintings in about 1731. These two show: «Book of Solomon, chapter 2, v.2. Make your ear (figurative) attentive to wisdom and incline your heart (figured). Then you will understand the fear of the Lord and find the knowledge of God» and «Psalm 113, v 3. From the rising of the sun (figurative) unto the going down of the same the LORD's name is to be praised. As long as the Sun shall rise, glory shall be to the Lord». (Text adapted from Christie & Christie 1981–93). Photo: Birger Lindstad and Joppe Christensen 1994.

It seems reasonable to assume that the church painters had models for the decorative paintings, although very few have been found to date. The use of models was common in the Middle Ages and has been proven for small-format church art in the 1600s and 1700s.<sup>100</sup> The construction of the tendril motifs on the east wall of Urnes stave church, where a central figure stands and holds the tendrils that cover the wall, is very similar to the decoration of the gable area of the Temple of Hadrian (100–500 AD) in Ephesus, Turkey. One can only speculate how this motif ended up among the models used by the Urnes painter.<sup>101</sup> The rebus paintings in Nore stave church from ca. 1731 are painted on the basis of an illustrated bible published in Copenhagen in 1710.<sup>102</sup>

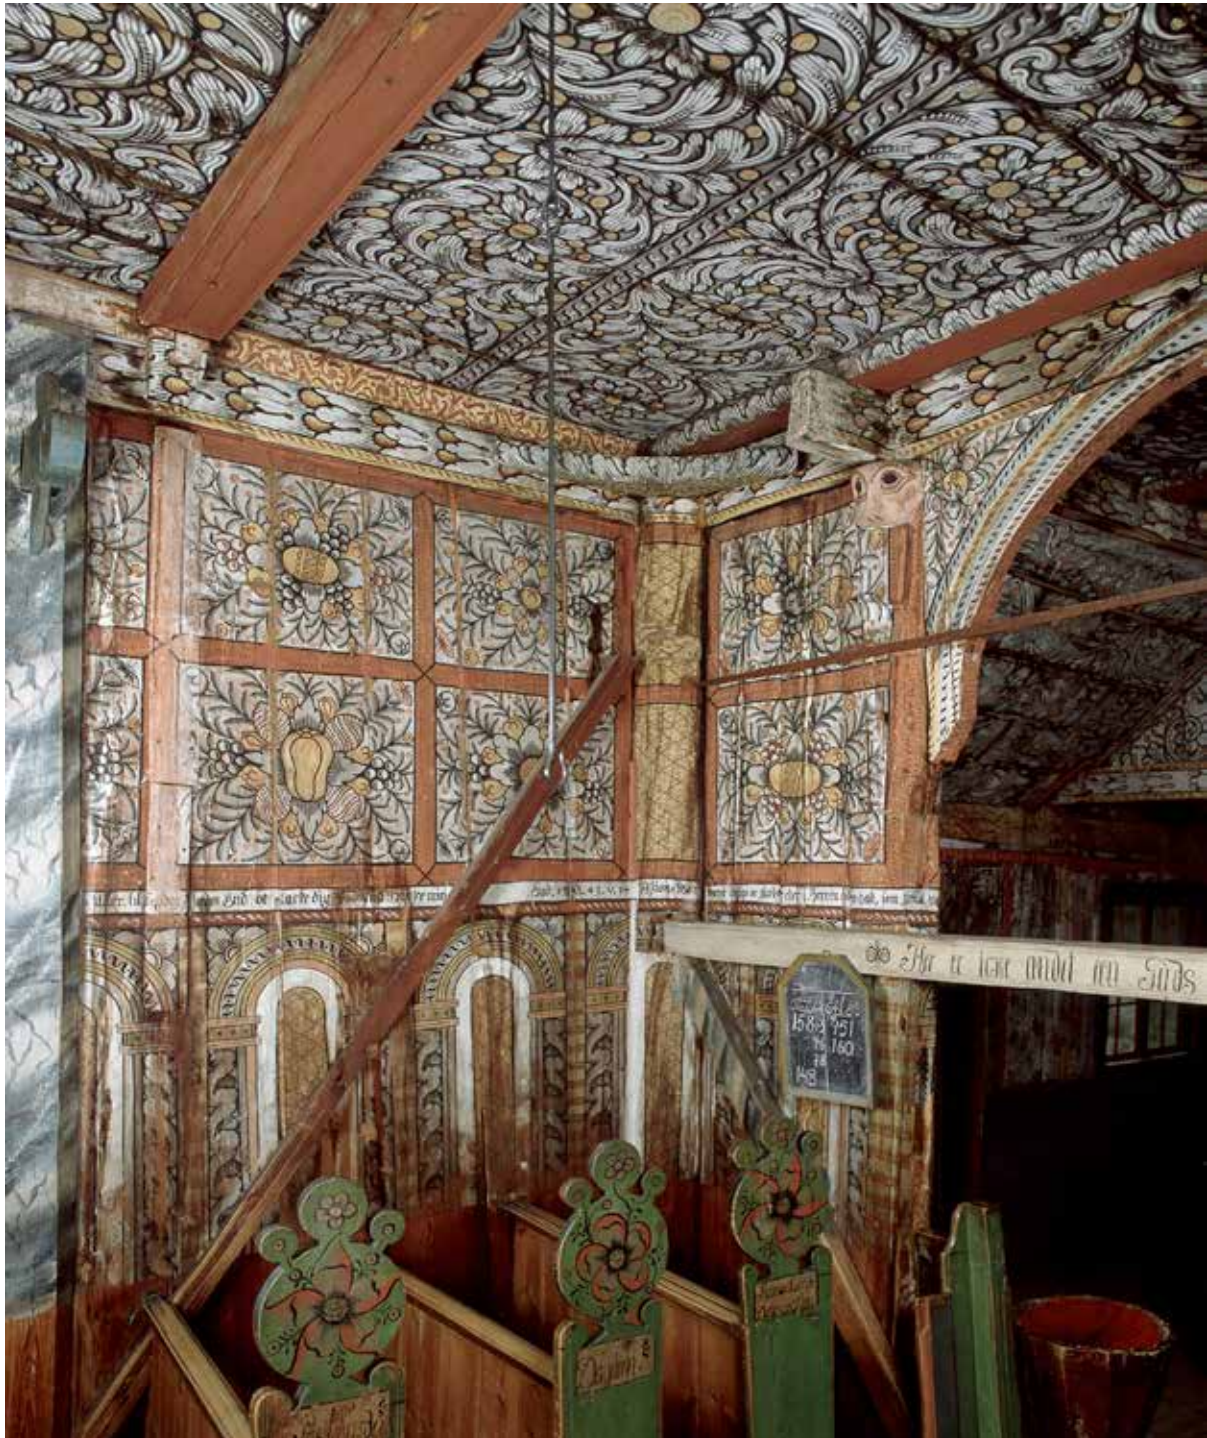
Uvdal stave church. North-eastern part of the nave with the Numedal painter's decorative distemper painting from 1656. Note the decoration on the ceiling and the elements in the decoration on the walls. The same elements are to be found in the other stave churches in Numedal, and in Gol stave church. The painted parapet consisting of round-arched panels with decorative frame wood can be seen in the revealed decoration in Flesberg. Photo Birger Lindstad 1993.

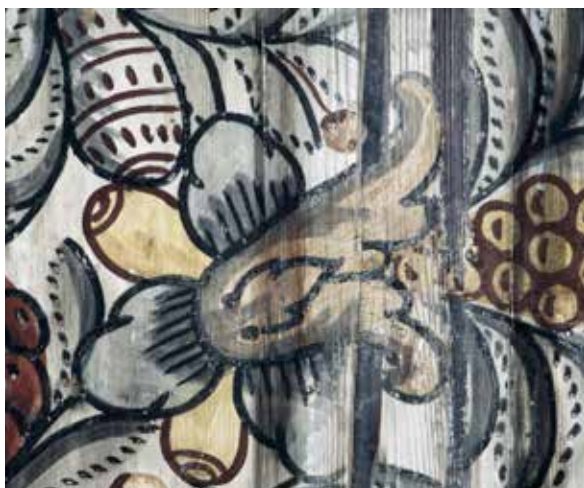
Nore stave church. Detail from the Numedal painter's decoration from 1655. The decorative elements and how they have been portrayed and painted are recognisable in the Numedal churches. Typical of the Numedal painter are the lacy leaves. Here they are grey, but originally they would have been green. Photo: Kristin Solberg 1997.

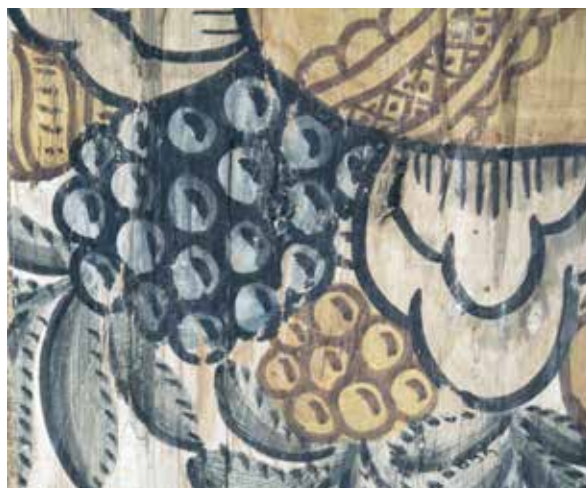
Rollag stave church. The Numedal painter's decoration from 1655. Detail of the decoration on one of the surviving tiles stored at the vicarage. Grapes, leaves and fruit are painted, as at Nore and Uvdal. Note the leaves. Here the green colour has survived. The blue colour, which is indigo, has also survived. This is because the decoration has been kept in the dark. Photo: Kristin Solberg 1997.

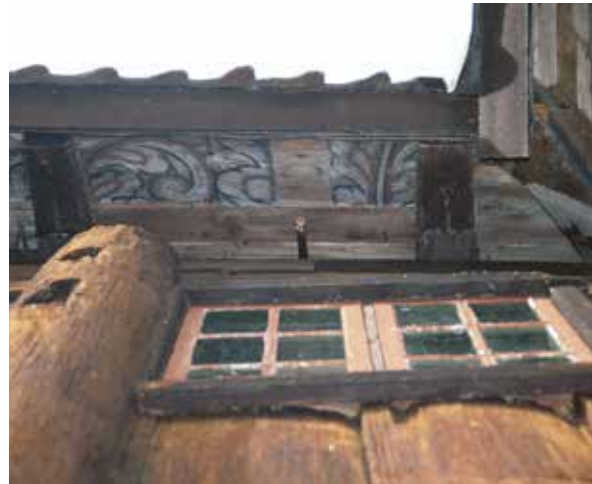
Among the roof boards in Rollag church are many with decoration. These are in the loft, but can be seen if you stand by the wall outside and look up under the edge of the roof. The re-used boards were painted by the Numedal master. The ceiling decoration from the 1650s was the same in Nore and Rollag stave churches and is very similar to Uvdal. Photo: Tone Marie Olstad 2015.

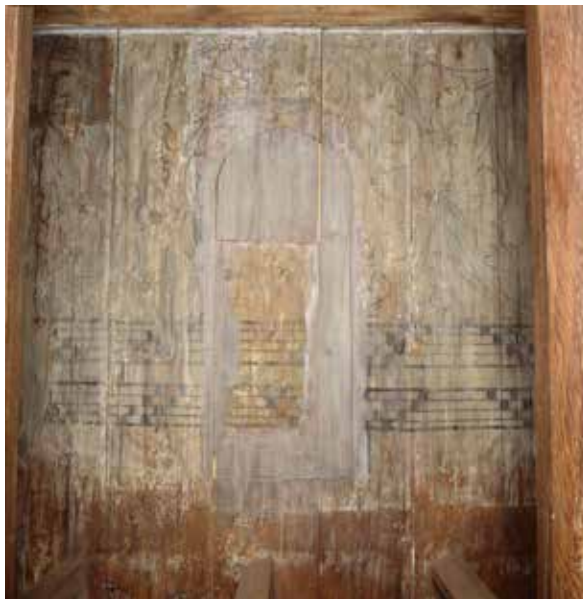
Kaupanger stave church. Part of the south wall with traces of a 1800s window inserted. The secondary inserted material is muted using a grey-white «wash» with oil-based paint. The original colourful decorative distemper painting has been reduced to a weak, almost black and white decoration. Below the vines in the nave is a vertical frieze of neums, a musical notation from the Middle Ages. Photo: Birger Lindstad 2008.

When Kaupanger stave church was returned to its assumed 1600s state in the 1960s, it was impossible to remove all the layers of decorative overpainting covering the walls of the nave and chancel, as well as on the construction elements in the church interior. Both the nave and chancel had tendril decoration on the upper parts of the walls. Beneath the decorative plant motif in the nave runs a vertical frieze of so-called neumes, a form of musical notation from the Middle Ages.<sup>136</sup> Higher up the wall, above the arches between the staves or posts, neumes can be spotted through the remaining layer of overpainting, which is like a grey veil over the artwork, reducing the colours and making the motifs in the decorative distemper paint hard to distinguish.<sup>137</sup> The decoration is no longer experienced as distemper painting, and it is impossible to get an idea of how the

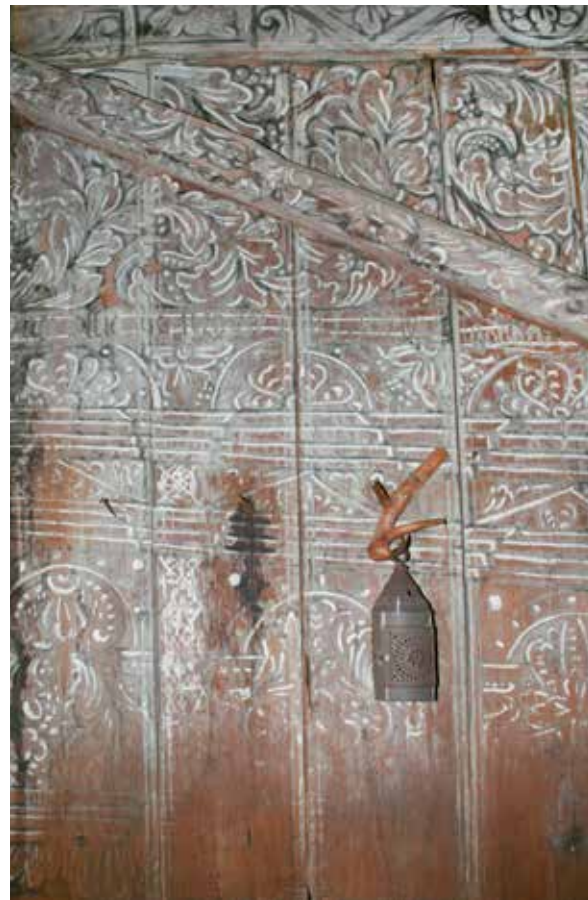
Rødven stave church. Decoration painted in the middle of the 1600s. The upper part of the wall is covered with grey, white and black vines on a red ground; the lower part with architectural elements in the same colours. The decoration is very worn and decayed. This is the only decorative distemper painting in the stave churches which has survived in an untouched state. Photo: Tone Marie Olstad 2011.

“Thanks to the church never being restored, here we encounter one of the very few surviving rural church interiors,” Håkon Christie writes about Rødven stave church in 1969.<sup>138</sup>

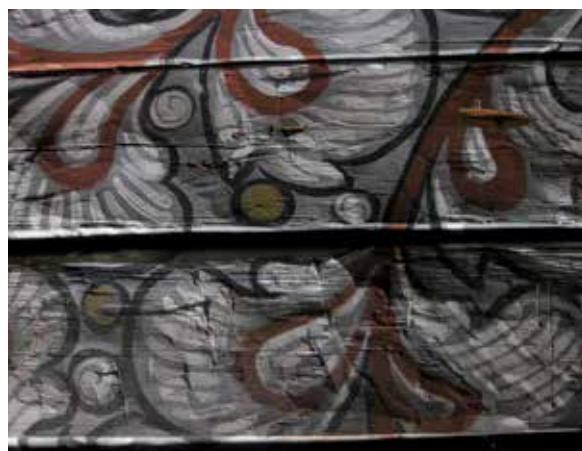
Nore stavkirke. The decorative distemper painting was painted directly onto the hewn surface and no further working of the wooden surface was needed. Here the vines on the timber walls of the southern gallery at Nore can be seen. These resemble the vines in the nave's oldest ceiling, but are freer and more coarsely painted. This adornment was probably added just after 1709. Photo: Tone Marie Olstad, undated.

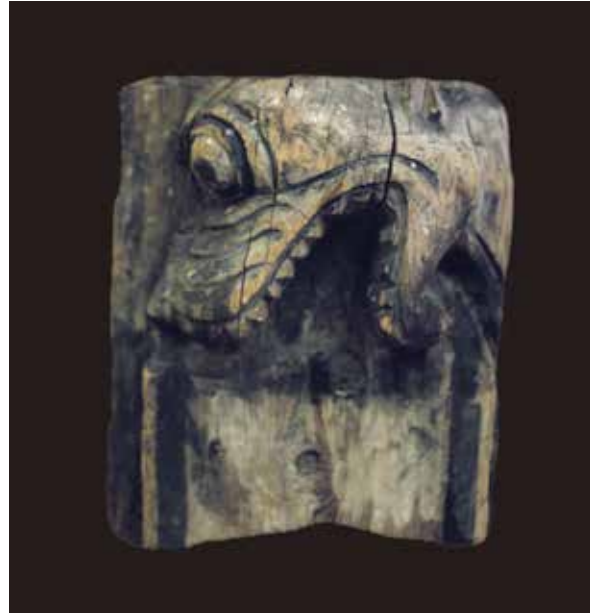
Ill. 4. Figure with most recent tree ring from 1134. Probably part of the original Ål stave church. Photo: Terje Thun 1995.

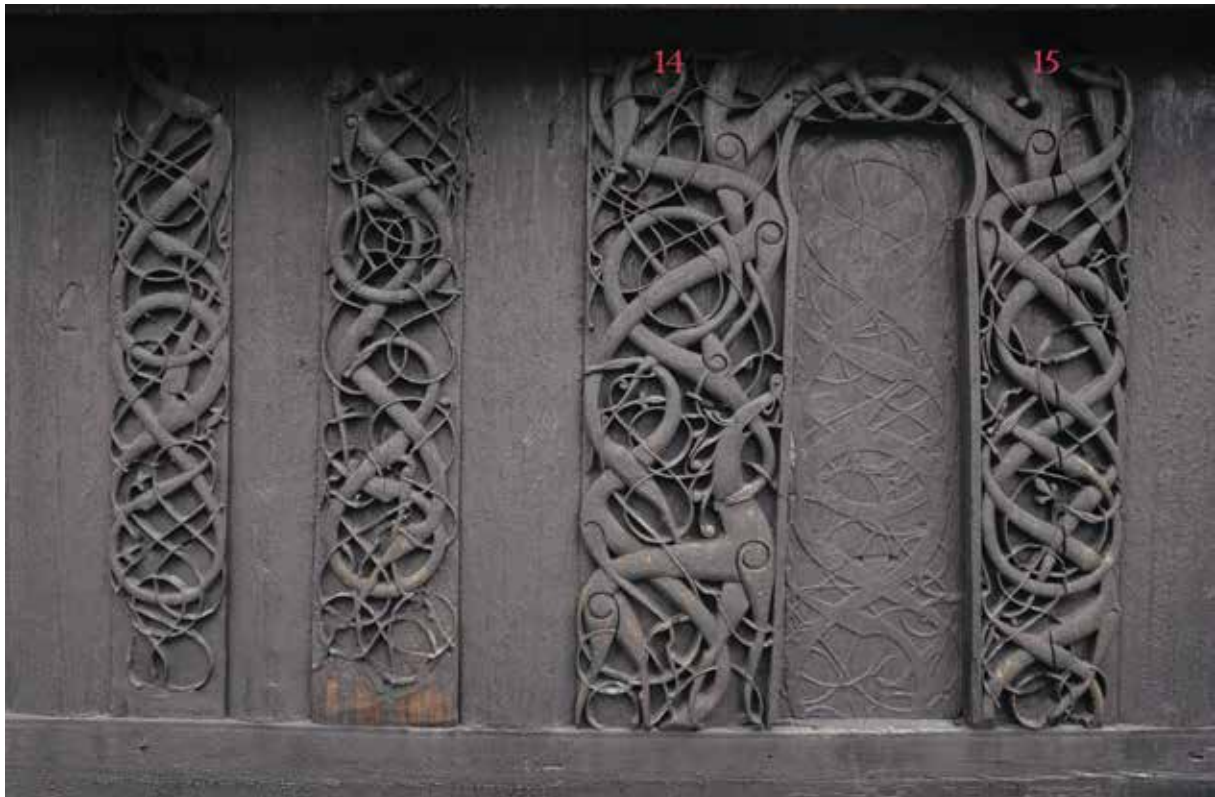
III. 11. The north wall of Urnes stave church with reused parts of the previous stave church. Planks nos. 14 and 15 from the east are those on each side of the key-shaped door: It should be noted that Knud Krogh numbers plank 15 as 16/F, as he numbered the portal's lintel as plank 15/E. The letters refer to the location of the planks in the preceding church's west wall. Photo: Arve Kjersheim 1993.

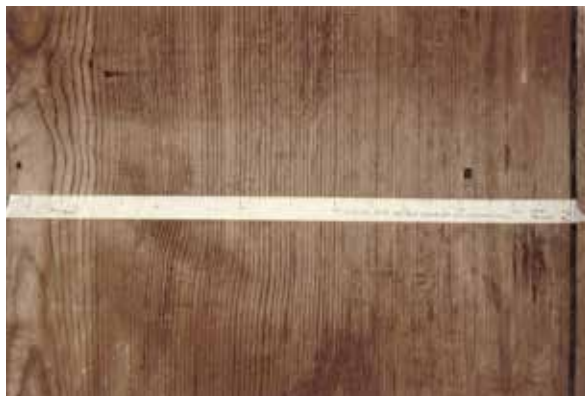
III. 12. Photograph of plank no. 14 from the east taken for the inside: the sapwood is missing. Photo: Jan Michael Stornes 2008

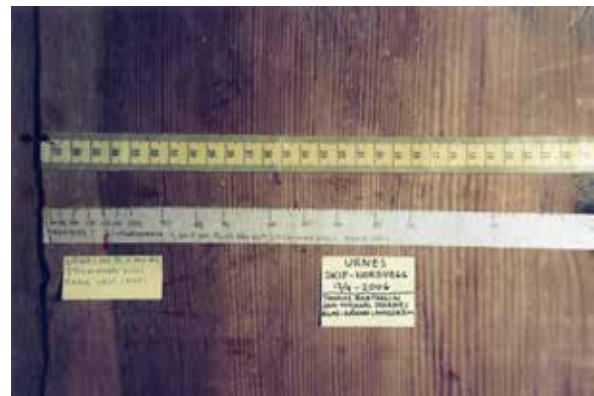
III. 13. Uppermost in the picture of plank no. 15 from the east, the sapwood has been preserved and the outermost tree ring is from 1069: this is the youngest dated tree ring for the north wall.

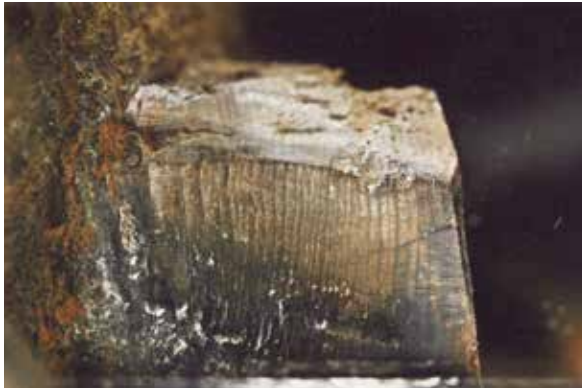
Ill. 14. The picture shows the shortest of the exposed radii on the outside of the plank on a part of the carving that lies directly below the main radius. Normally the radius on the plank's outer side will have the most tree rings, but due to the abnormal growth pattern, the external radii were dated to 1054 and 1056 respectively. Photo: Jan Michael Stornes 2008.

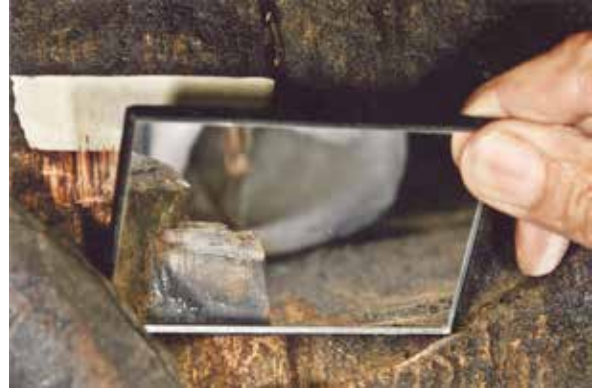
Ill. 15. Details of the outer surface of plank 14 showed by the help of a mirror. Photo: Jan Michael Stornes 2008.

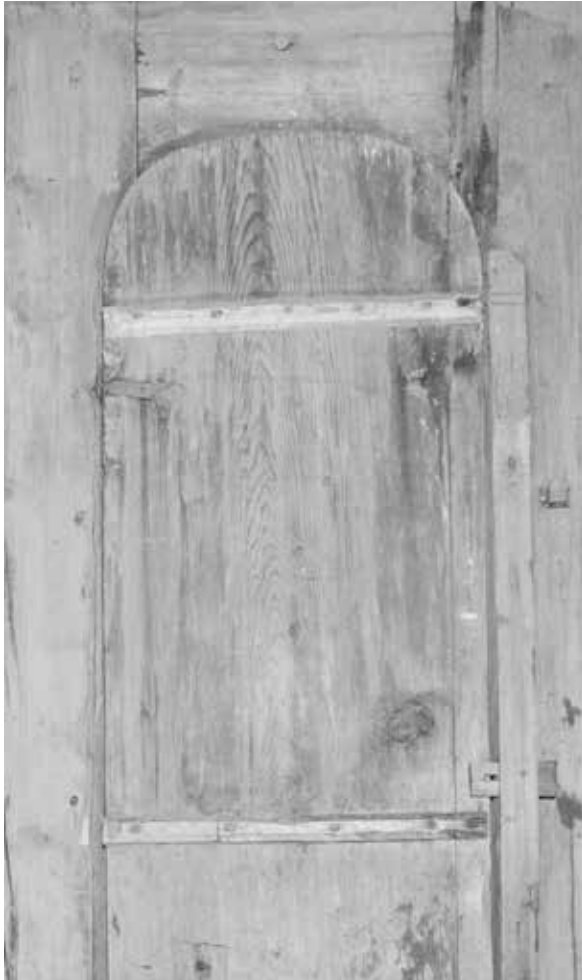
Ill. 19. Inside of door from the north wall of Urnes stave church. The plank is from a pine tree that grew quickly in its early years and with many, often large twigs. Photo: Håkon Christie and Knud Krogh 1971.

This material, dated to around 1070, comes from the present church's predecessor, known as the Urnes-style church, but it hardly meets the criteria that define high-quality material. Nonetheless it has not deteriorated due to decay or insect damage over many centuries.

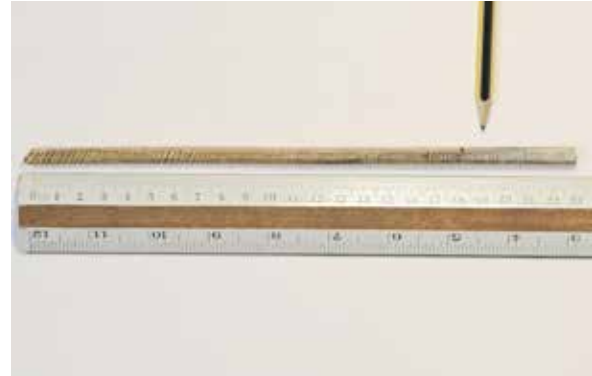
Ill. 22. Hopperstad stave church, 4th. stave from the west in the northern row of staves in the chancel, felled in the winter of 1131–1132. The sample contains 191 tree rings, of which 52 are in the sapwood. The pencil indicates the transition from heartwood to sapwood. Photo: Helene Løvstrand Svarva 2015.

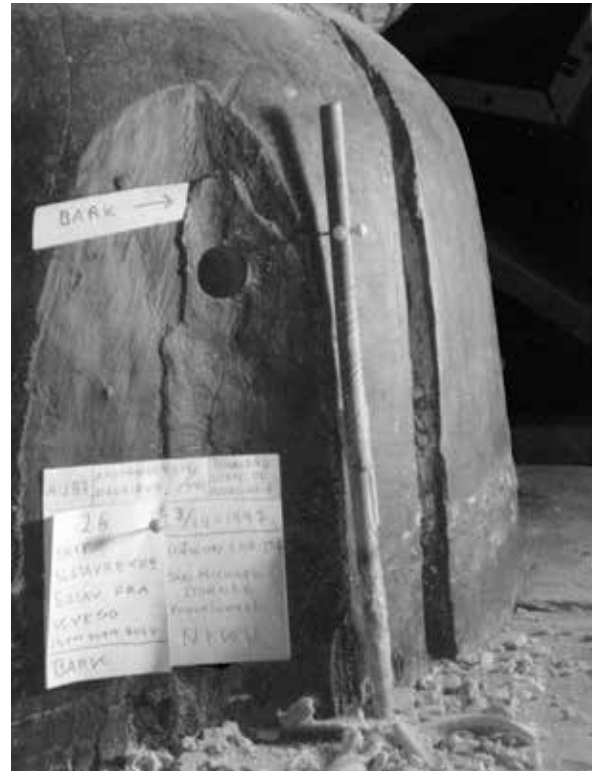
Ill. 23. Stave in Kaupanger stave church with damage. Photo: Jan Michael Stormes 1998.

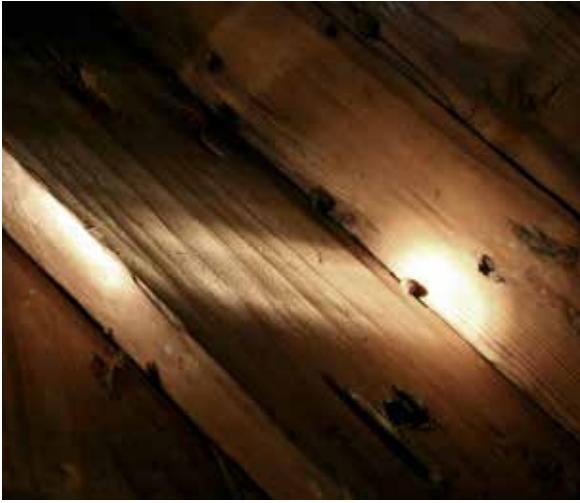
Side light is important for highlighting the relief created by tool marks. However, it can be difficult for the untrained eye to read and understand such traces. Photo: The Stave Church Preservation Programme 2002.

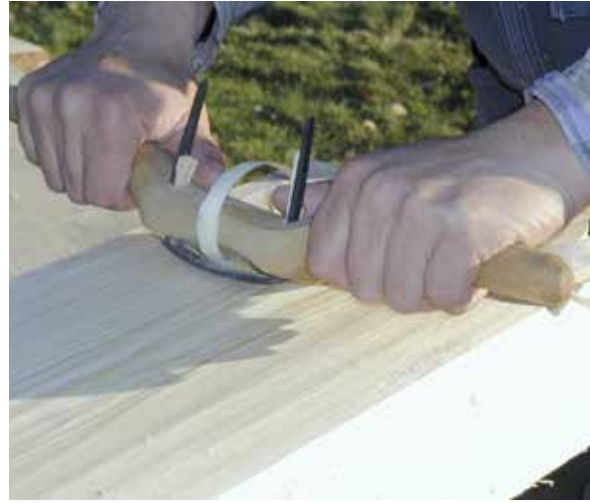
By trying out different tools and creating tool marks it becomes easier to understand the old traces. We find that the edge, and the humidity and characteristics of the materials affect the result. The picture shows a spoke shave that goes together with the hewing process. The more recent planes with a flat sole belong to sawing technology and modern carpentry. Photo: Kristen Åmodt 2002.

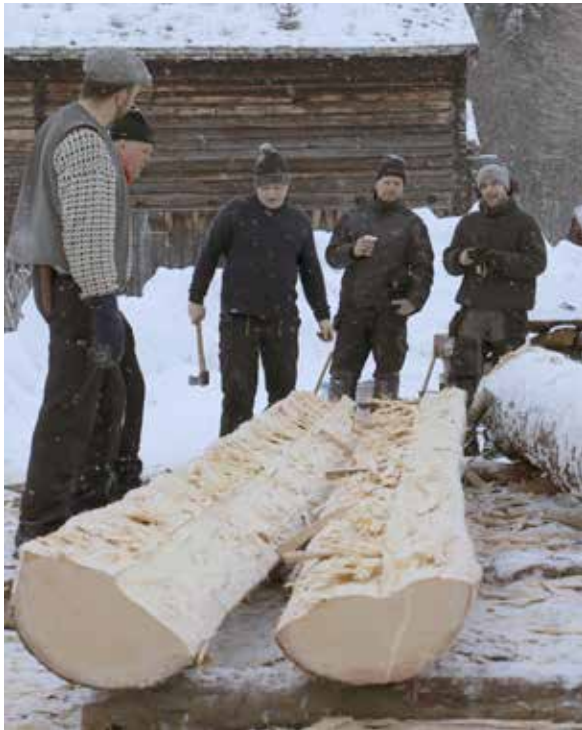
In the winter of 2015 a two-week practical seminar was organized on the process of producing roofing for Haltdalen stave church at Sverresborg. The process of cleaving the logs was based on the tradition of Roald Renmælmo and Konrad Stenvold from Målselv. The seminar investigated the practical side of the process from the forest to preparing the roofing boards, jointing and whittling of wooden nails. Not all logs are easy to split. Even this devil finally had to give in to axes, wedges and sledgehammers. Here Roald Renmælmo holds a narrow axe for cutting the fibres that are crossing over. Blacksmith Øystein Myhre is on site to learn more about how the tools he makes can be used and improved. Photo: Terje Planke 2015.

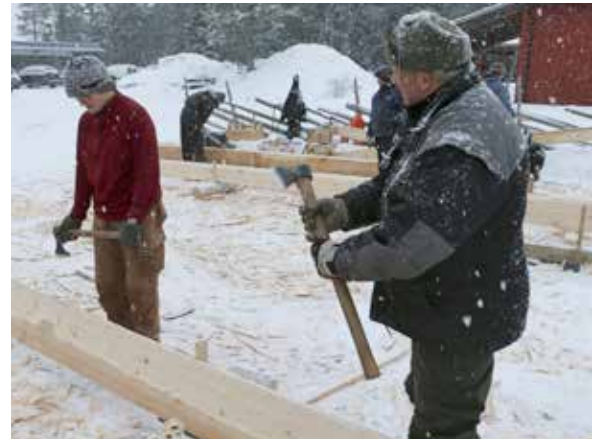
While working, the two experienced hewers, Siv Holmin and Hans Marumsrud exchange experiences. Siv Holmin is using an axe reconstructed from a medieval model from Fron in Gudbrandsdalen. Hans Marumsrud uses an axe reconstructed in a style used in north-western Russia. This log was split by band saw prior to hewing, giving the hewing primarily a decorative function. When splitting the logs by axe, the work is different in that the primary task is to remove wood. The hewing marks then become a result of the work and require more skill. Photo: Terje Planke 2015.

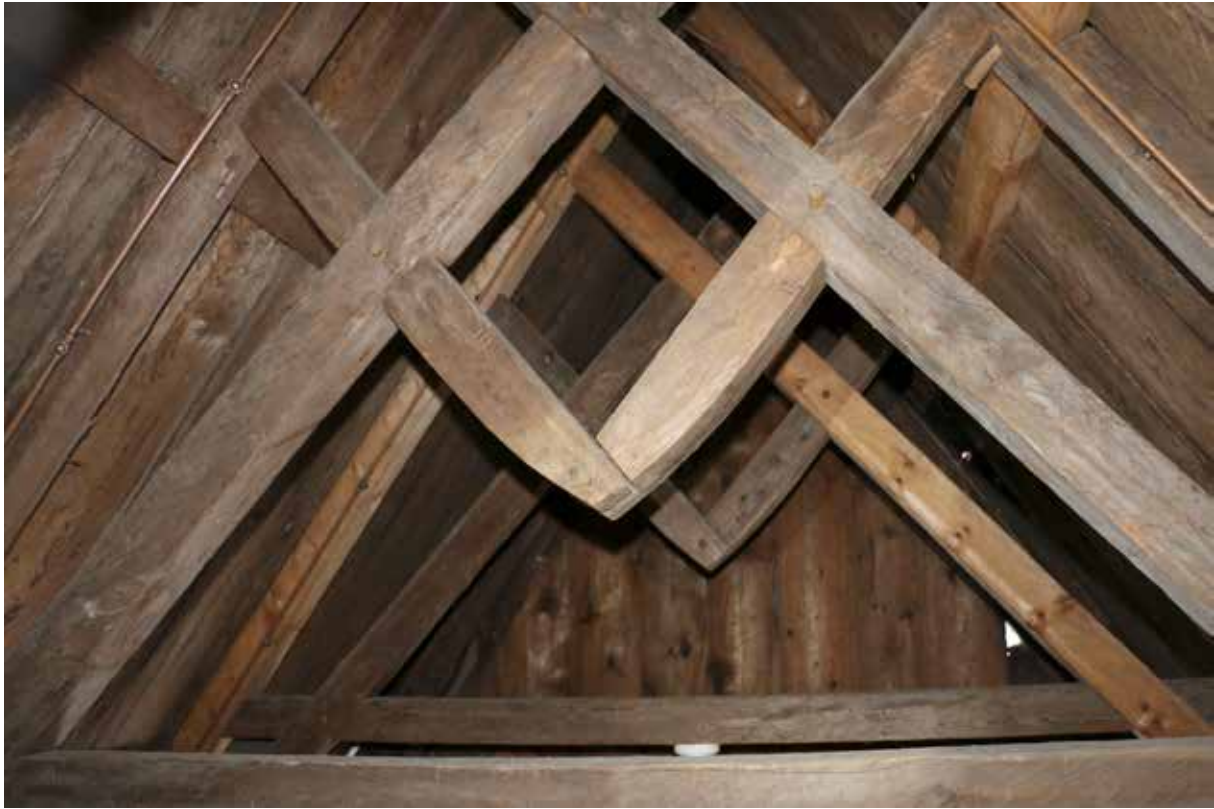
Section of the framework and roof construction in Haltdalen stave church at Sverresborg. The framework forms a delicate and advanced technology with great strength and enough properties to counteract the side pressures on the walls. However, little has been done to study the construction in depth and to understand the underlying pattern and how the different construction elements work together. Between the rafters are three by three vertical roof boards. Outside is the original cladding, fastened with wooden nails. The characteristic shingles on the roof are old, but still a secondary roofing. The two layers of roof boards that intersect creates rigidity and stability in the roof construction. Photo: Terje Planke 2015.
