# PRESERVING THE STAVE CHURCHES

## CRAFTSMANSHIP AND RESEARCH

## Craftsmanship and Research

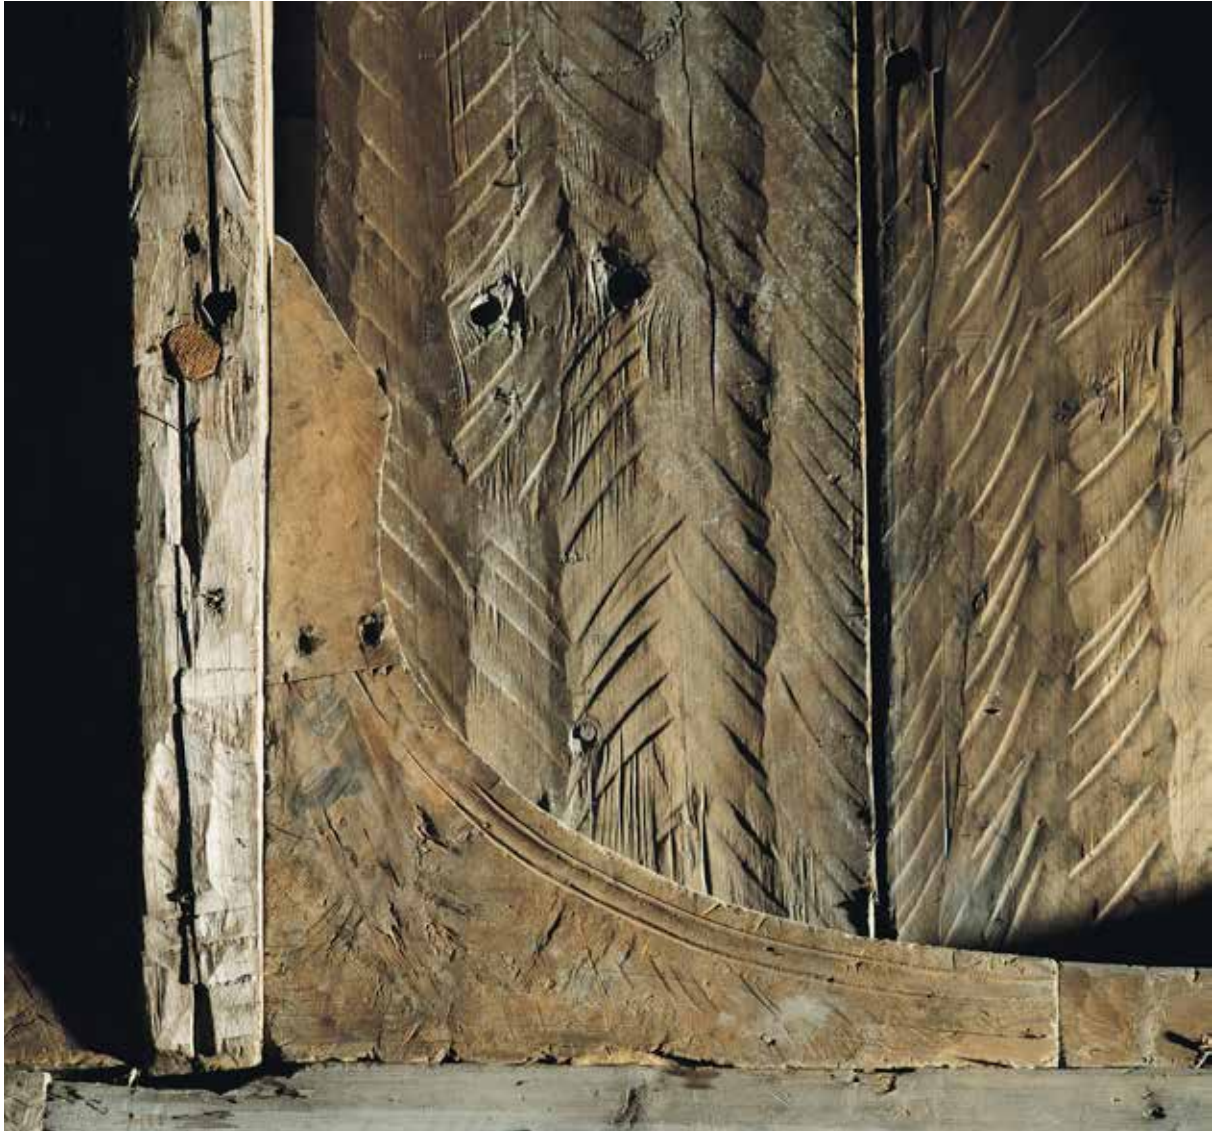
Section of the cladding in the ceiling of Haltdalen Stave Church. A wooden knee bracket binds together the rafter and the wall plate. Three by three vertical planks lie between the rafters. The ceiling has clear, marked traces of splash whittling. The axe marks are somewhat unusual as they run along the fibres. This cladding and the axe marks in the ceiling, are a good source for reconstructing the work behind the horizontal boards that lie above. Photo: Birger Lindstad 1999.

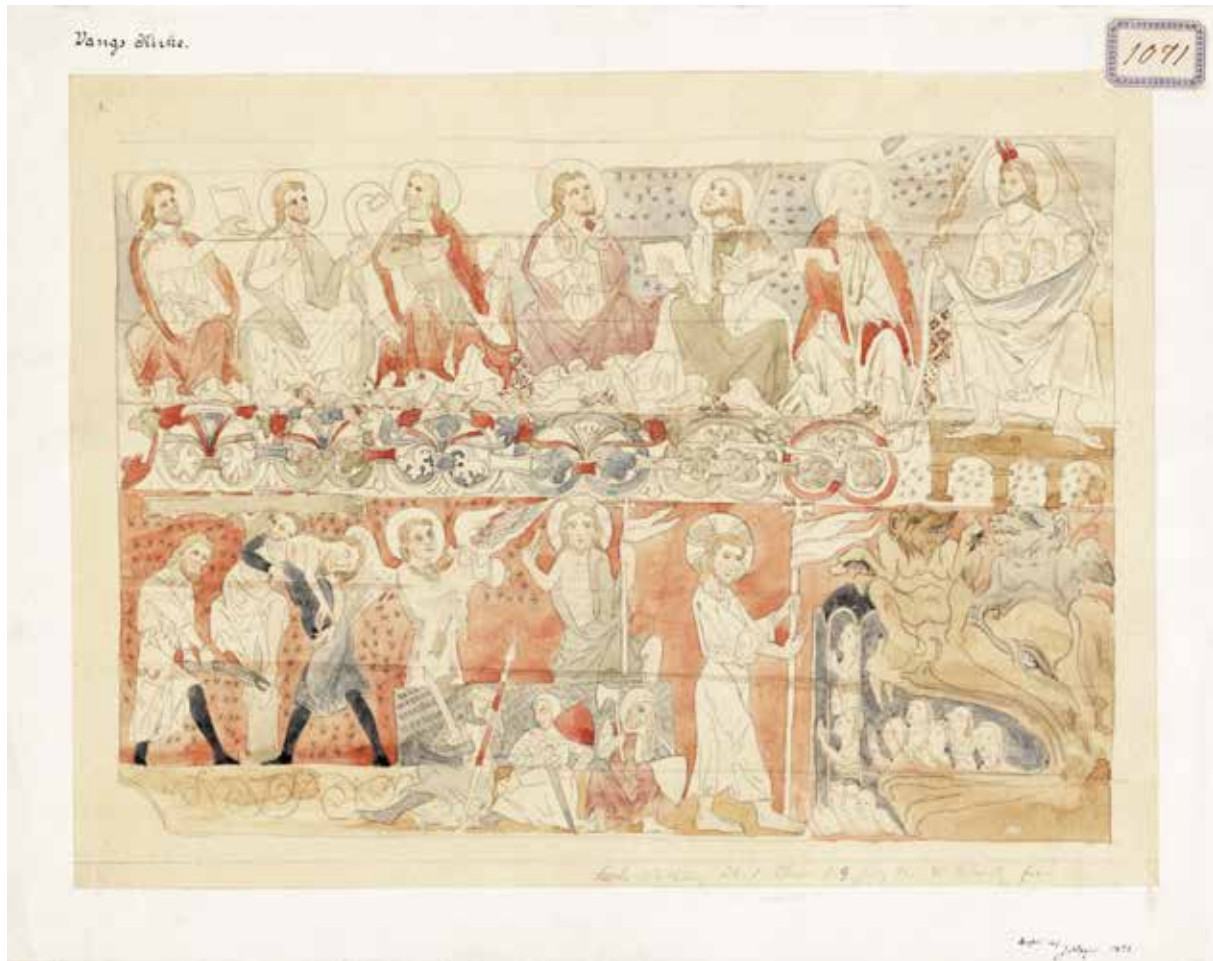
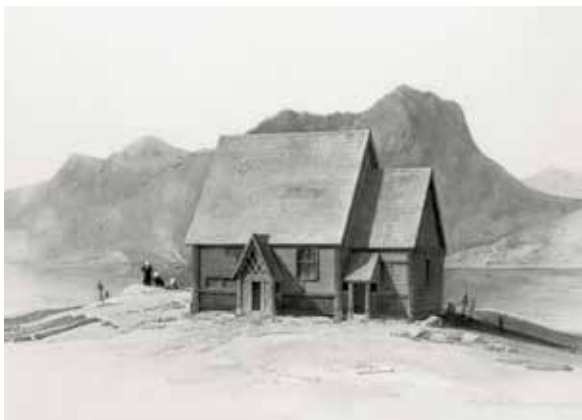
Vang stave church in Valdres was demolished in 1841. It was bought by J.C. Dahl who in this way was responsible for the first stave church rescue-mission. His student, F.W. Schiertz conducted a survey of the church and directed the demolition process. Most of the building parts were transported over the mountains to Lærdal. From here, the journey went to Germany. Dahl had sold the church to the King of Prussia, Friedrich Wilhelm 4th. The church was reconstructed in what today is Karpacz in Poland, which at that time was a part of German Silesia.

The top illustration shows the chancel vault in Vang stave church, which arrived in Berlin but has since disappeared. Today we know it only from Schiertz' water-colours; here reproduced in Johan Meyer's copy from 1897. The décor is considered one of the foremost examples of medieval interior paintings in Norway.

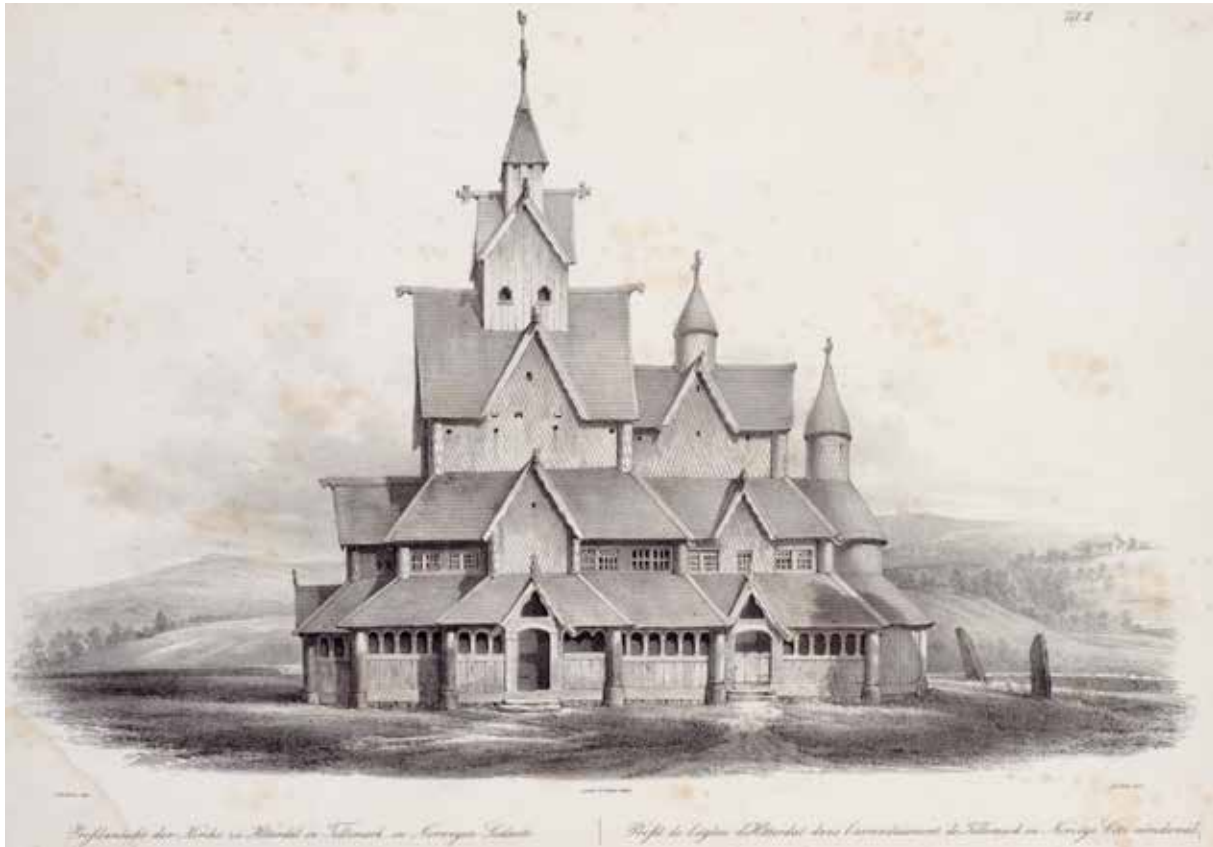
Heddal stave church, facade to the south, plan and interior to the east. Lithographs published in Dahl's book after drawings by Dahl's pupil Franz Wilhelm Schiertz (1813–1887). The description and illustrations in Dahl's book contain significant documentation of the church before the comprehensive restoration between 1848–50.

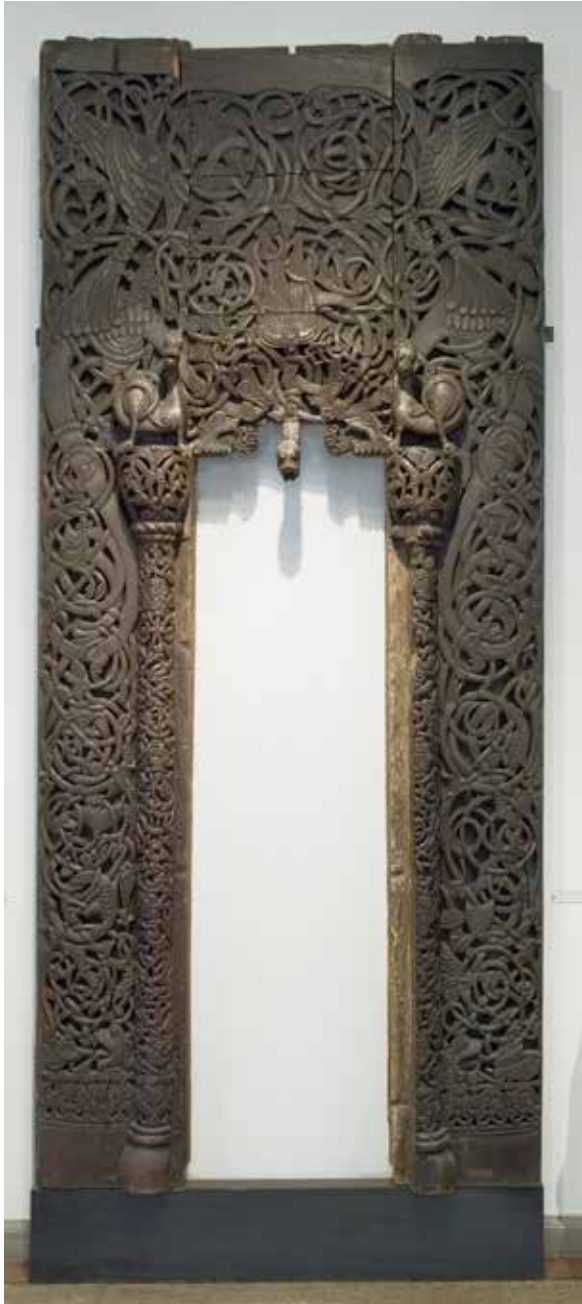
The west portal of Ål stave church, Hallingdal, is one of the most important of the preserved stave church portals. It is dated to around 1150. The opening is 252 cm high, 80 cm wide at the bottom, reducing to 71 cm at the top. The apparent wilderness on the sidepieces consists of spiral vines, small writhing dragons and wild animals. At the top are two dragons facing each other, biting a smaller, central dragon. The carved half-pillars each carry a lion about to devour a human. The significance of the motifs is much discussed. Photo: Ann Christine Eek, undated.

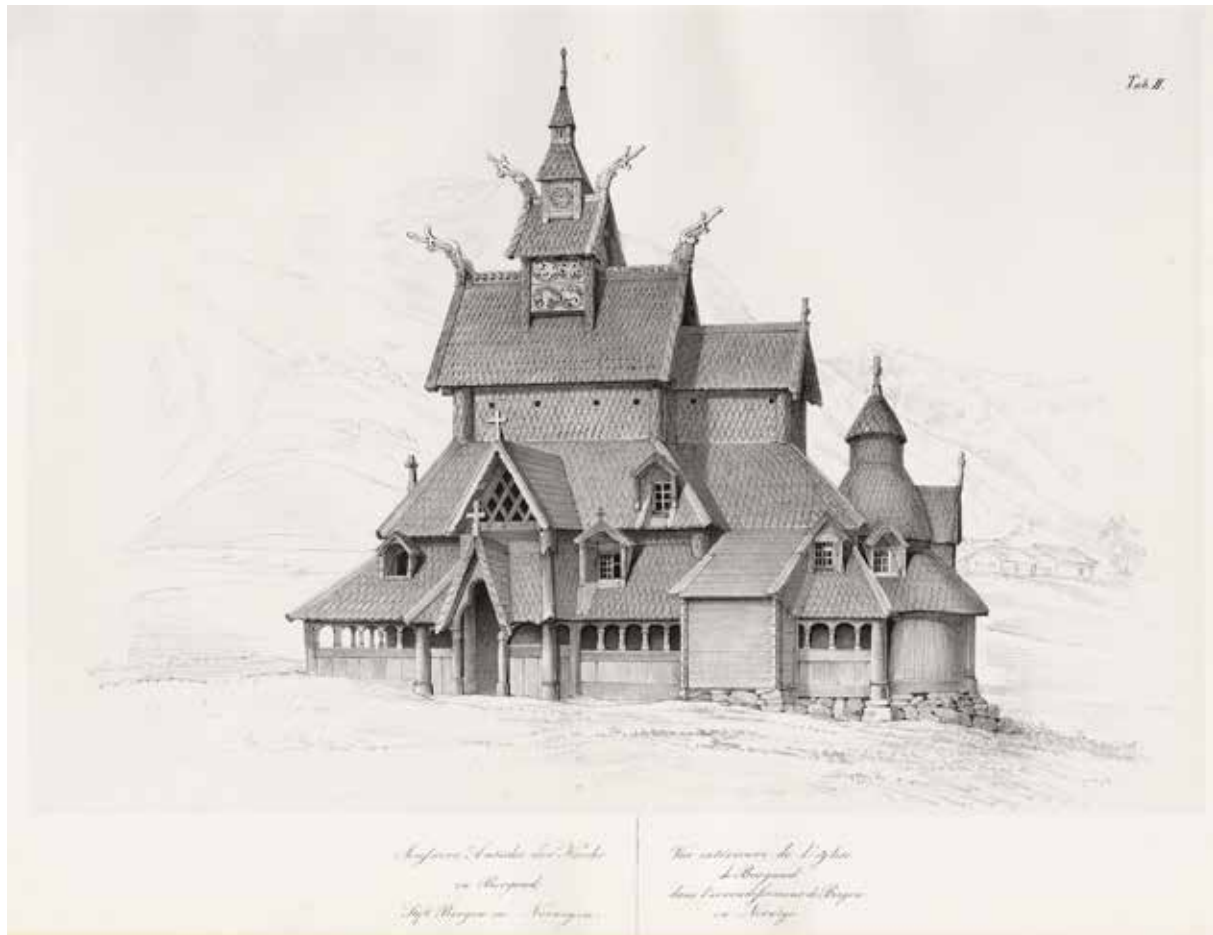
Borgund stave church. Lithographs published in Dahl's book from drawings by J.C.Dahl's pupil Franz Wilhelm Schiertz (1813–1887).

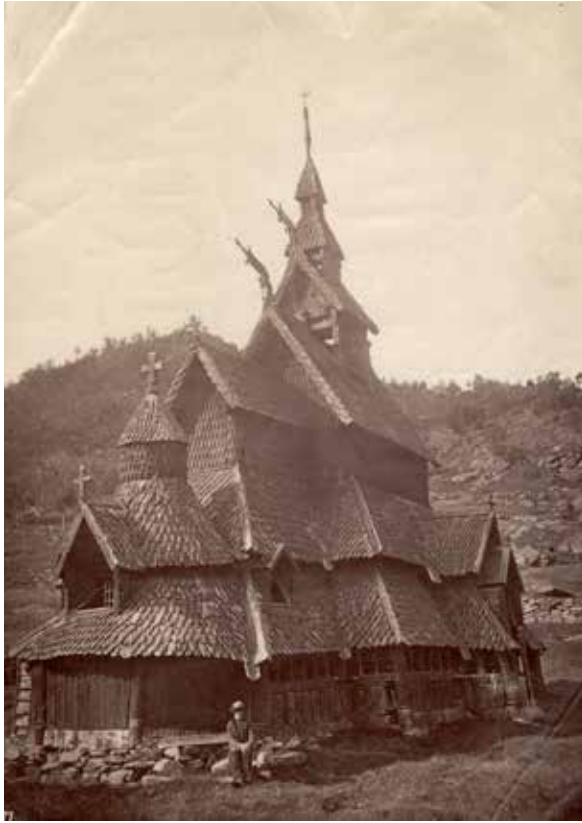
Borgund stave church. The photograph shows one of several window arches and windows dating from after the Reformation. Windows, arches, the sacristy, the galleries and most of the fittings and decoration from the 1600s and 1700s were removed during the restoration in the 1870s. The stave churches played an important role in developing a national identity. The history of the stave churches had to be traced back as far in time as possible, and at least to before the union with Denmark, so that they could be perceived as an expression of something uniquely and genuinely Norwegian. This meant that there was little interest in the post-Reformation history of the stave churches when the stave churches were first restored. Photo: unknown, pre-1870.

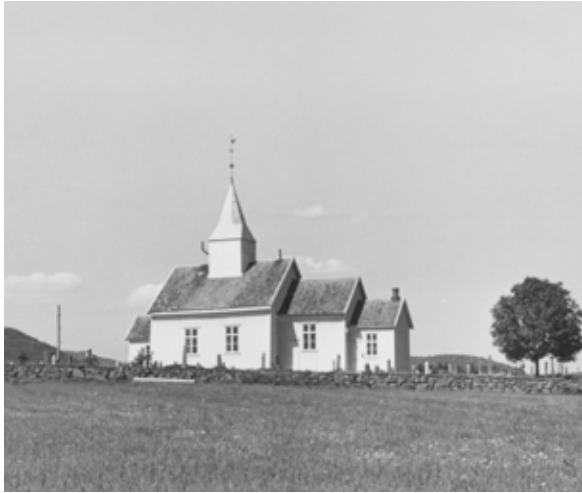
Høyjord stave church in Vestfold after building works in 1848, with large windows, panel cladding and ceramic tiles on the roof. Photo: Riksantikvaren

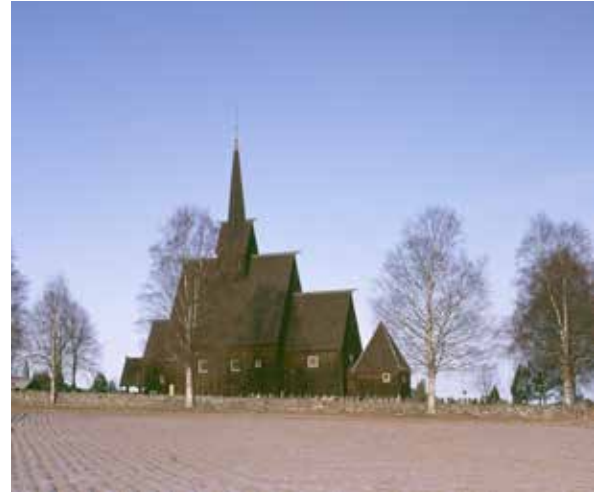
Høyjord stave church after the extensive interior and exterior restoration, completed in 1953. The roof became steeper, with a new tower and a tall spire supported by a central mast. The panel cladding is new, and old window openings have been re-installed with lead glass. Photo: Birger Linstad, Riksantikvaren.

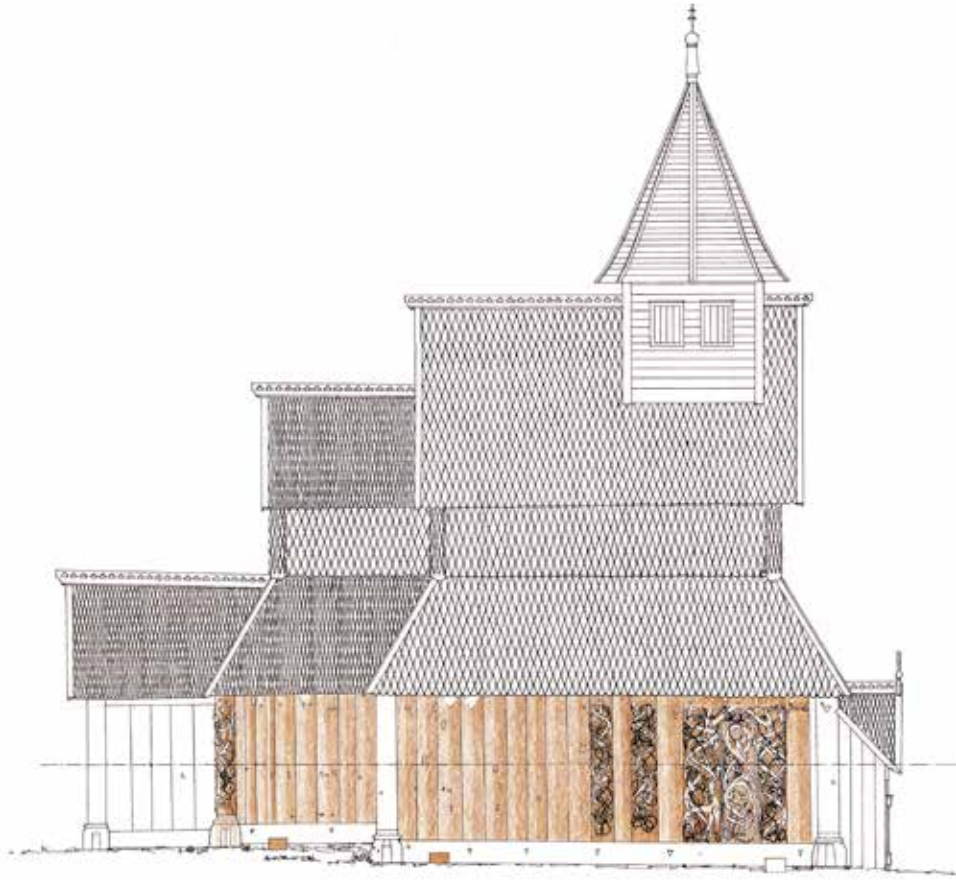
Documentation as research: in Knud Krogh's *Urnesstilens kirke* (*The Urnes-style church*) the church is analysed in depth; small, possibly insignificant details are revealed and made more meaningful. With the help of decorated construction elements, carved in the so-called «Urnes-style», re-used on the north wall, a gable end and minute traces, Krogh succeeds in setting out a convincing reconstruction proposal for the preceding church on the site, which he calls the «Urnes-style church». The drawing, the re-used materials in the extant church are marked in brown.

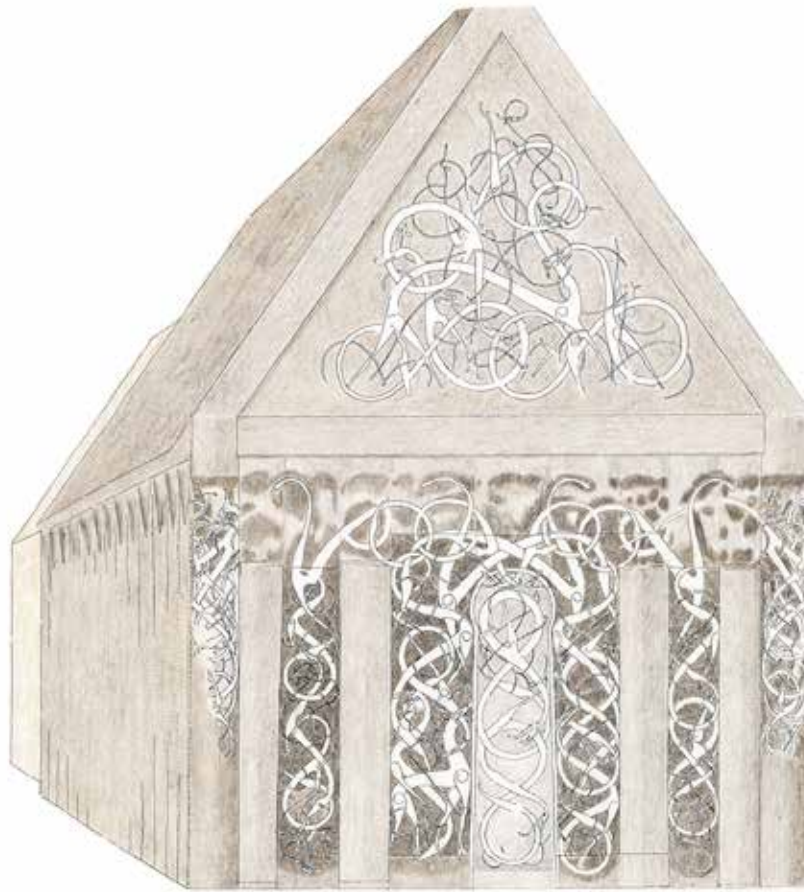
Krogh's reconstruction of the preceding church at Urnes based on the preserved reused materials and traces in these. Non-documented parts are shown without an outline.

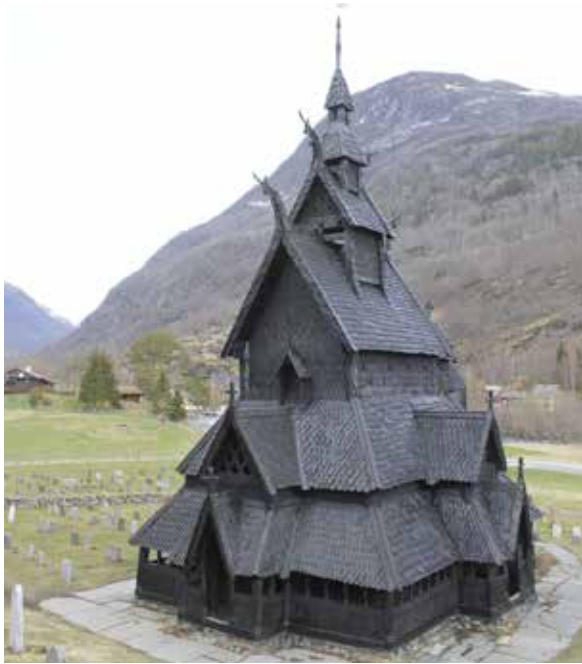
### Borgund stave church, Lærdal

Borgund stave church is one of the best preserved stave churches. It is dated to ca. 1180. Under the Stave Church Preservation Programme, about 5,800 shingles were replaced on the stave church. In contrast with the work on many of the other stave churches, a decision was made to check each individual shingle and only replace them where absolutely necessary. The work revealed leaks and rot in the gutters and the sills, but not to a degree requiring action. The rafters were improved and new copper fittings were mounted on all the gutters. The work at Borgund was carried out in the period 2006–2012. This provided an opportunity to study the ridge turret of the church and make and mount new copies of the characteristic dragon heads, which were actually also copies, made in the 1700s. The triptych in the church is from the early 1600s and was treated by a conservator. The status of the ground beneath the floor was registered. The free-standing bell tower at Borgund stave church is the only one left from the Middle Ages. The support structure of the bell tower was severely damaged by rot. The Stave Church Preservation Programme ensured that the rotten parts of the construction were filled in where this was sufficient, and elements were replaced where necessary. The panelling of the bell tower was copied and secured with wooden pegs.

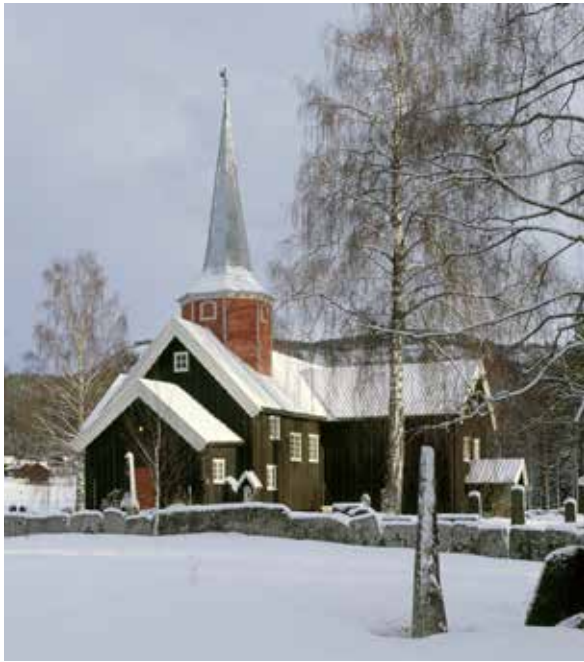
### Flesberg stave church, Flesberg

Flesberg stave church is dated to the latter half of the 1100s. In the Middle Ages the church had a rectangular nave and a narrower chancel. Its current form dates from 1735 when the stave-built nave was torn down and rebuilt in a cruciform shape, with new parts made of cog-jointed logs. Sections of the original stave construction now comprise the western part of the nave. Much of the church's structural damage was in the cog-jointed part, which was badly affected by rot. The rotten logs of the southern wall were replaced. Rot in the wall above the southern transept was dealt with and the roof construction was renovated. The work was done in the period 2004–2005. In the stave church portion of the building, layers of paint were removed to reveal the old distemper painting.

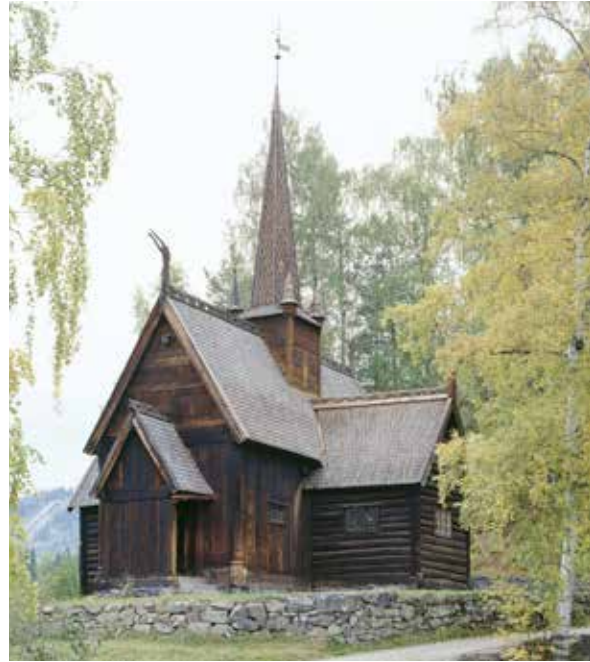
### Garmo stave church, Lillehammer

Garmo stave church was originally located at Garmo in Lom, but now stands in Maihaugen open-air museum in Lillehammer. It was one of the last stave churches to be demolished, as late as 1882. In 1921 the church was reconstructed. Through the Stave Church Preservation Programme the church was given new roof shingles and was re-tarred. When the work was being done the two characteristic dragon heads of the roof were replaced by new copies and the church was given new ridge crests like the old ones. The interior furnishings of the church were inspected by a conservator and minor improvements were made, including the restoration of the chancel screen. Work on the church was done in the period 2005–2009.

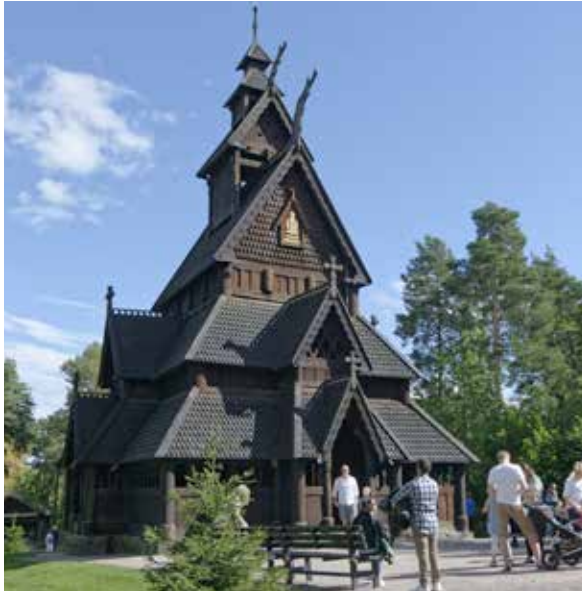
### Gol stave church, Oslo

Gol stave church is originally from Gol in Hallingdal but it was moved to the Norwegian Museum of Cultural History at Bygdøy in Oslo in 1884. The church is dated to the beginning of the 1200s but it may have older parts. The church has looked as it does now as far back as the 1600s, with a pentice around its nave and chancel. The ridge turret was renewed in 1694 when a ceiling was built over the nave. Sometime later the chancel and apse were demolished and a new cog-jointed log chancel was erected. The old material was re-used in the ceiling of the new chancel and this is how the wall paintings survived, which were later restored in connection with the move. The medieval parts of the church were registered during the Stave Church Preservation Programme. The church was given new roof shingles and the crosses and dragon heads on the church were replaced with copies. A replica of the original monogram of King Oscar II has been mounted on the west gable of the church. The condition of the art and furniture in the church was registered. The work on the church was done in the winter of 2012.

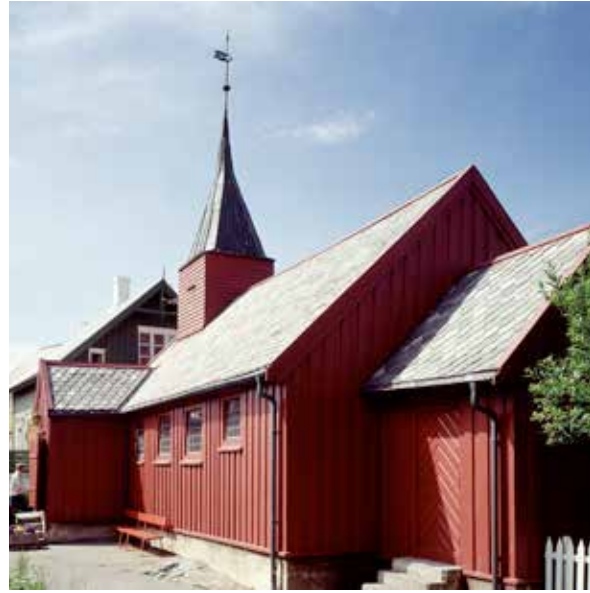
### Grip stave church, Kristiansund

The stave church on the island of Grip is a small church with an original core from the Middle Ages. In 1621 the walls of the chancel were replaced and richly decorated. In the 1870s new windows were mounted and the outer and inner walls were panelled and painted. In 1933 the church was extensively restored and we believe it now looks as it did in the 1600s. During the Stave Church Preservation Programme the church was given new slates on its roof and the spire was repaired and re-roofed. The western wall of the church was given new panelling. Panelling was made using thicker boards to reduce any fire hazard. In 2006 the church was measured and work was done to improve ventilation beneath the floor. The decorative interior painting in the church was restored in connection with the Stave Church Preservation Programme in the period 2001–2006. The distemper painting décor in the nave was cleaned and consolidated. The medieval triptych was also conserved.

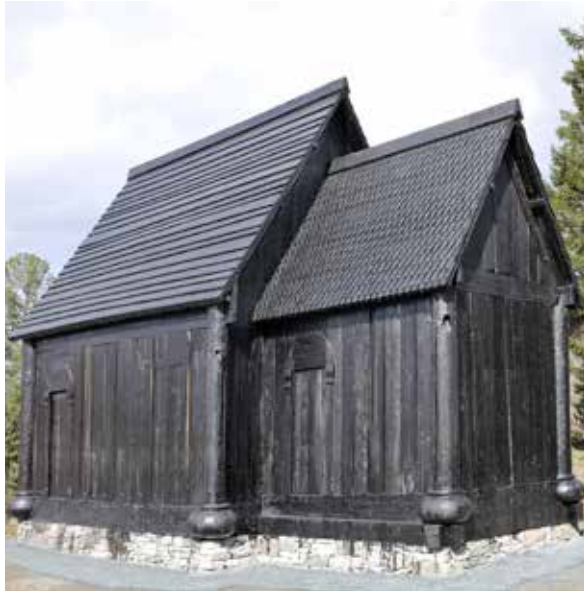
### Haltdalen stave church, Trondheim

Haltdalen stave church was demolished and moved via Kalvskinnet to Sverresborg, where it was re-erected at the Trøndelag Folk Museum in 1937. At this time, it was given a new west wall and portal. The church is small and consists of a rectangular nave in the east and a lower rectangular chancel in the west, constructed from parts from Haltdalen stave church and the western portal from Ålen, which is dated to ca. 1160. Restoration work was done on the church in the 1970s. In 2015 the church was given a new stone wall foundation and the chancel was straightened. Damage from rot was repaired, including the replacement of wall planks on the west. A decision was also made to replace the portal from Ålen stave church with a copy in 2016. The church has been given new shingles and the roof surfaces on the nave were given overlapping boards, a type of roofing that the church had originally. A discovery was made at this time; the nave's southern roof surface appears to have its original boards intact. In connection with the Stave Church Preservation Programme a course was held on the production of roofing material.

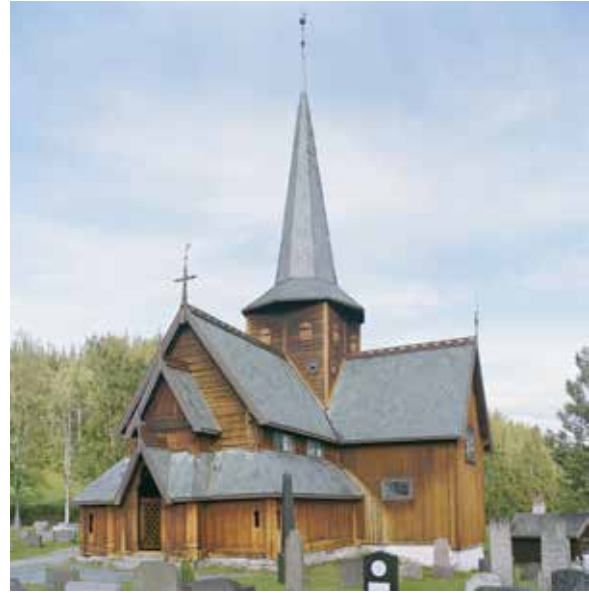
### Hedalen stave church, Sør-Aurdal

Hedalen is dated to after 1160. It was rebuilt as a cruciform church in the late 1600s. In 1902 the church was restored with a new chancel, where the altar is placed today. The church contained art which is considered to be amongst the most beautiful Norwegian works of art from the Middle Ages. Of significance are its dragon portal, crucifix, the Hedalen Madonna (a statue of the Virgin Mary) and unique wrought ironwork on its western door. The bell tower of the church was renovated by filling in where wood had rotten, and repairs to the roof were made. The foundation wall beneath the church was improved and the porch on the north side was jacked up in place against the north wall. The supporting stone wall around the churchyard was improved as well. Maintenance was done on the slate roof and the gutters of the church, and it was also re-tarred in the period 2009–2011. The Hedalen Madonna was returned to the church after 20 years in Oslo. The medieval crucifix and triptych have been restored.

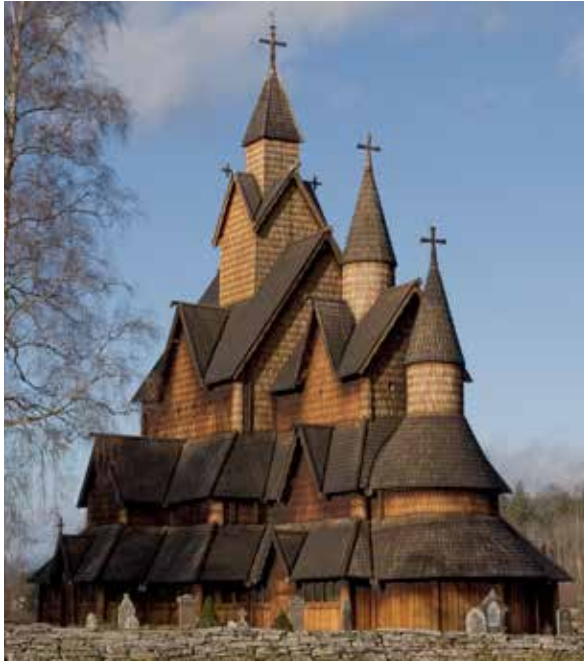
### Heddal stave church, Notodden

Heddal stave church was probably built in the 1200s. The church has a raised chancel and nave and is the largest surviving stave church in Norway. The church was extensively restored in the period 1849–1851. In the 1950s Heddal was reconstructed to return it to its presumed medieval design. The church has four outstanding preserved stave church portals. In connection with the Stave Church Preservation Programme, the bell tower of the church was restored and the gates in the churchyard wall were re-shingled. The flagstones in the pentice were re-laid in 2013. The interior is distinctly influenced by the period following the Lutheran Reformation in 1536–37, and by later restorations. The decorative distemper paintings were cleaned and consolidated in the period 2008–2010. Analyses of the distemper décor were made using new methods to document the extent of the surviving medieval decorations.

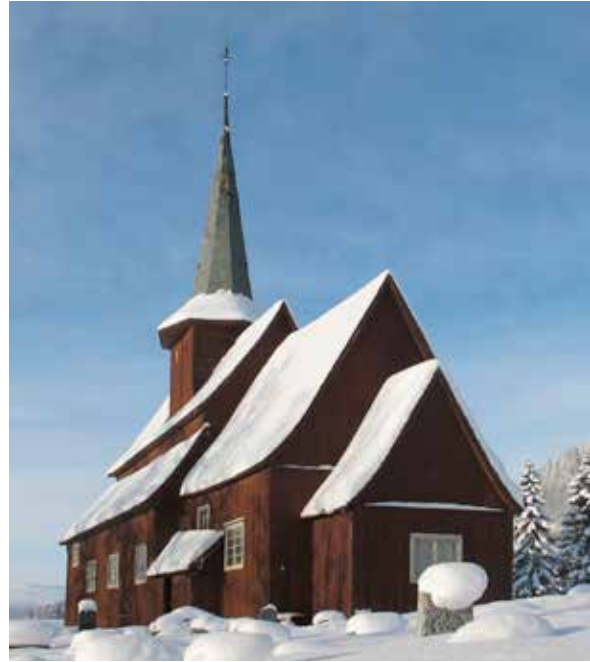
### Hegge stave church, Øystre Slidre

Hegge stave church is dated to the early 1200s. It is a so-called interior post church with a rectangular floor plan. The church was rebuilt and has little original material left from the Middle Ages. A foundation was cast beneath the staves when it was repaired in 1924. It was given a new floor, and during the renovation work the church's walls and staves were painted and new pews were installed. Groundwater seepage had caused severe damage and rot in the wooden structures and the church floor of Hegge stave church over a lengthy period. Drainage improvements were implemented in connection with the Stave Church Preservation Programme to divert and limit the flow of water. Rotten floor beams were replaced and air ventilation in the foundation was enhanced by excavating some of the underlying terrain. The digging was supervised by an archaeologist and intriguing finds were made, including several graves. A cog-jointed bell tower at Hegge stave church was repaired by replacing the rotten timber. The church art was assessed and found to be in good condition. The work on the church was done in the period 2004–2005.

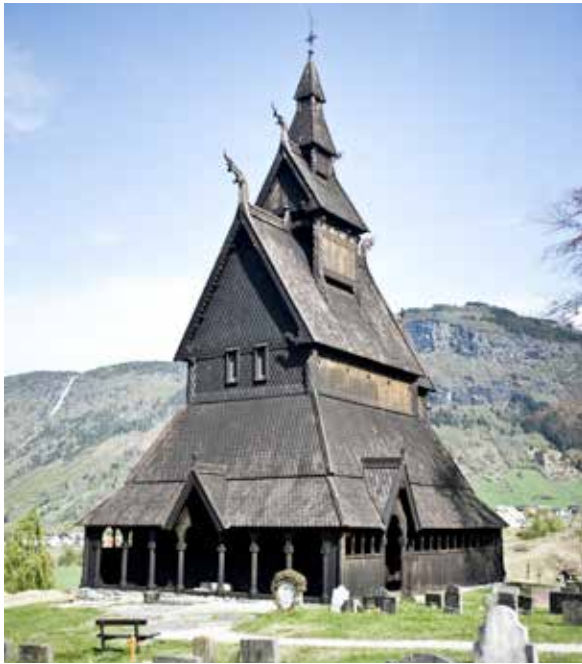
### Hopperstad stave church, Vik

Hopperstad stave church is dated to the 1130s. The church remained fairly unaltered until the 1700s, when the nave was extended to the west and a bell tower was erected above the new section. Due to this renovation, very little of the medieval exterior has been preserved. All four medieval portals are distinctive elements of Norwegian building history. In the 1880s the church was given its present appearance after being restored by the architect and engineer Peter Blix. Under the auspices of the Stave Church Preservation Programme restoration work was done on the portals leading into the pentries. Additional improvements were made to the roof in 2007 and 2008 when a total of 19,000 shingles were replaced. The new shingles were of excellent quality, of pine heartwood cut in the same way as shingles from its restoration in the 19th century. Gutters and fittings were also upgraded and the church was re-tarred. An examination of the wall decoration in the nave and chancel of Hopperstad stave church showed this to be in poor condition and in need of conservation. In addition to the art, two funeral shields and a memorial plaque were conserved.

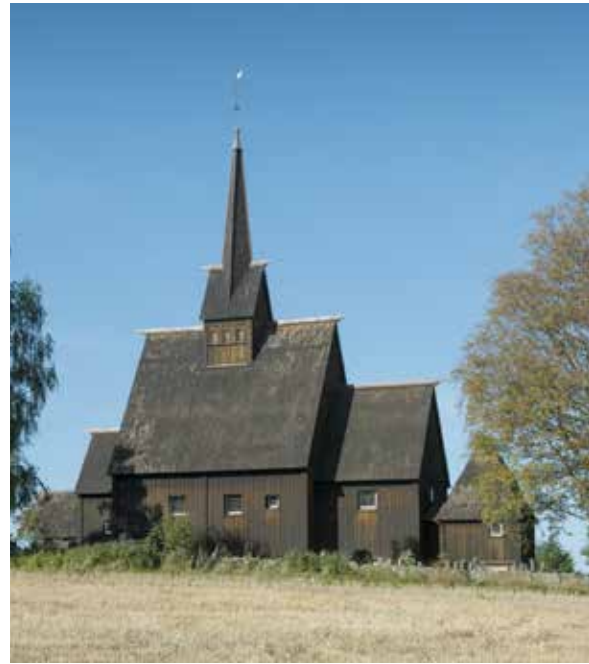
### Høyjord stave church, Andebu

Høyjord stave church is the only stave church in Vestfold county and also the southernmost in Norway to have survived since the Middle Ages. The church was originally of the centre post type. The centre post and a ridge turret were, for reasons that are unclear, reconstructed in connection with restoration work implemented in the period 1948–1953. The chancel is thought to have been built in the last half of the 12th century, but the nave is from ca. 1275. The church also had pentries until 1689. The church has 12 load-bearing staves in addition to the centre post. In 2014, in connection with the Stave Church Preservation Programme, the building was fitted with new shingles and extensive roofing work was carried out. A replica of the church's unique weather vane from the 1200s was constructed, covered with gold leaf and mounted. Measurements have been made of the medieval parts of the church, and a condition assessment was made of its art and furnishings.

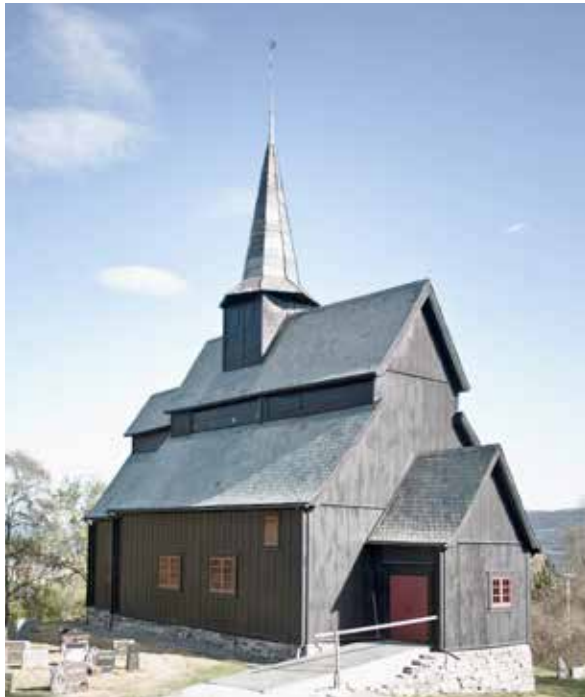
### Høre stave church, Vang

Høre stave church is dated to ca. 1180. The stave church is an interior post church with a rectangular nave and a narrower chancel. It has some of the most renowned Norwegian stave church portals. These are richly decorated with carved leaf motifs and animal ornamentation. An older roof turret was taken down earlier and re-used as a lych-gate, a gateway to the churchyard. The church is characterised by the extensive renovations made in the 1800s. Much of the southern side of the dry-stone foundation was rebuilt. Fungus was discovered beneath the floor in supporting structures and these were replaced. The slate roof was cleaned and damaged stones replaced. New gutters were added and the cog-jointed log bell tower from the 1600s was repaired. Damage was found on the east side of the bell tower, but this is sheltered by the roof and repairs were deemed unnecessary. The work on the church was conducted in the period 2005–2007. The condition of the church art was registered and found good.

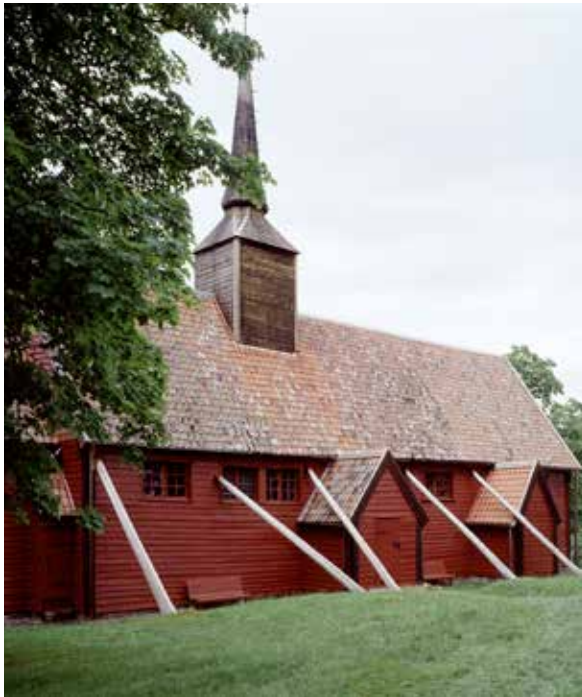
### Kvernes stave church, Averøy

Kvernes stave church may be one of the country's youngest, dated to ca. 1300. The church is of the so-called 'Møre type' with its characteristic construction. The nave and chancel are both from the original church. The chancel is cog-jointed at the same width as the nave. Kvernes is particularly exposed to weather. As a result, in 2015 under the Stave Church Preservation Programme, several smaller portions of the outer panelling were replaced and spliced. The church's outer supporting struts were repaired and new lead fittings were mounted on the ridge turrets and gutters. Damaged roof tiles were replaced. The interior furnishing of the church were treated in the period 2011–2013. The walls in the nave and the baptistery, a royal monogram on the chancel screen and the door on the south side of the chancel were consolidated and repaired. The triptych from the late Middle Ages and an epitaph from 1671 were conserved.

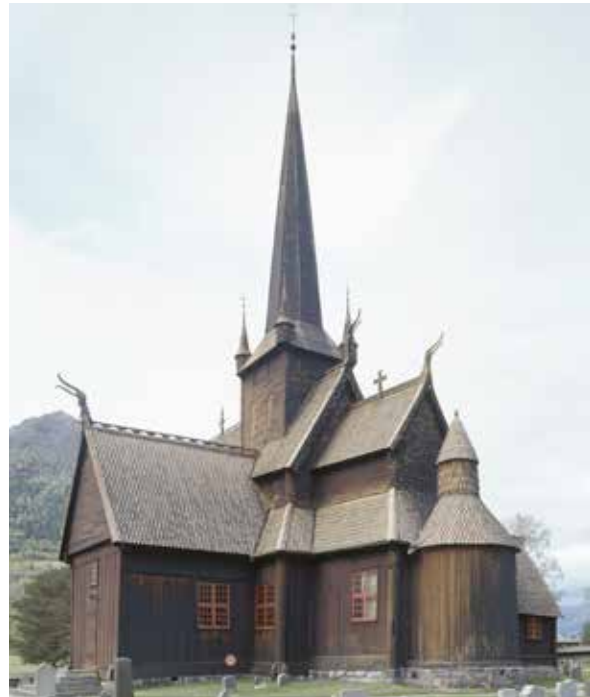
### Lom stave church, Lom

Lom stave church is dated to ca. 1160 and is one of the largest stave churches in Norway. The nave has detached staves round an elevated interior post structure with a pentice on all four sides. The stave church has a narrower chancel which is also elevated. Major changes were made to the church in the 17th century. In 1634 the church was expanded to the west with a notched log addition with a gallery. More room was needed in 1664, so a framework transept was added to both long sides of the church and a sacristy was placed on the north side of the chancel. Under the auspices of the Stave Church Preservation Programme, the churchyard lych-gate was restored and the churchyard wall was repaired with new shingling. Shingles on the church were also replaced and gutters and drainpipes were repaired. The church was re-tarred. Major conservation was carried out on the art in Lom stave church in 2009. Work was done on the corpus of the triptych and the chancel screen and the altarpiece and two coat-of-arms were taken out of the church for restoration in conservation studios.

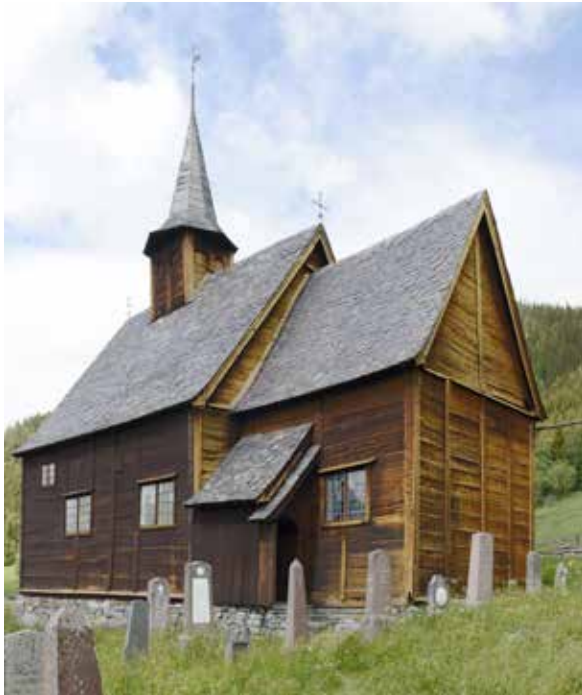
### Lomen stave church, Vestre Slidre

Lomen stave church is dated to the end of the 12th century and was rebuilt in 1749 to look as it does today. The church is perched on a hill and had suffered sinkage and destabilisation. This has also occurred earlier in its history and the church was straightened in both the 1600s and 1800s. In the course of the Stave Church Preservation Programme the southern long wall was jacked up. In this connection, a stave was repaired, several parts of the dry-stone foundation were repaired and improved. Loose soil was removed from beneath the church, a job which was supervised by an archaeologist. Fungal rot was discovered in one of the staves beneath the floor and had to be repaired. The slate roof and the windows were examined and repaired. In the bell tower, from 1771, rotten timber was replaced or filled in and the slate roof was renovated. A large tree in the churchyard growing right in front of the entrance to the porch was felled. The dry-stone graveyard walls were repaired. The work continued from 2004 to 2007. The condition of the church art was registered and a canvas painting from the 1600s was restored.

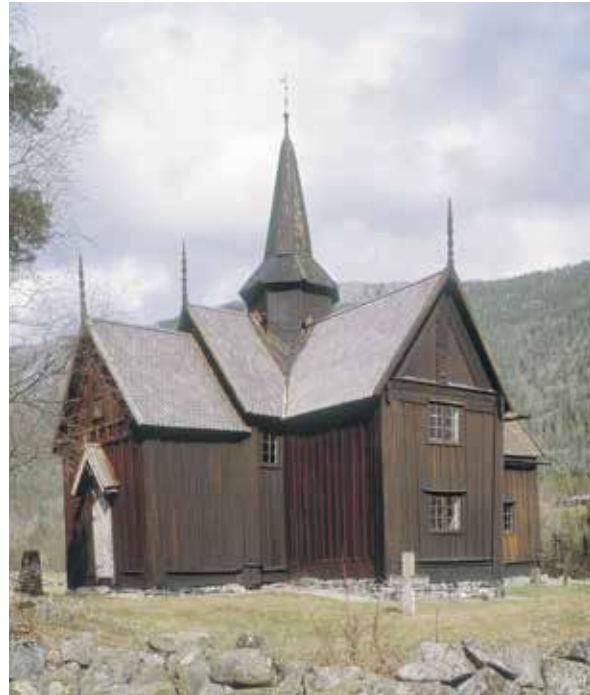
### Nore stave church, Nore and Uvdal

Nore stave church is dated to ca. 1170. The church is of the centre post type. The church has been expanded and rebuilt multiple times. A new chancel was built in 1683 and the first transepts were replaced in the beginning of the 18th century. As early as the 1700s, several walls of the church were clad with vertical wood panelling and it was given a new roof turret 1730. The interior is dominated by the post-Reformation furnishings from the renovation in the 1600s and 1700s. The decorative paintings in the church are also from this period. Nore stave church was in the poorest condition of all the Numedal churches. Improvements have been made to the load-bearing structures of the church, in the nave, transepts, and the bell tower. However, damaged portions have been retained in several sections of the structure, in keeping with a wish to keep changes to a minimum. New shingles have been added to several of the roof surfaces. The re-shingling work was implemented in two periods, first in connection with the work in 2002–2006, then in 2015. Rotten logs have also been replaced in the sacristy. The interior panelling was dismantled in this connection. Conservation work was carried out on the distemper painting in several parts of the church in 2004 and 2005.

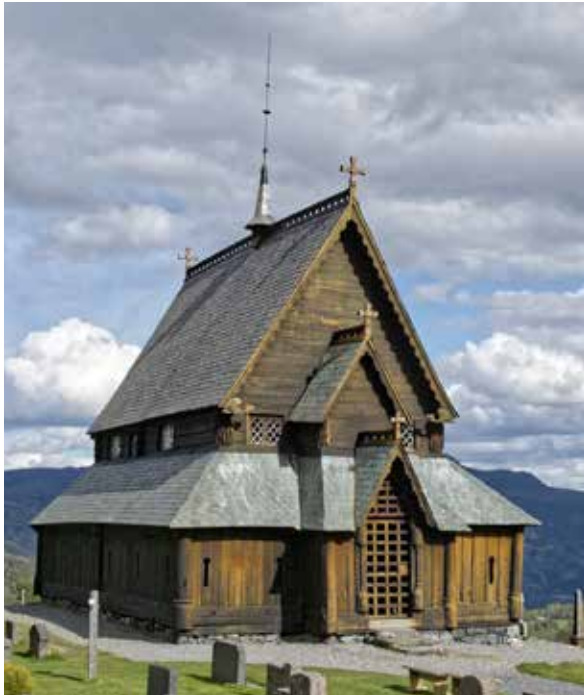
### Reinli stave church, Sør-Aurdal

Reinli stave church is dated to the early 14th century. Traces have been found of earlier churches on the site, as is the case with many other churches. Reinli is the one of the stave churches built with a nave and chancel of equal width, a so-called long church, and one of the best preserved. It has six portals, three in the portico and three in the church itself. The church was repaired in the Stave Church Preservation Programme from 2007 to 2009. Major improvements were made to the roof, which was damaged by rot. The damaged slates were replaced and the rot damage was repaired. The churchyard wall had collapsed. Stones were taken down and re-stacked to straighten the wall. The foundation beneath the church was also repaired. The bell tower, which is a combination of staves and cog-jointed timbers, was restored after severe rot was detected. In 2007 the church art was restored. The triptych and the pulpit were consolidated and the antependium in the stave church was repaired by a textile conservator.

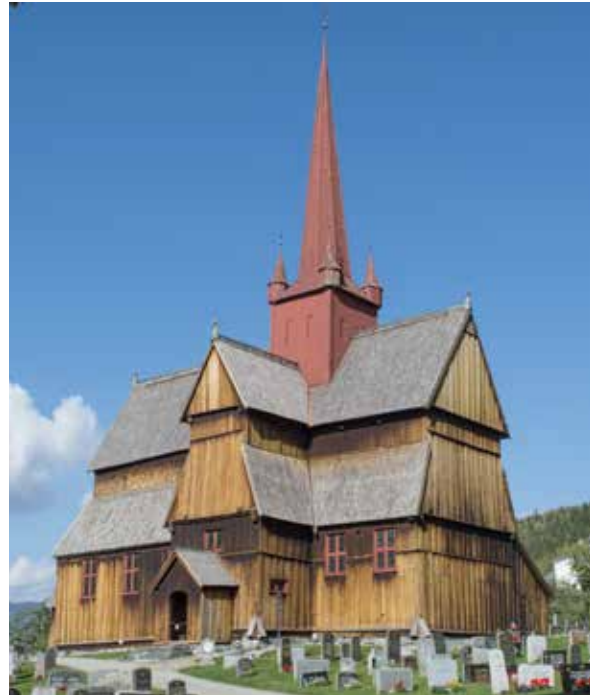
### Ringebu stave church, Ringebu

Ringebu stave church is one of the largest stave churches in the country. The church is dated to the beginning of the 1200s and has been in use continuously. The church was originally cruciform but in the 1630s it was extended with new transepts, a chancel and a new bell tower. In the course of the Stave Church Preservation Programme, the church was given new shingles and re-tarred. The southern churchyard wall was repaired and one stave was given a new foundation. Two medieval crucifixes were treated at the start of the preservation programme. One of them was returned to its medieval state, looking as it did before being painted over in the 18th century. Extensive work was done on the church interior, including the consolidation and repainting of the decorative distemper painting in the chancel. The work on the church was carried out in the period 2010–2015.

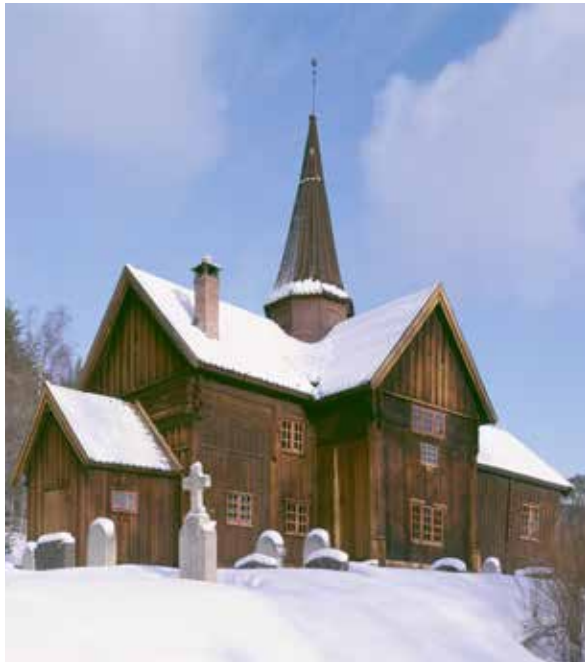
### Rollag stave church, Rollag

Rollag stave church was first mentioned in written sources in 1425, but on the basis of historical style it probably dates to the 13th century. In 1670, the stave church's chancel was replaced by a larger one made with cog-jointed logs. Transepts of stave construction were later added and additional alterations in 1760 gave the church its current form. Work on the church was carried out in the period 2003–2006. It was severely damaged by rot in parts above the southern transept. Drainage work was done on the north side of the church to lead water away from the building. Rot was also detected in the lower parts of the northern and southern transepts. This rotten wood has been replaced. In the sacristy, parts of the logs had been replaced earlier but new rot damage had occurred since the previous repairs in the 1930s. Damaged logs were filled in without removing inner panels. Large parts of the tiled roof and the gutters have been fixed. The church art has been restored. Among other things, a medieval crucifix, two epitaphs and a part of a gable from the 1600s have been conserved. One of the epitaphs proved to be painted on both sides. The painting on the reverse side had probably not been seen for over 240 years.
