# PRESERVING THE STAVE CHURCHES

## CRAFTSMANSHIP AND RESEARCH

## Craftsmanship and Research

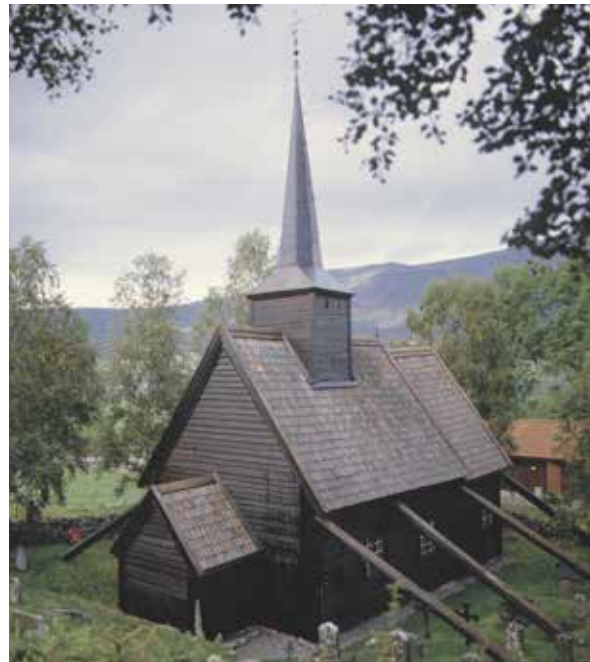
### Rødven stave church, Rauma

Rødven stave church has an uncertain dating in its present form, but remnants of the southern portal are dated to the 12th century. The church is of the so-called “Møre type”. It was built in several phases but the construction history is not fully understood. The original chancel and pentices were demolished in the 1600s and a notched log chancel was built later. Special features of the interior are the furnishings and the decorative painting from the 17th and 18th centuries which have seen little change. Structural damage was mainly restricted to the tower, which was taken down so that improvements could be made. Rot has also been detected in the original stave constructions but this has not been fully repaired, as it was sufficient to replace the most damaged parts. The connecting parts of the wall structures were had rotted away, so new steel ties were attached behind the exterior panel. The roof was strengthened. Work on the church was implemented in 2003–2005. The condition of the art and inventory in the church was registered and they were treated according to need.

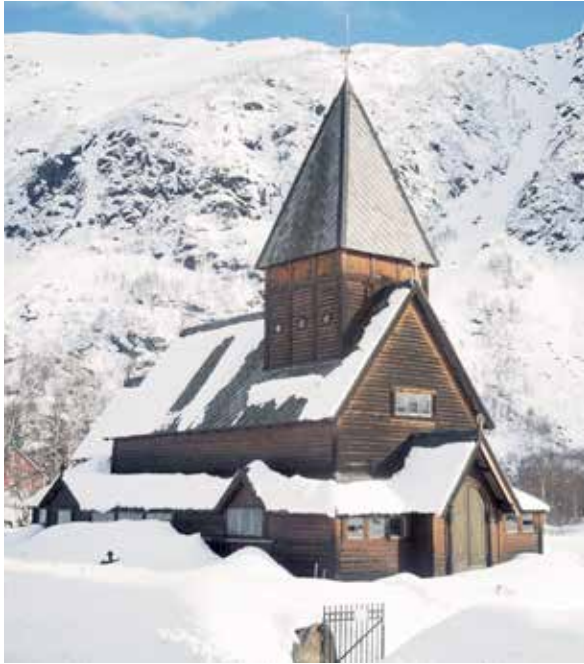
### Røldal stave church, Odda

Røldal stave church is dated to the 1200s. The church was originally built with a chancel and nave of equal widths. In the 1600s the nave was given a new ceiling and the church had new furnishings. In 1844 the nave was extended to the west and made higher with a new ceiling. At that time the walls were clad with boards inside and out and the church was given a smaller chancel. The current appearance of the church interior is the result of extensive rebuilding and restoration in the period 1915–1918. A number of lesser improvements were made in 2015 in connection with the Stave Church Preservation Programme. Damaged panel boards were replaced, and damaged slates on the roof were replaced and new zinc fittings were mounted. The foundation wall of the church on the north side was repaired and the condition of the church art was registered.

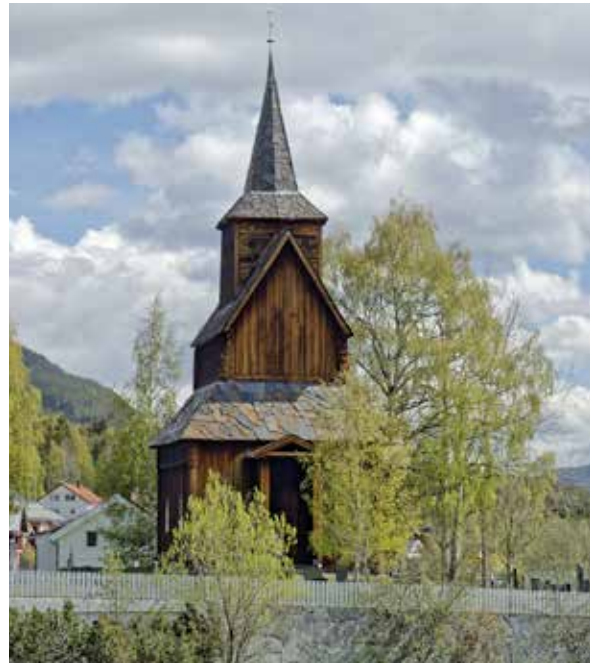
### Torpo stave church, Ål

Torpo stave church is dated to the latter half of the 1100s. Only the nave of the original stave church survives, after the chancel and apse were demolished in 1880. The roof was originally wood-shingled but in the 1800s it was given a slate roof. The church interior has a baldachin with a representation of Christ and a hagiography. The ceiling decoration in distemper paint was consolidated in the period 2007–2009. The stave church has been found to be otherwise in good condition. Minor improvements and restoration work were carried out under the auspices of the Stave Church Preservation Programme.

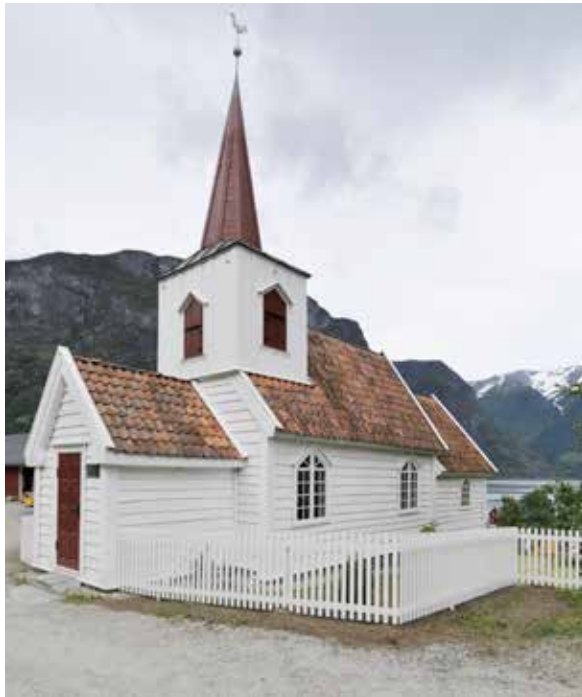
Undredal stave church, Aurland

Undredal stave church is the smallest of the stave churches still in use. The church dates to the latter half of the 1100s. A characteristic of the church is the original decorative distemper painting on the walls from the 1600s and the staves have bell-shaped pedestals. In 2012 the church was elevated by about 30 centimetres and a new foundation wall was added to prevent water damage. Work on the church provided an opportunity to study the exterior of the walls in the stave-built nave, which have not been examined since the mid-1800s. In connection with the Stave Church Preservation Programme the connections between sills and corner staves were studied, along with construction elements which had not previously been documented and investigated. In 2013, the pulpit and the distemper paintings on the ceiling and walls were treated.

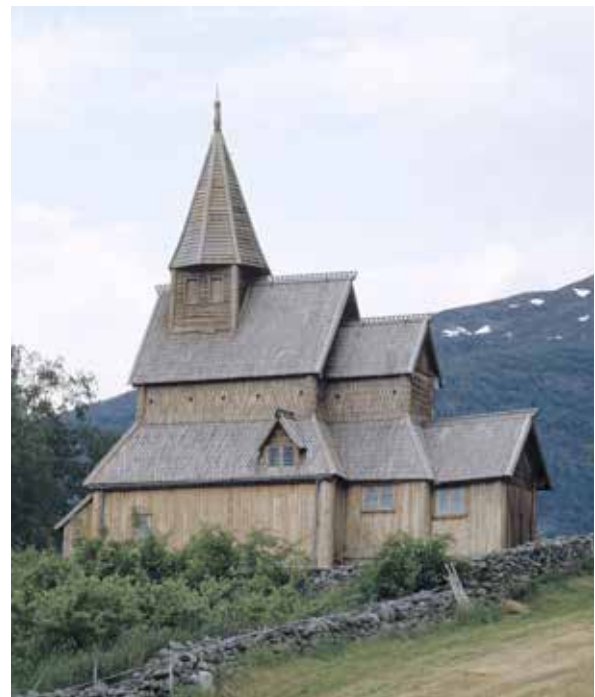
Urnes stave church, Luster

Urnes stave church is dated to shortly after 1130 and is the only stave church listed by UNESCO as a World Heritage Site. Churches have stood at this spot since the 11th century. The church is of the so-called interior post type with a nave elevated in relation to the pentices. Stability was a major problem at Urnes because the foundations had deteriorated. This had led to a critical situation for the north wall, putting a load on the wall planks. In the Stave Church Preservation Programme the north side of the church was jacked up and new foundations were provided beneath all the structural supports. The ridge turret was straightened after the church was raised. At the beginning of the preservation programme the calvary group in the church was taken apart and consolidated. Later the entire church was emptied of furnishings and the floor was removed. In connection with this work, the condition of the ornamental distemper decoration in the chancel was assessed and in places this was cleaned and consolidated. The remaining church art was also assessed and treated where this was deemed necessary. The work at Urnes was conducted in the period 2007–2011.

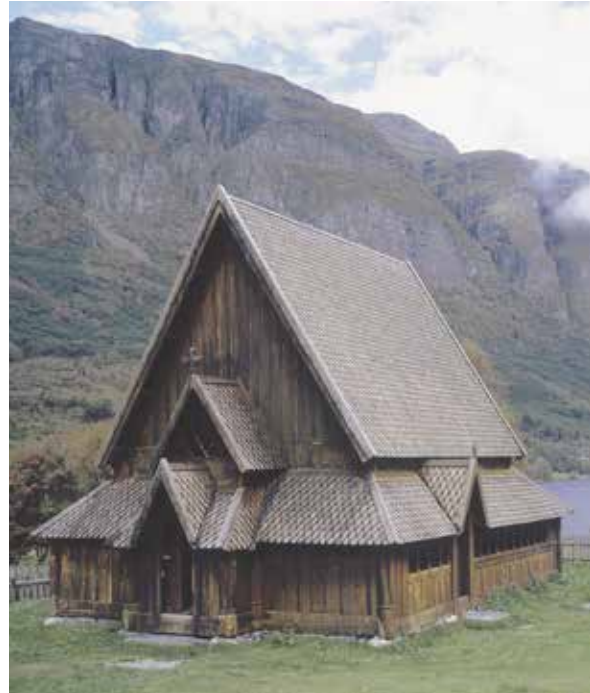
### Uvdal stave church, Nore and Uvdal

Uvdal stave church is dated to 1170 and is of the centre post type. The church has been renovated many times and was made given its cruciform shape with a ridge turret around 1725. The transepts are also built in a stave construction. The portals, half-masks next to the chancel opening and the woodcarvings in the western gallery are from the Middle Ages. The painted Renaissance decor is from the 1600s, whereas the Rococo decor is from the 1700s. Severe damage was found in several of the roof surfaces of Uvdal stave church. Roof surfaces that were particularly damaged due to exposure to harsh weather were re-shingled. The shingles on the spire have also been replaced. The shingles were hewn by axe from thick, straight-growing heartwood pine. The shingling was carried out in two periods, first in 2003–2005 and then in 2014. The condition of the church art has been registered and categorised as being good.
